REPORT # 16-Const-0120P

A RESIDENTIAL PROPERTY LOCATED AT
XXX TRAILS, Any Where City, TX 77XXX

ENGINEERING INVESTIGATIVE REPORT

Subject Property: XXX Trails, Any Where, TX 77XXX

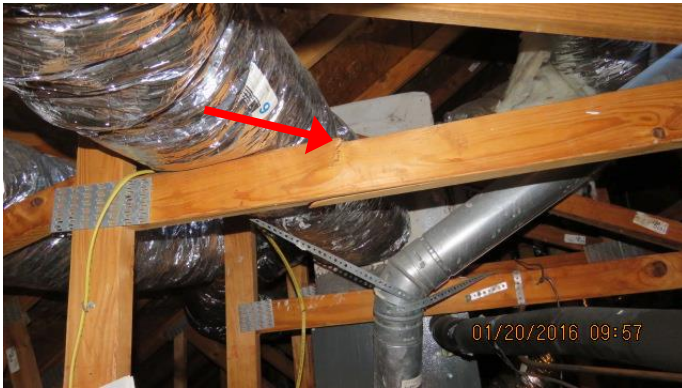
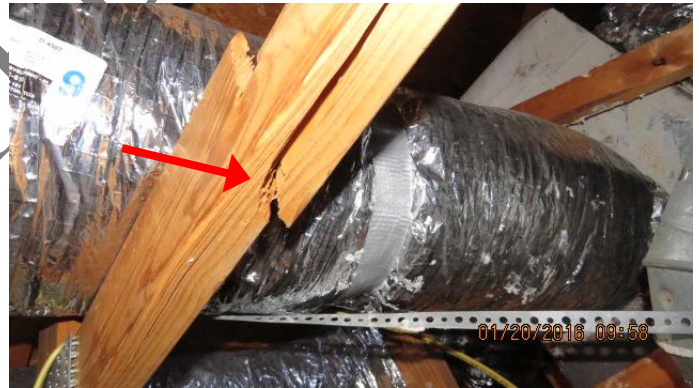
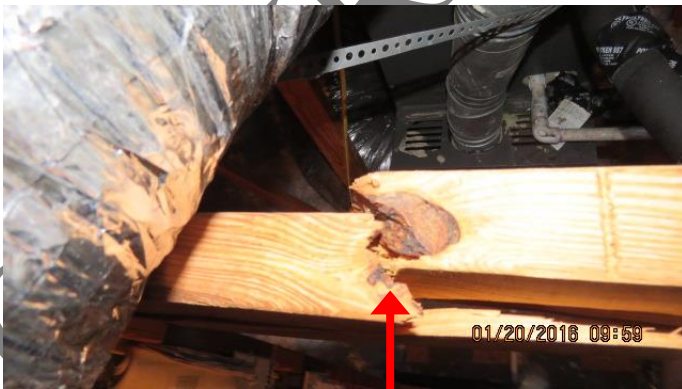
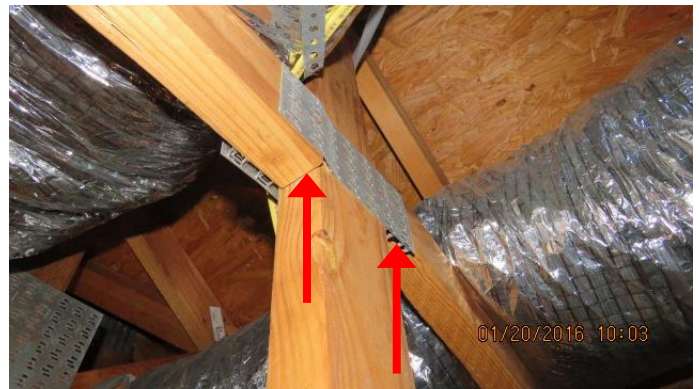
1. It was the third truss on the left as I walked into the attic. See first row left photo.
2. There was a main tension member that was badly cracked.
3. First row right photo depicted the condition of the underside of the member while the second row left photo showed lateral shift of damaged piece on back side of the member at the knot.
4. Second row right photo showed a lateral shift (left arrow) at the front end of the main tension along with the shift in gusset plates (right photo).

1. The truss, in question, was unsafe in its present condition.

In the opinion of the author of this report, attic framing had failed to serve its intended purpose due to indicated conditions cited above and the attic framing was potentially unsafe.

A drawing of intended repair to the affected truss is enclosed at the tail end of this report and becomes a part of this report by reference.

A close monitoring by a Licensed Professional Structural Engineer, from Foresight Engineering & Inspections, LLC, is recommended.
