## STRUCTURAL & MECHANICAL SYSTEMS' CONDITION SURVEY REPORT

**1234 ABC ROAD**

**HOUSTON, TX 770XX**

**(XYZ APARTMENTS)**

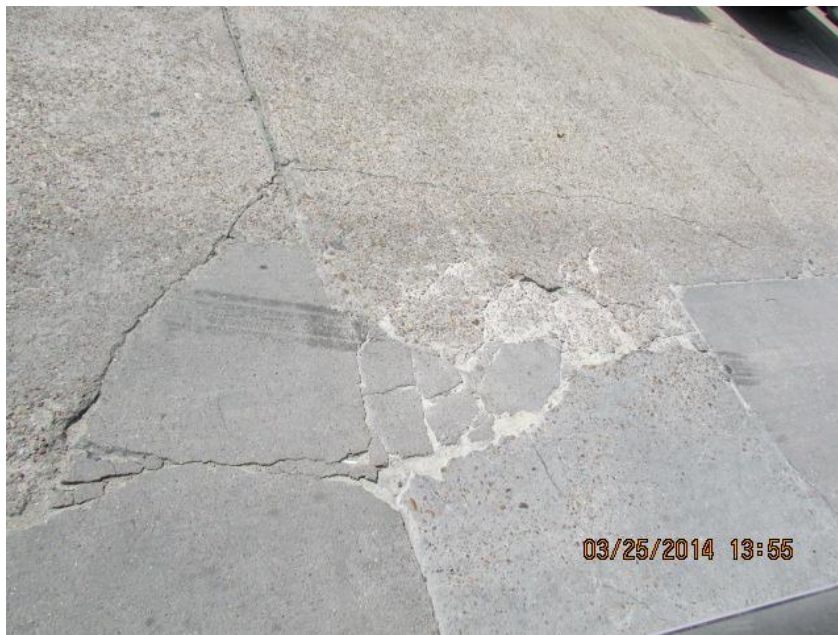
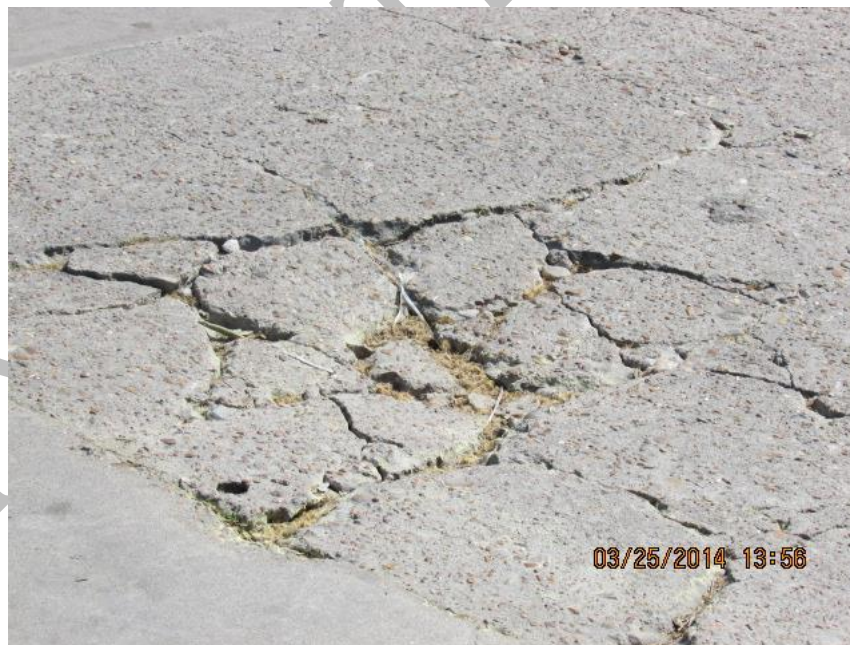
Concrete paving was cracked in many locations with some repairs appeared to have been performed in the past. See photos #ed 01 and 02. The paving appeared to be in fair condition. Underground drainage was noticed in the paved areas of the parking.

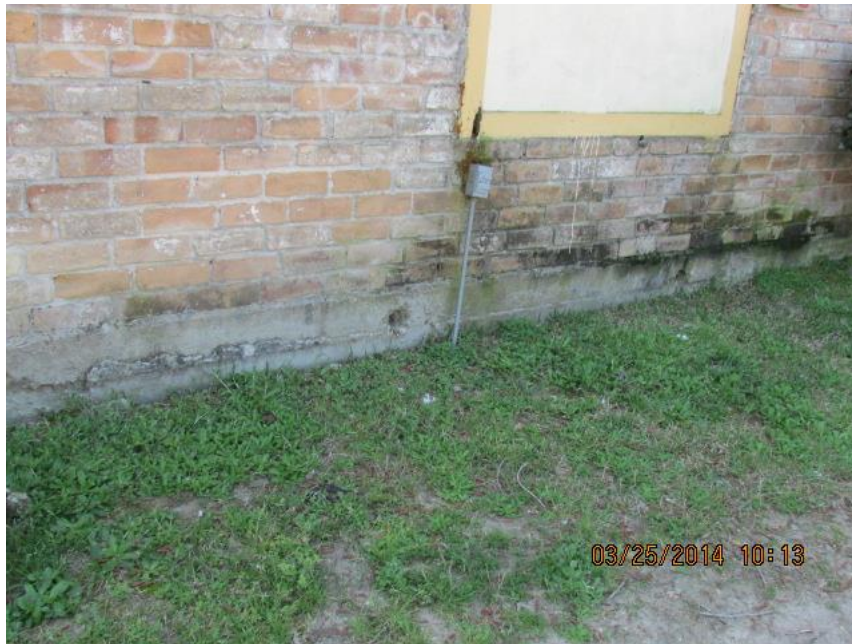
**PHOTO NO. 03**

I walked around all the 16 buildings and surveyed the accessible areas of the foundation. The foundation appeared to be post-tension slab system. Dead ends were exposed as can be seen photo #03.

I recommend that all exposed post-tensioned cable ends be covered with a good quality cement mortar and that foundation should have a minimum exposure of 4" above grade for brick veneer and 6" above stucco or wood siding.

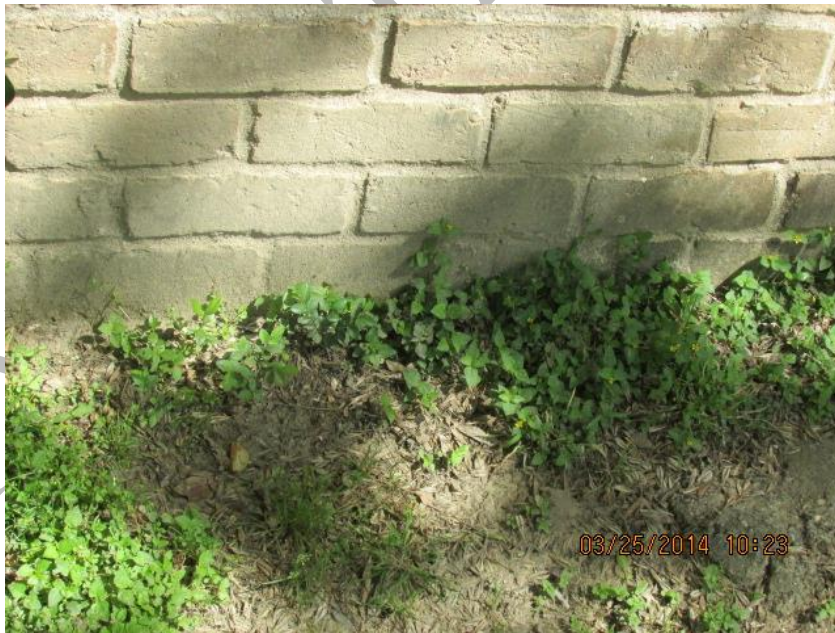
**PHOTO NO. 04**

Insufficient &/or missing weep holes in first course of brick/stone veneer wall at foundation level. Weep holes should be placed at no more than 33 inches on centers to provide sufficient wall breathing and minimize chances of fungal growth and disintegration of framing members from any moisture build up. See photo #ed 03 and 04.

**I also recommend that additional weep holes should be placed in the first course of bricks so that the spacing is no more than 33 inches on centers. Also one to two weep holes should be placed in each post. The concrete paving and landings where it is partially or fully covering the weep holes should be re-poured to allow at least 2" of foundation exposure. This will prevent water to pond and stagnate in the wall cavity and minimize chances of fungal growth and disintegration of structural members.**

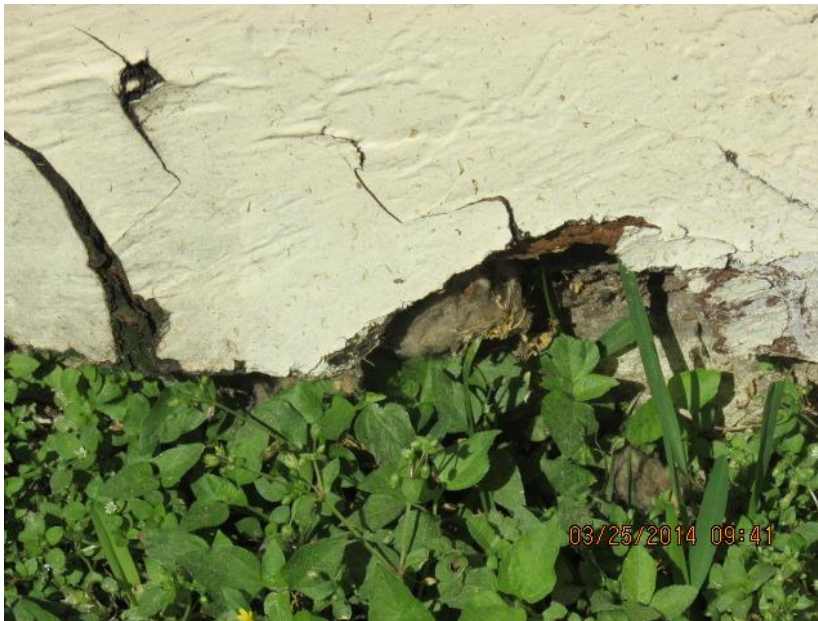
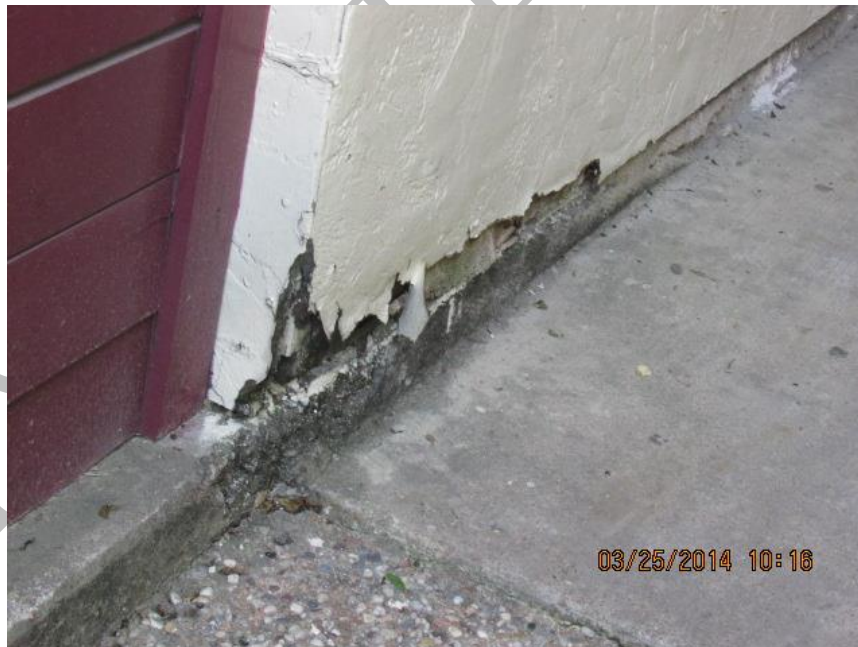
Deteriorated/warped masonite siding was observed in most areas. Masonite siding deteriorates much like an old sponge. As the material deteriorates, the layers of the laminated materials start separating and falling. Masonite siding has been the subject of any number of lawsuits and funds from these lawsuits had been set aside for the replacement of the siding. It is not known if any of these funds are still available. You should determine if there are funds from these lawsuits available for the replacement of the siding. It was in poor condition in many areas especially near the bottom. See photo #ed 05 and 06.

**I recommend that all rotted/warped masonite siding be replaced with cement based siding. All holes should be sealed with a good quality sealant.**

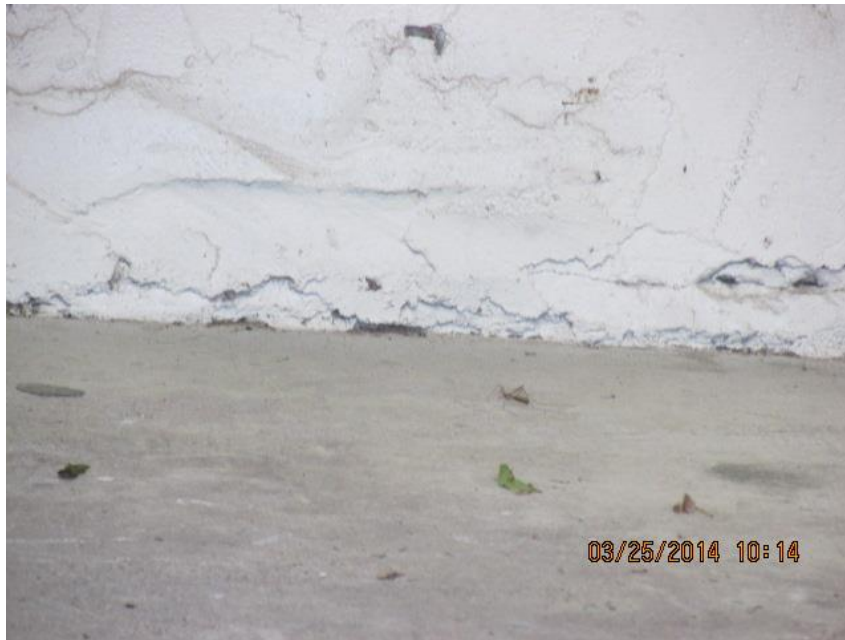
**PHOTO NO. 07**

Stucco was the second most common siding material on the exterior. It was improperly installed. Stucco veneer was not a minimum of 2" above the hard surface per industry standards. See photo #07. Weep screed was missing at the bottom of stucco for venting stucco. Stucco was damaged in some areas especially on building #11.

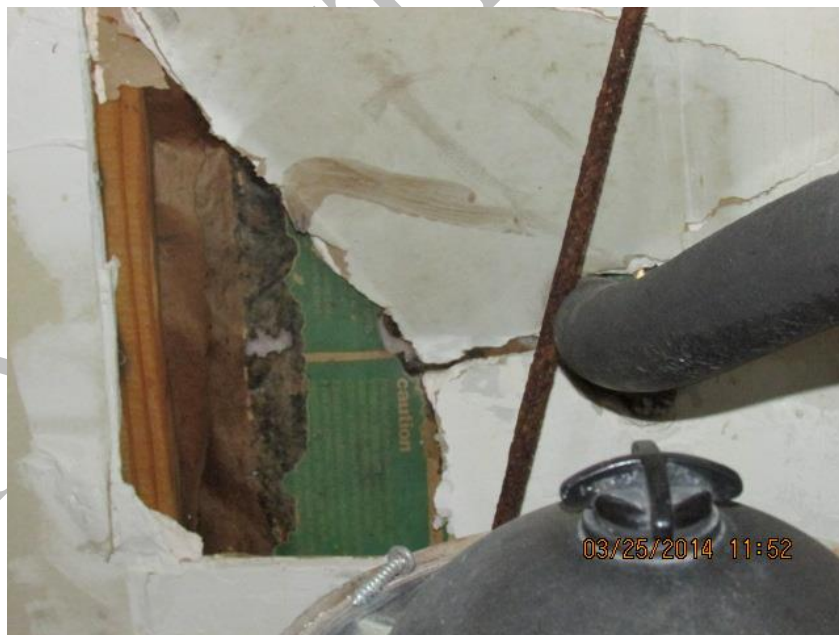
**PHOTO NO. 10**

Interior accessible walls in visible areas of 11 surveyed units appeared to be good condition except the walls in the boiler room and pool equipment room where drywall was missing. See photo # 10.

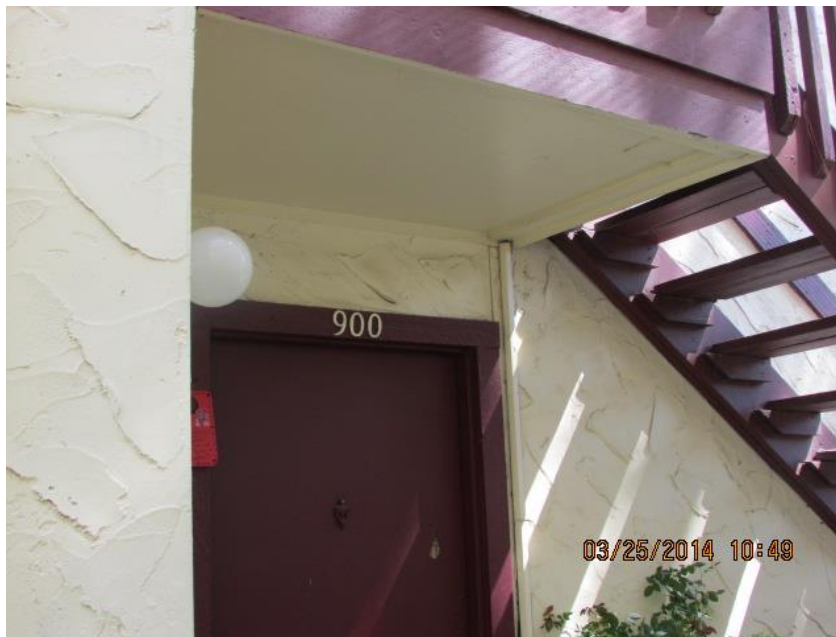
**PHOTO NO. 11**

Flashing was missing over many exterior openings (see photo #11) or improperly installed on many other openings (photo no. #12)-this is an unsafe condition. Prompt attention is recommended.

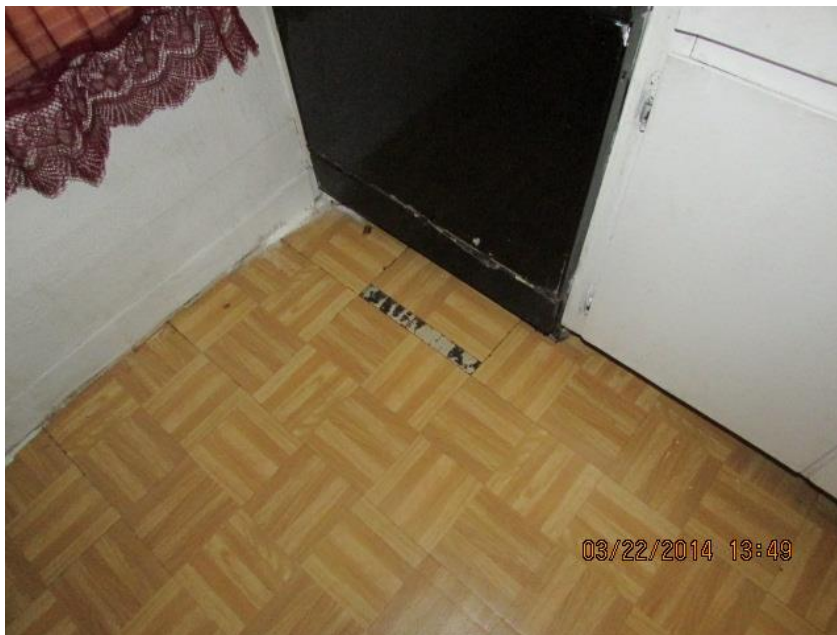
**PHOTO NO. 13**

Vinyl was damaged in breakfast area in unit # 119 and in the kitchen & breakfast area in unit #300. See photo #13.

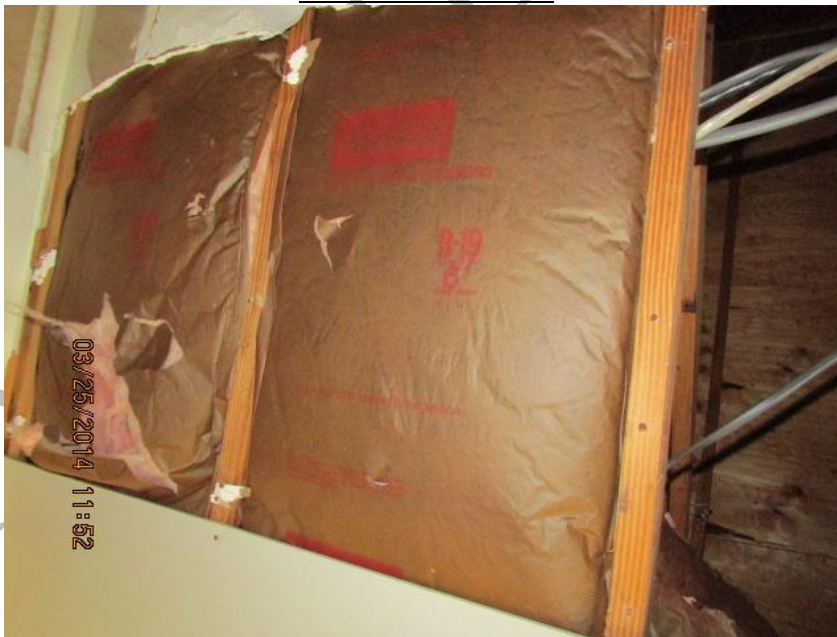
**PHOTO NO. 14**

Ceiling was missing pool equipment room which was a part of building #4 and houses furnace for the office areas. See photo #14. Metal collar was missing around boiler's exhaust vents in building #9. See photo #15. Such conditions present unsafe conditions as the fire to traverse quickly into the office areas and adjoining rentable units in building #9 as the fire barrier was broken.

**I recommend that all drywall repairs promptly to reduce risk of loss and liability.**

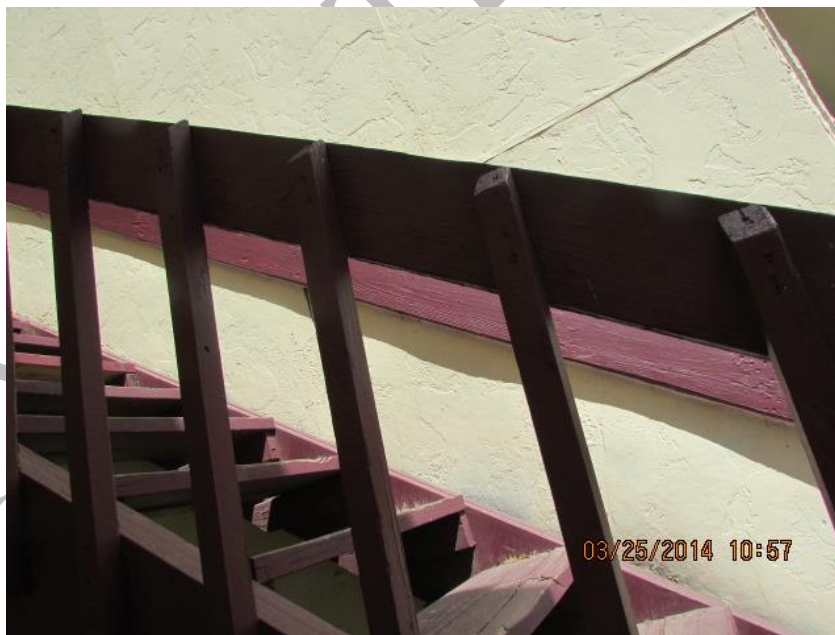
**PHOTO NO. 16**

I observed that the intermediate baluster spacing on stair rails exceeded 4 3/8" clearance. Such opening(s) are unsafe for small children as they have a potential of getting their head stuck &/or falling in such open areas and hurting themselves. Maximum allowed spacing between intermediate balusters should not allow passage of a sphere 4 3/8" in diameter. This is potentially an unsafe condition and violates safety code. See photo #s 16 and 17.

Wooden non-grippable handrails on most stairs. This is potentially an unsafe condition. Handrails should be round and the diameter should be between 1 1/4" to 2 5/8". See photo #s 16 and 17.

Open tread spacing on stairs exceeded 6". Such opening(s) are unsafe for small children as they have a potential of getting their head stuck in such open areas &/or hurting themselves. See photo #s 16 and 17.

**It is strongly recommended that adverse phenomenon of steps, treads, stair and guard rails should be promptly addressed to minimize any mishaps and reduce liabilities.**

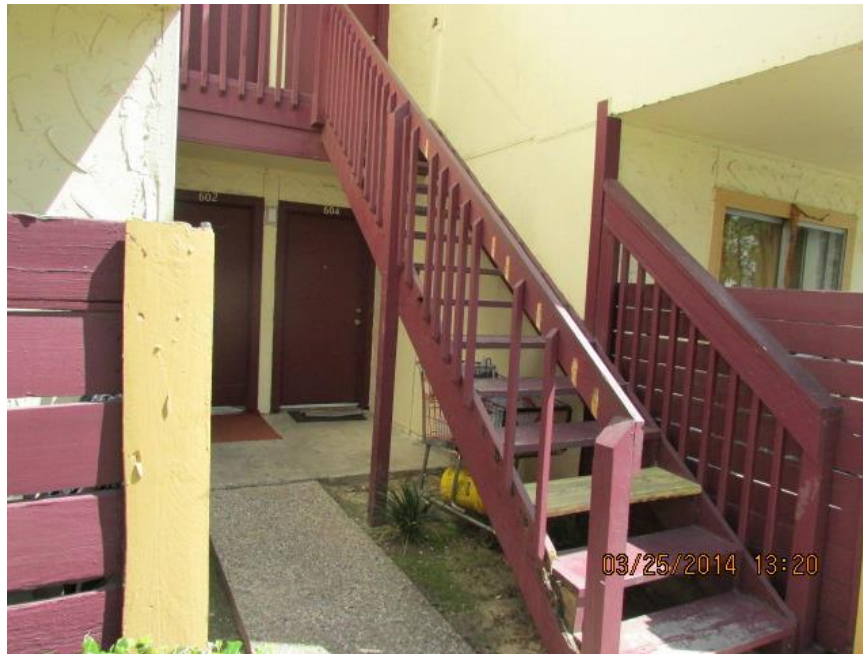
**PHOTO NO. 17**

Balusters were missing on many stairs. See photo # 17. Hand rails were loose on many stairs.

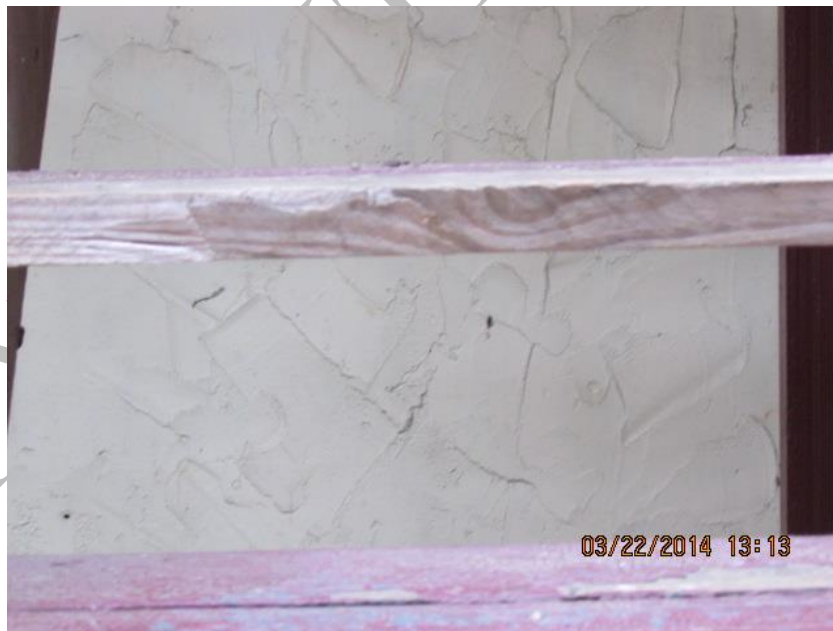
**PHOTO NO. 18**

Steps were damaged &/or were rotted on some stairs. See photo #18.

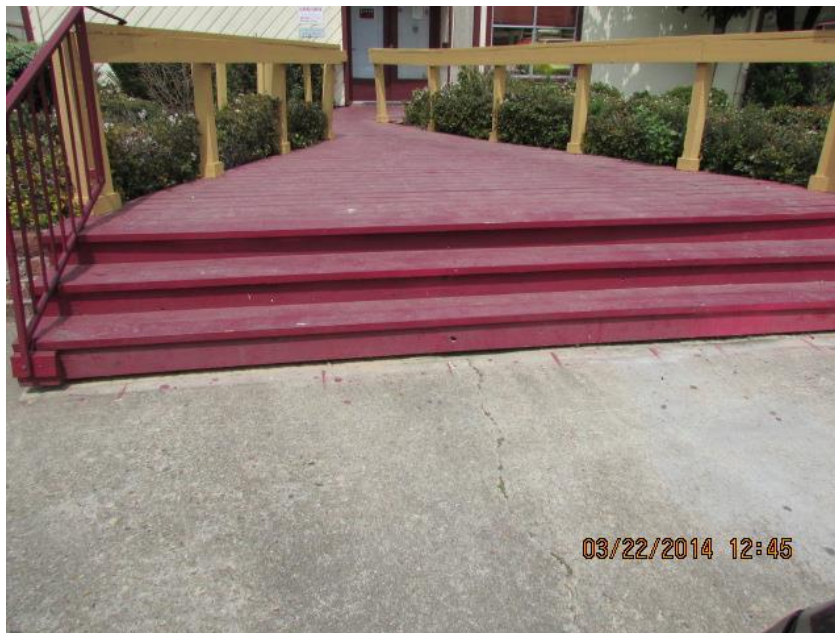
**PHOTO NO. 19**

Risers on steps to the office building were uneven. See photo #19. Maximum difference between tallest and shortest riser should not exceed the maximum limit of 3/8" & do not comply with current industry standards, and was unsafe. This condition should be altered for improved safety.
