STRUCTURAL & MECHANICAL SYSTEMS SURVEYING REPORT

FOR PROPERTY LOCATED AT
**1234 FM ABCD EAST
HOUSTON, TX 77009**

Reg.: PROPERTY CONDITION SURVEY – 1234 FM ABCD East, Houston, TX 77009

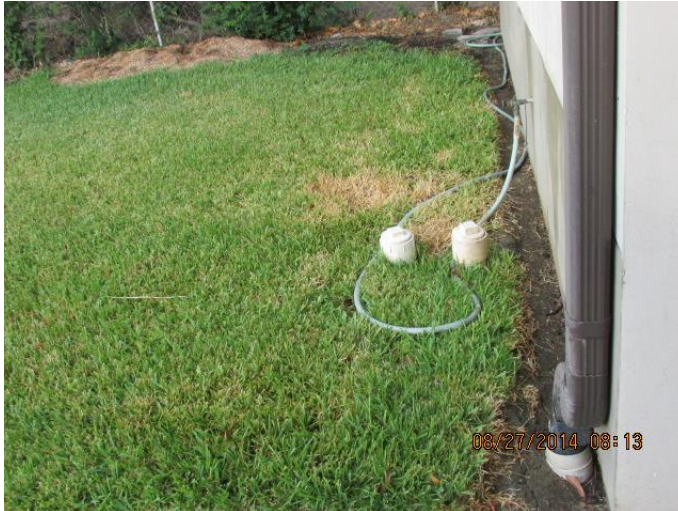
PHOTO NO. 05

4. There was a negative slope on the left side (s) of the property causing ponding. Such areas of potential ponding adjacent to the foundation should be eliminated as such areas could cause differential movement of the foundation &/or water intrusion during heavy rains and could cause fungal growth and structural decay. Common industry practice requires that 4" (for brick veneer) and 6" (for other cladding) of clearance should be maintained between soil level and the top of the foundation walls and the grade away from foundation walls should fall about 6" (more the better) within the first 10' or to a swale when 10' is not available. See photo #05. Some of the discharge may be collected by the catch basin in photo #06.

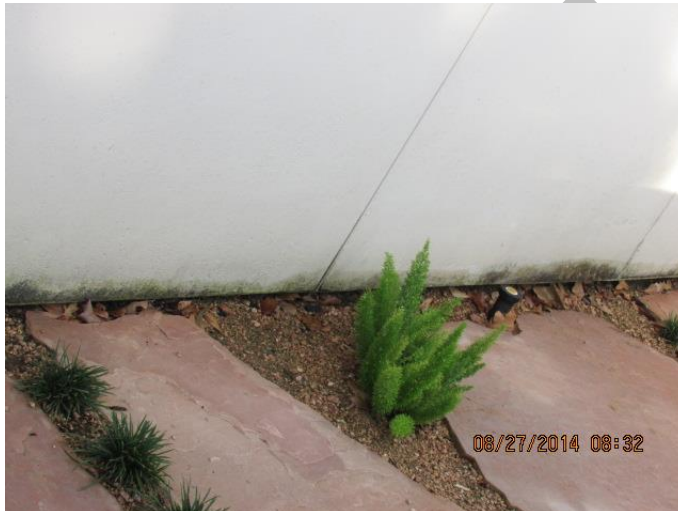
PHOTO NO. 07

1. The height of the backfill (soil adjacent to the foundation) appeared to exceed the acceptable limit. Such a condition has the potential of water intrusion in the house during heavy downpours. Common industry practice (and also current IRC Code References: 404.1.6 height above finished grade) requires that concrete and masonry foundation walls shall extend above the finished grade adjacent to the foundation at all points a minimum of 4 inches (102 mm) where masonry veneer is used and a minimum of 6 inches (152 mm) elsewhere. See photo #07.

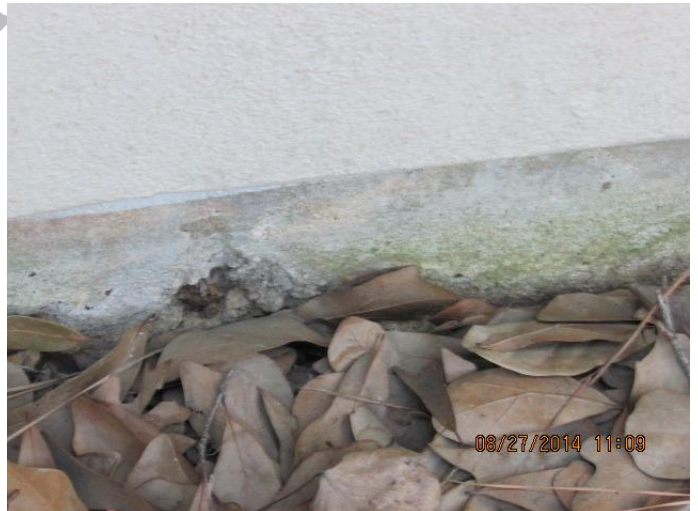
PHOTO NO. 08

2. Exposed &/or rusted post tension cable ends were observed on the exterior of the foundation. This should be protected to prevent further corrosion and foundation problems. See photo #08.

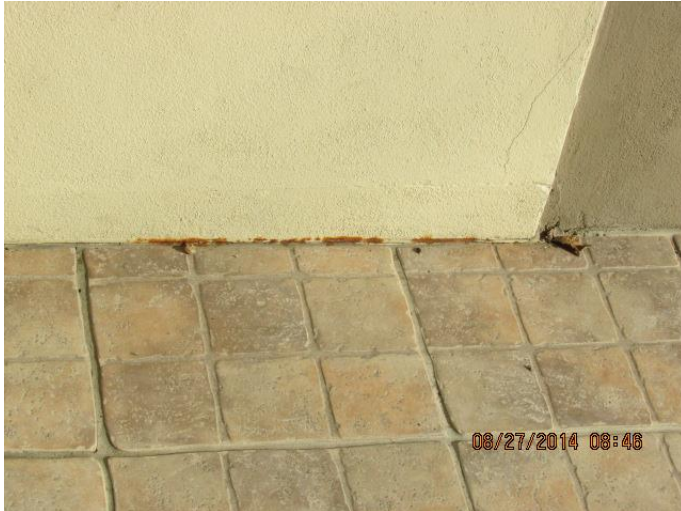
PHOTO NO. 09

1. Stucco/stone/brick veneer was not a minimum of 2" above the hard surface per industry standards and recent IRC codes. See photo #10.
2. Weep screed was missing or blocked at the bottom of stucco in some areas required for venting stucco. See photo #09.

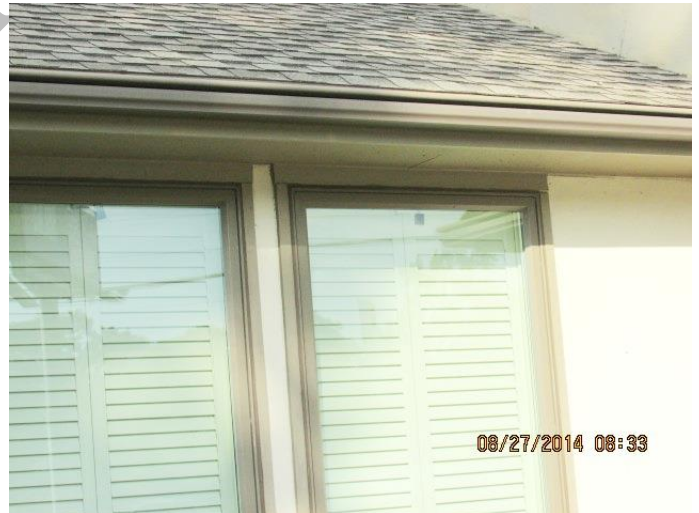
PHOTO NO. 12

4. Flashing was missing over all exterior openings such as doors, windows and other openings- this is an unsafe condition. Prompt attention is recommended. See Photo #12.

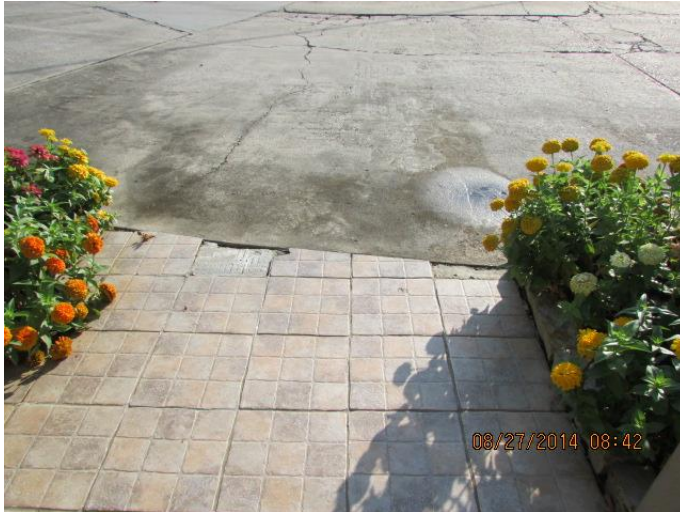
PHOTO NO. 13

1. Floor tiles were damaged outside the front door-could be a tripping hazard. See photo #13.

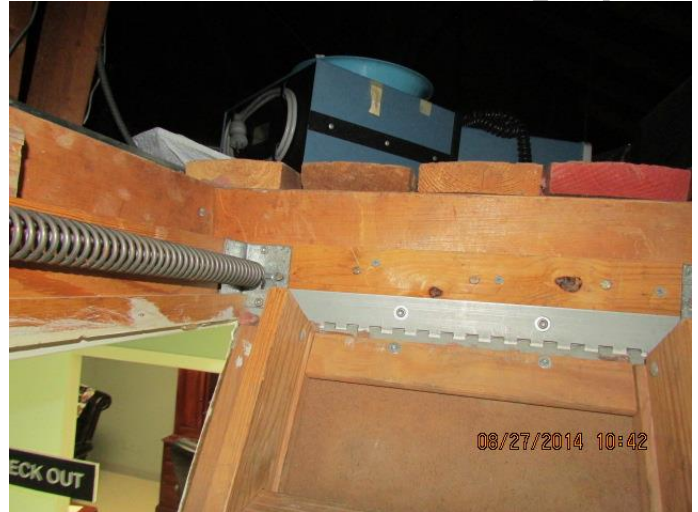
PHOTO NO. 14

1. The pull down ladder &/or brackets holding springs not installed with 16-16d nails OR 1/4" x 3" lag screws as recommended by many folding ladder manufacturers. Such a condition is potentially unsafe as the ladder can fail under the weight of a heavy person &/or when any heavy equipment is moved over it while storing or removing from the attic creating an unsafe condition and should be promptly attended to. See photo # 14.

2. The pull down stair(s) was (were) not insulated &/or sealed. It is recommended that weather stripping be installed &/or other repairs be made to prevent conditioned air loss to attic &/or sucking attic air into house as well as insulating stairway if not done already and thus saving on energy bills. See photo # 14.

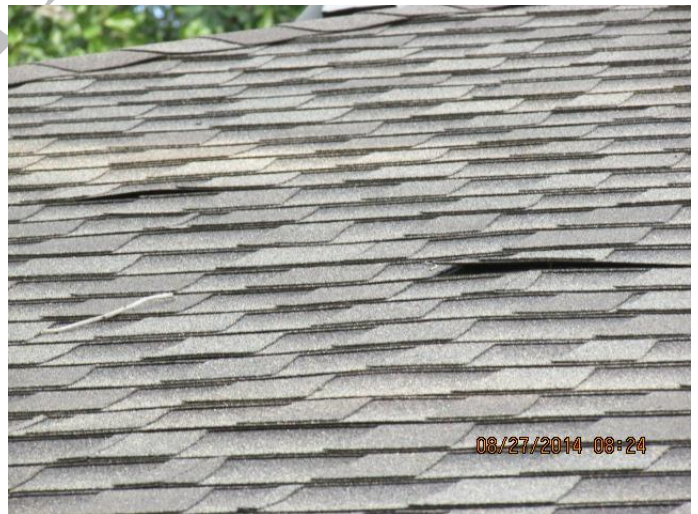
PHOTO NO. 16

1. Shingles were lifting/fishmouthing. This should be repaired promptly to minimize shingles blown off the roof, water intrusion into the interior. See Photo #16.
2. The exterior stucco/siding material does not terminate above the roof covering and were sitting on the roof. Therefore, the presence of flashing &/or other building components to direct storm fluids away from the stucco finishes could not be confirmed. Such a condition is conducive to rotting of wood siding (which may be rotting &/or already rotted). The exterior stucco/siding material should terminate at least 1 1/2" above the roof covering. See photo #17.
3. There was an unsealed area (hole) at the ridge line. See photo # 18.

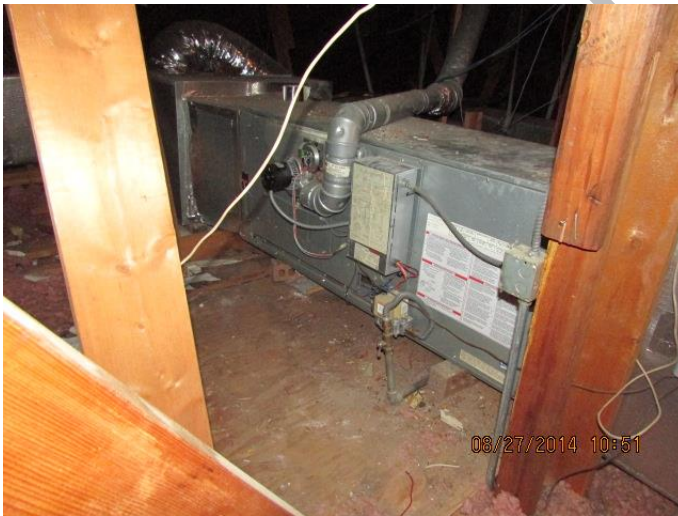
PHOTO NO. 19

2. Replace old gas shut-off valve on left unit as these tend to leak. See photo # 19.
3. No sediment trap was present on gas line. A min 3" long sediment trap pointing downwards with a directional change in gas line is recommended. This is required by most furnace manufacturers. Absence of sediment trap may void equipment warranty from the equipment manufacturer. It is required per common industry practice (and IRC G2419.4). See photo #s 19 & 21.

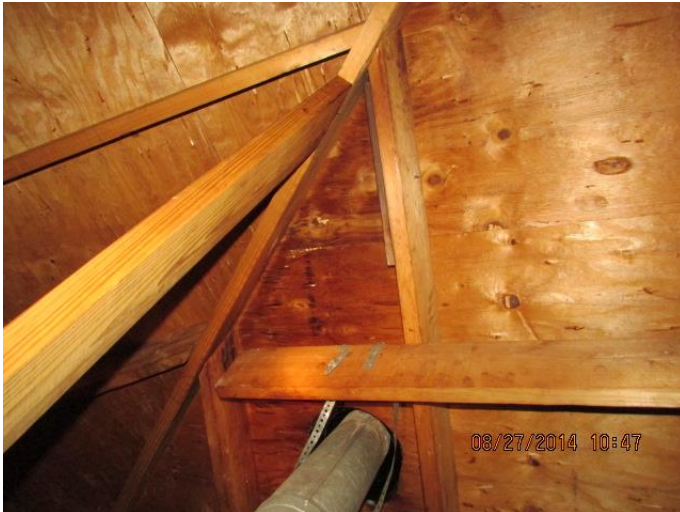
PHOTO NO. 21

6. The vent pipes serving the furnace did not have safe clearance (1") from combustible materials-unsafe. Has a potential of igniting combustibles from the heat. See photo # 21.

7. Vents appeared to be too close to combustibles as there were burn/heat marks on the sheathing. See photo #s 21 & 22.
8. No service receptacles were discovered at or near furnace units -potentially unsafe.

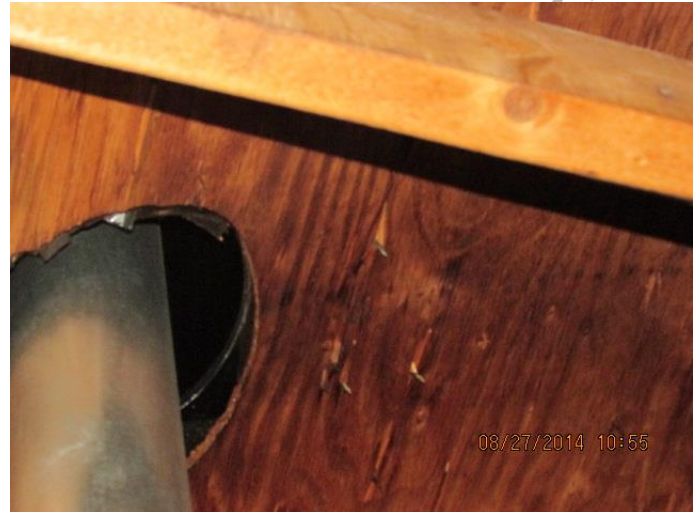
PHOTO NO. 22

9. Furnace vent(s) was(were) not sealed or properly sealed at the roof jacks. See photo #22.
10. Flex ducts were touching and are missing required 1" clearance from other ducts to prevent condensation between ducts that touch.

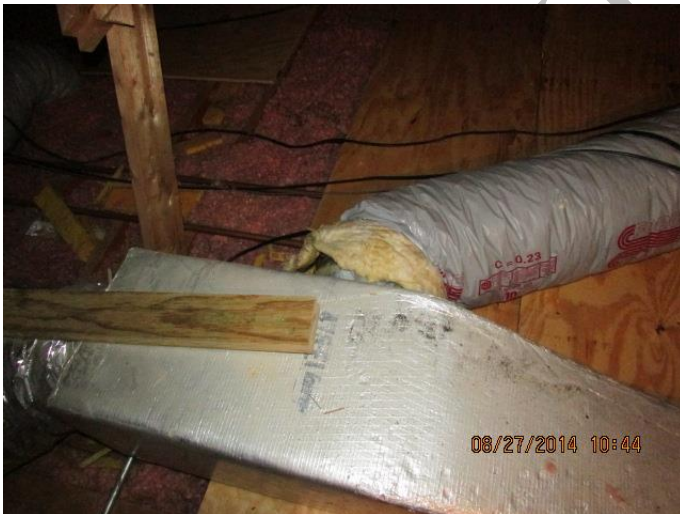
PHOTO NO. 23

11. The ducts need to be raised off the attic insulation.
12. Some gray duct type wrapping was observed. This product was recalled many years ago due to deterioration of exterior vapor barrier when exposed to light. Such ducts should be replaced. See photo #s 23 & 24.

13. Duct was not properly secured to plenum as seen in photo #23.
14. Auxiliary drain pan was not sloped to drain. Water can build up and overflow onto attic flooring which can leak down to ceiling below causing damage to interior and fungal growth.

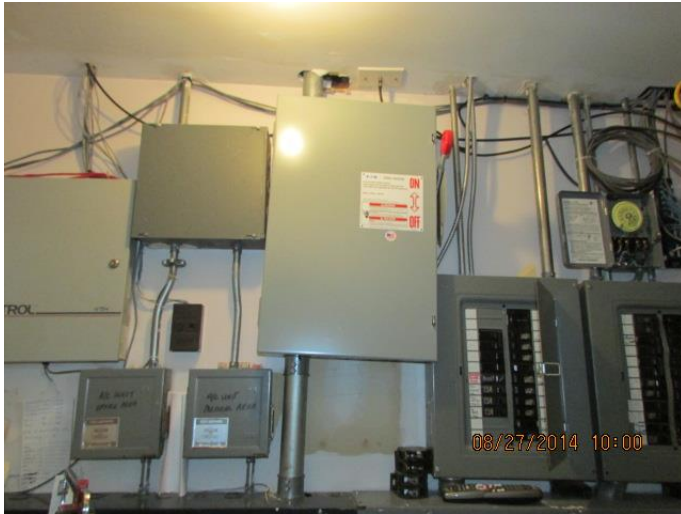
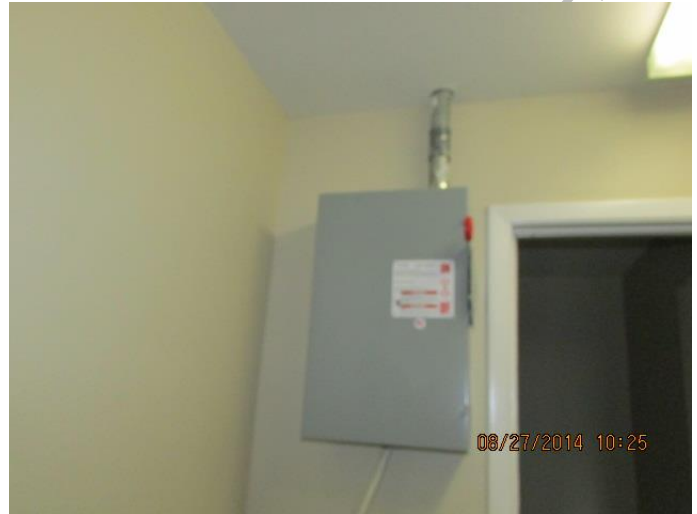
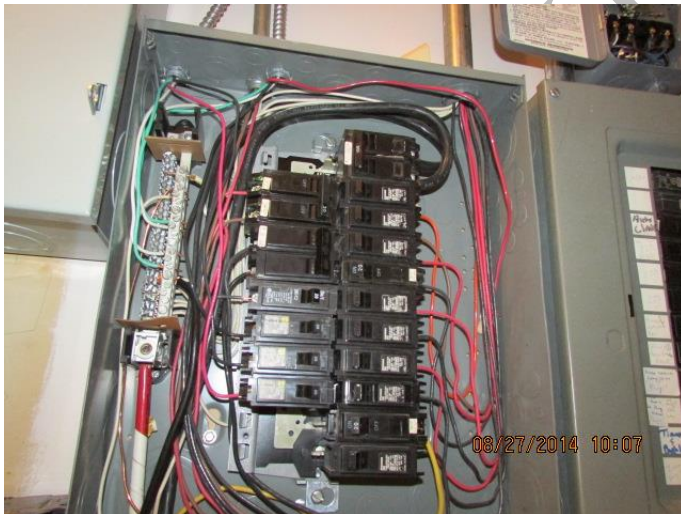
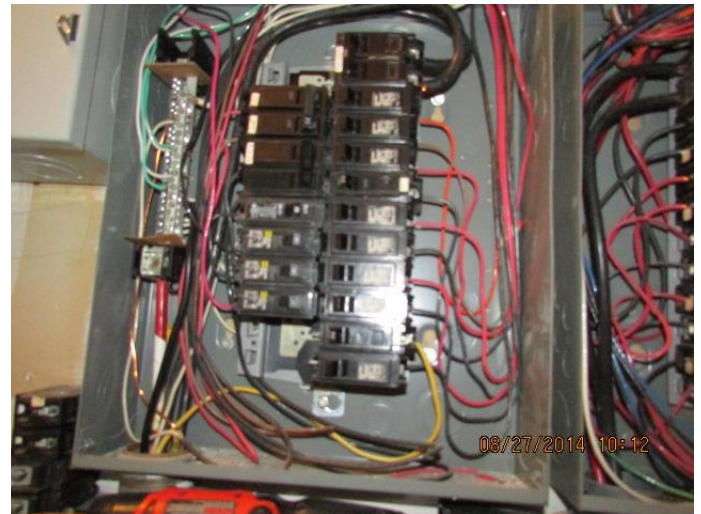
I opened the 2 sub-panels and the fuse disconnects to observe the condition of the wiring. The power comes through copper feeders through gutters. See photo #s 25 through 28. Wiring appeared to be in good condition.
