PHASE 1 (PRE-POUR) PROPERTY INSPECTION REPORT

REPORT # SM 1X-0825P1P

A SINGLE FAMILY RESIDENCE AT

12861 XYZ DRIVE, PORTER, TX 77000

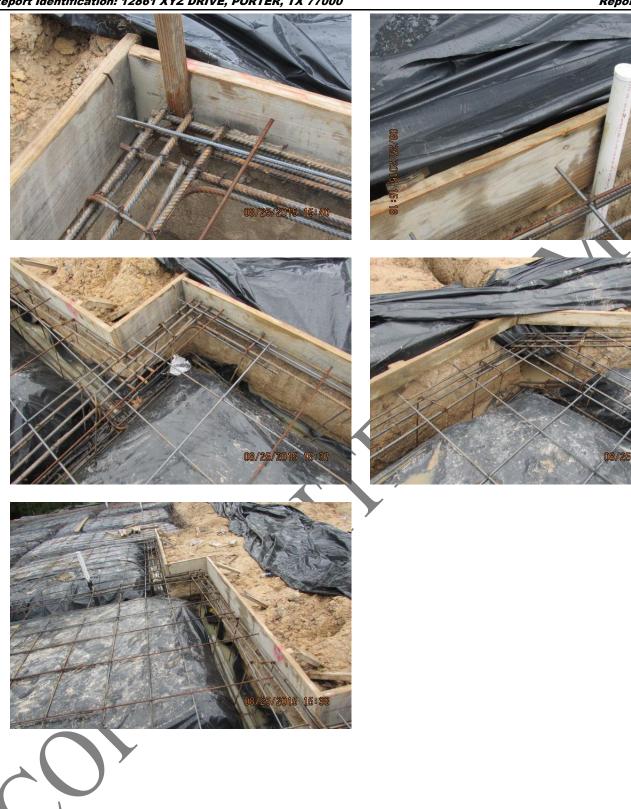
- 3. A minimum of 3" clearance shall be maintained from outside & bottom of beams and rebars. See first 3 photos.
- 4. Bottom of all beams should be pumped out of all muddy water and cleaned of all debris & foreign matter. See all photos.

- 5. Bottom rebars of grade beams may supported on 3" tall concrete bricks. No clay bricks allowed. See second row photos.
- 6. There were plumbing risers in the beam areas. This condition is no recommended as it weakens the beams and beams' integrity. See top row right photo.

- 7. Two #4x4' diagonal rebars shall be placed on all front side on all inside corners. See second row left photo.
- 8. Assure that all rebar chairs were in place at no more than 4 centers before the concrete pour. Floaters may be used instead. See last photo.

- 9. Make sure that all rebars have a min. of 1° clearance from the plumbing risers or horizontal pipes so that the rebar is embedded in concrete. See last photo.

- 10. Assure that all beam stirrups are in vertical position before concrete is poured. See second row right photo (lower beam).
- 11. It appeared from the drawing that there was a kitchen island; however, there no conduit/branch wire was installed for the power to the island. It must be in place before the concrete pour to avoid breaking concrete out later. See second row right photo.
