# PHASE 2 (PRE-COVER) PROPERTY INSPECTION REPORT

REPORT # SM XX-0816P2P

A SINGLE FAMILY RESIDENCE AT  
**XXXXX WRENWOOD WAY, HOUSTON, TX 770XX**

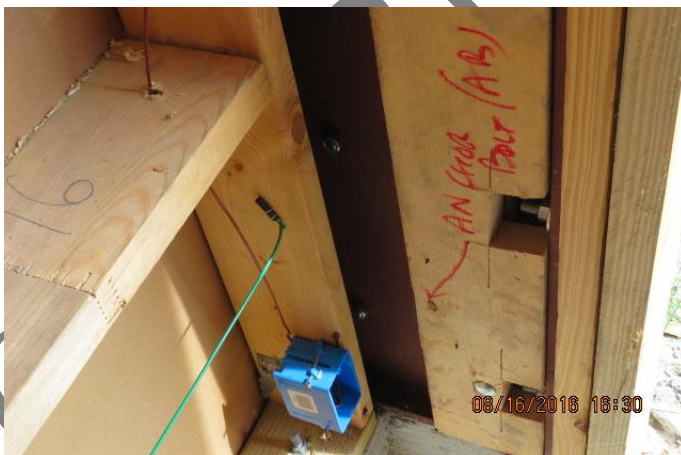
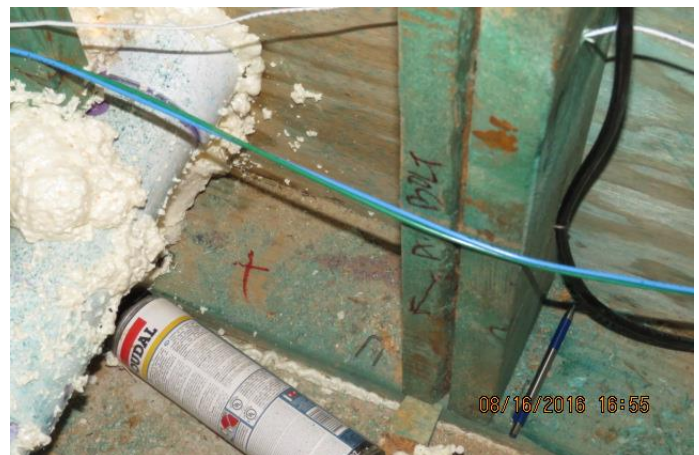
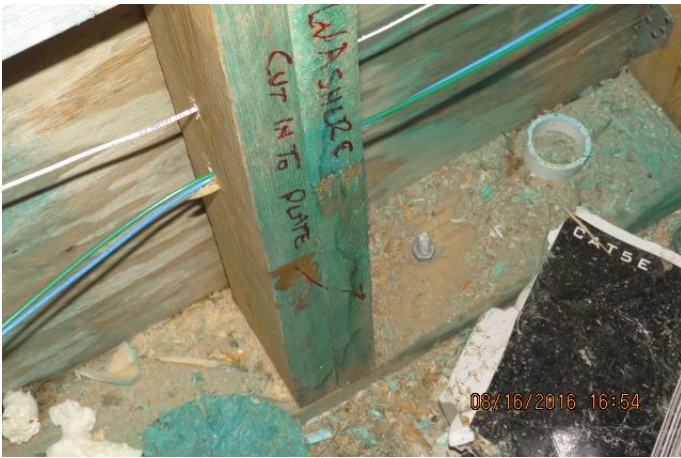
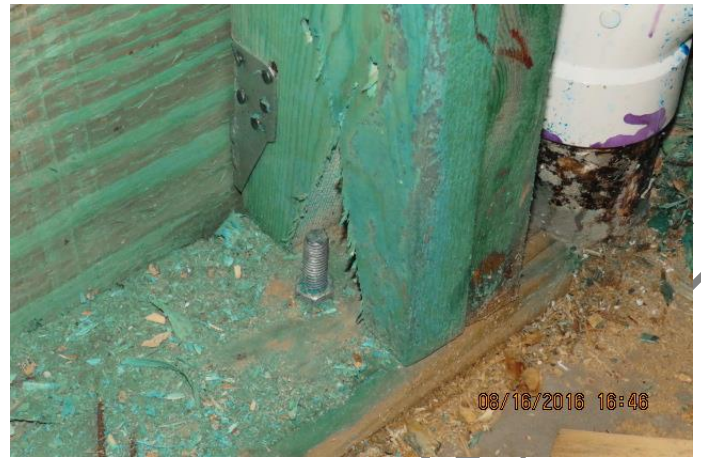
1. Missing anchor bolts in required locations. Anchor bolts were not installed within one foot from sill plate ends, from corners &/or doorways. Such locations marked on nearby lumber. See photos below. Foundation should be checked thoroughly and anchor bolts should be installed within one foot from sill plate ends & not less than 7 dia. of anchor bolts, from corners &/or doorways in such locations. A minimum of 2 anchor bolts are required per sill plate. 1/2" dia. x 10" long expansion bolts may be used where conventional anchor bolts are required. Such locations were marked on lumber. See first row of photos.
2. Missing 2"x2"x1/8" washers on anchor bolts required in wind prone areas.
3. Missing washers on some anchor bolts.
4. Round washers and nuts were over tightened and biting into bottom plates and thus reducing the load carrying capacity of base plates. See second row of photos.

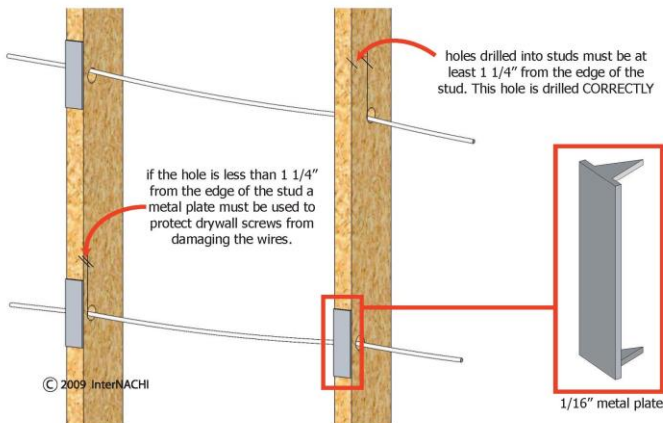
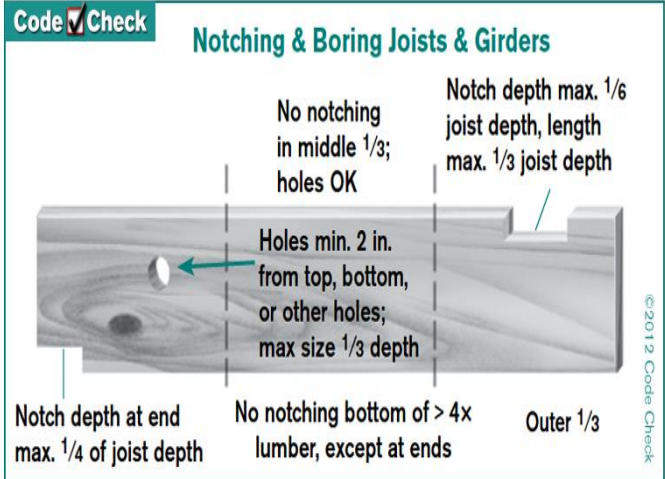
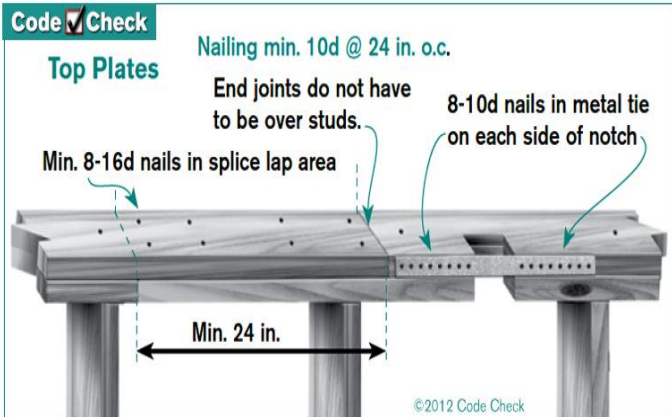
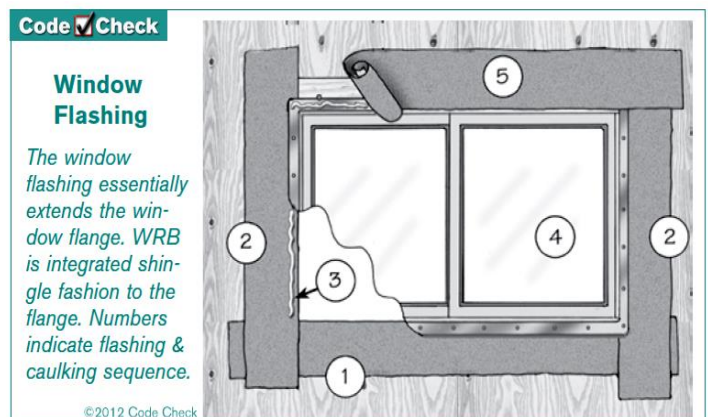
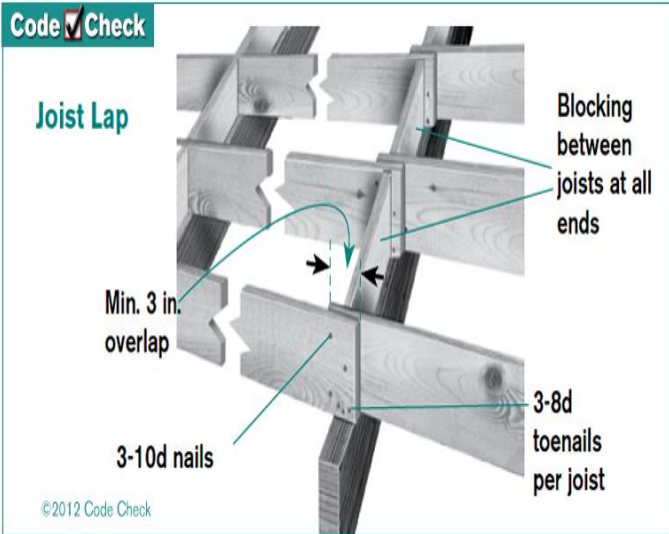
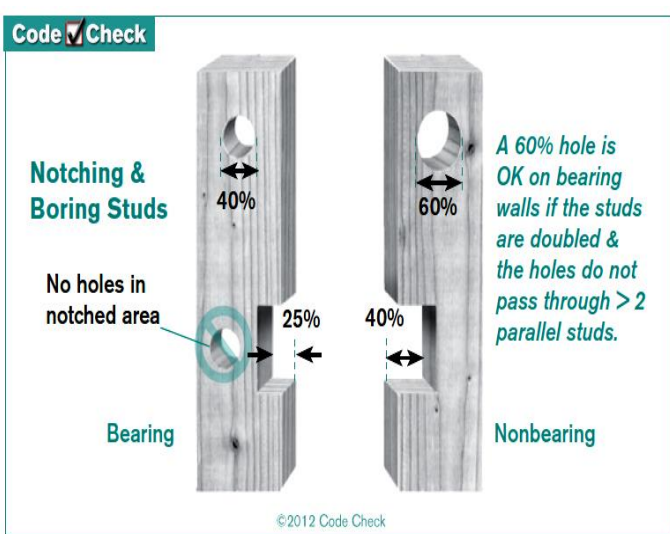
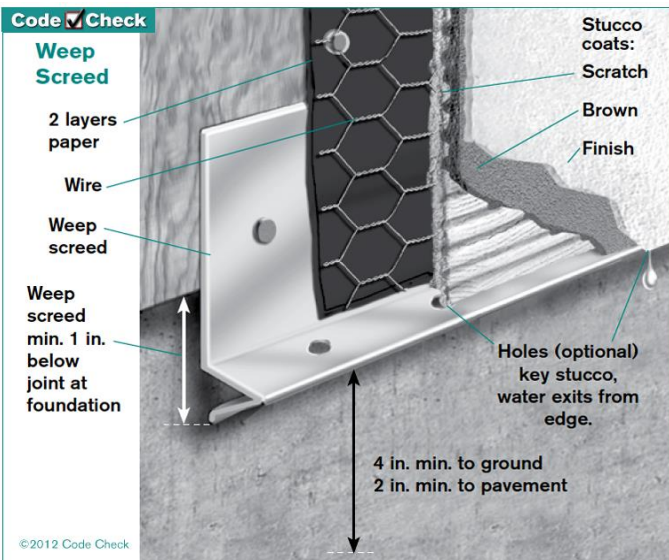
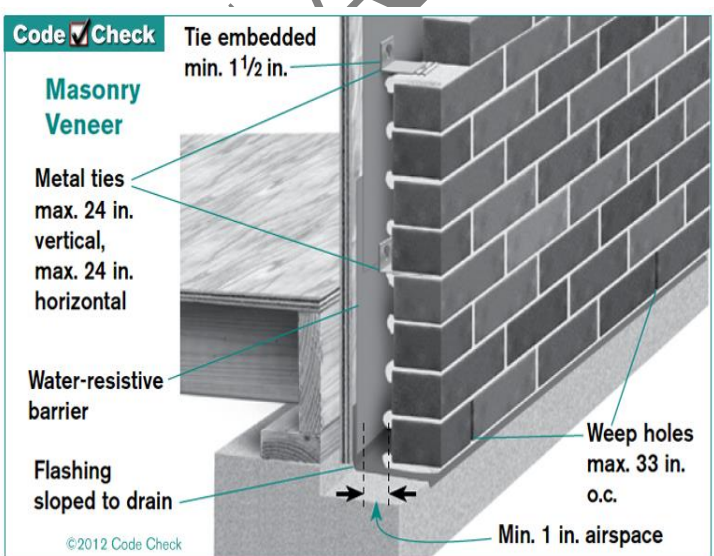
Wires Installed Less Than 1 1/4" From Edge of Stud

**(NOTE: Problem locations marked on lumber or nearby)**

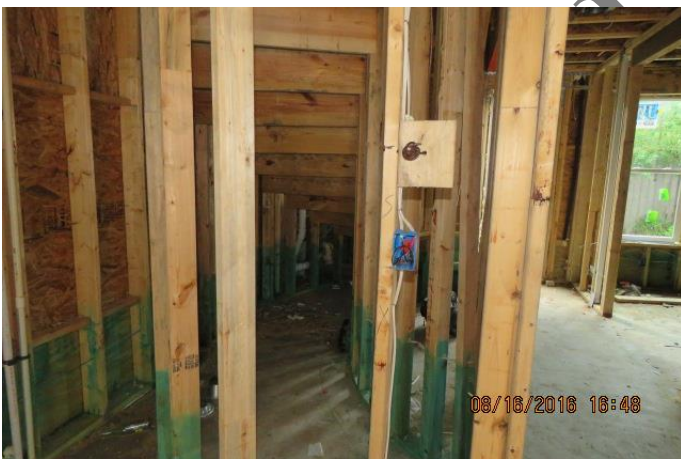
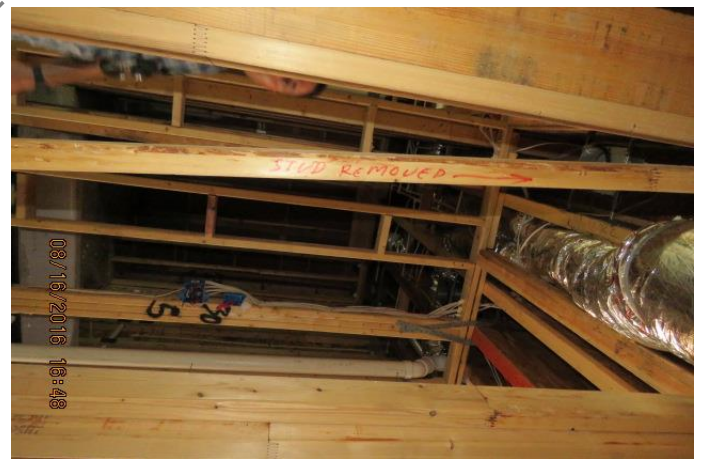
5. Guest closet opening under stairs was blocked by studs and electrical switch box. See sixth row left photo.
6. A stud was removed to accommodate HVAC duct which was improper. See sixth row right photo.

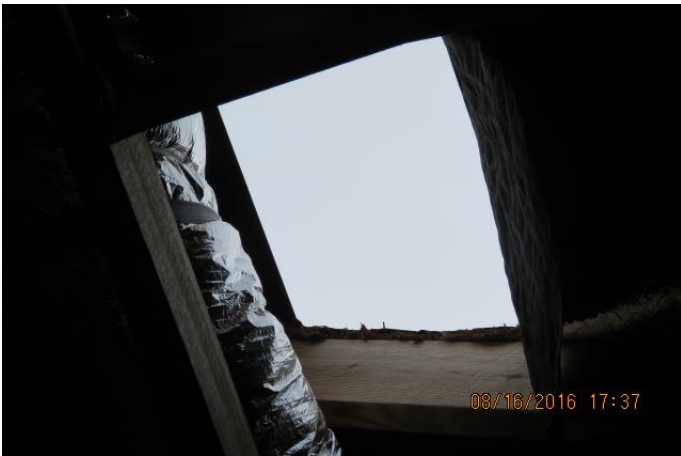
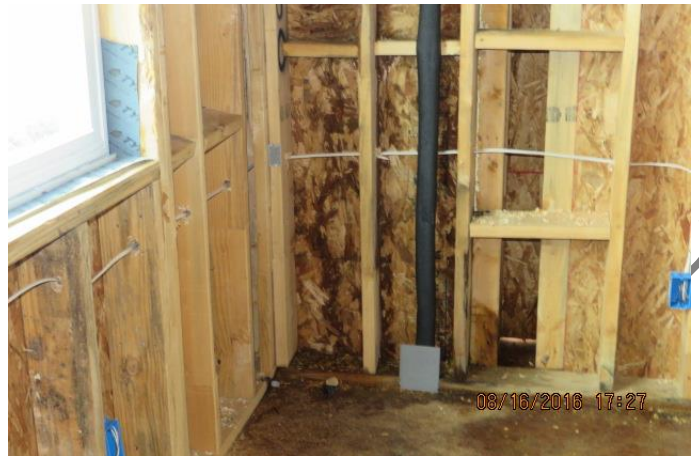
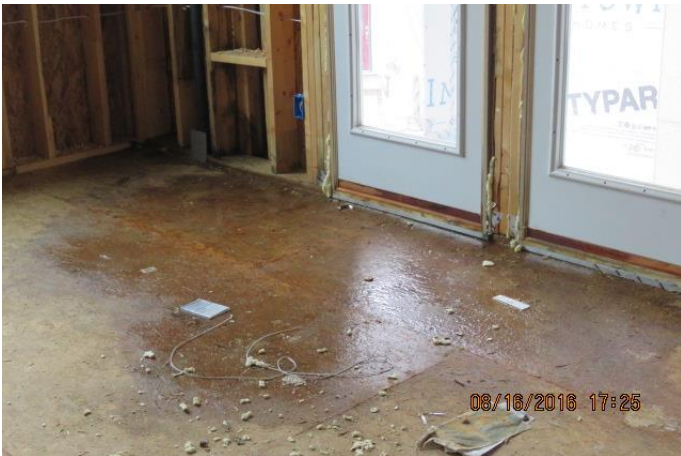
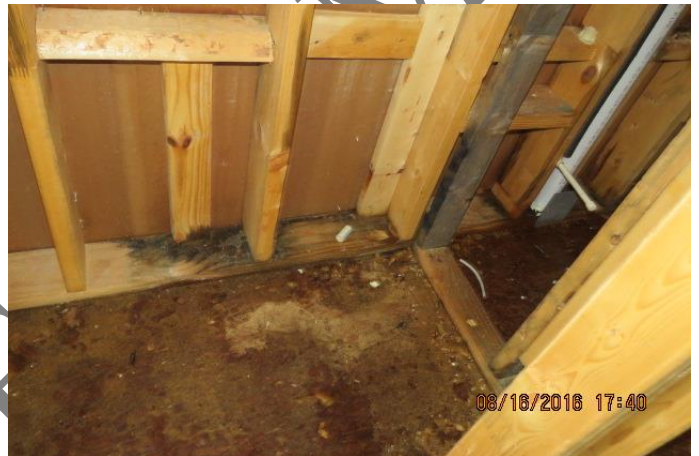
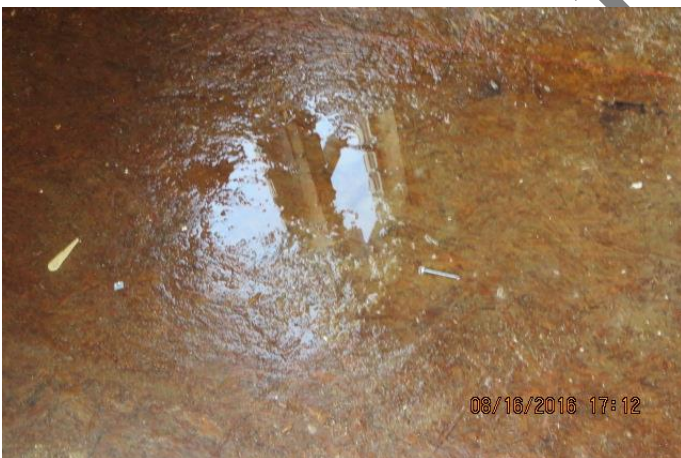
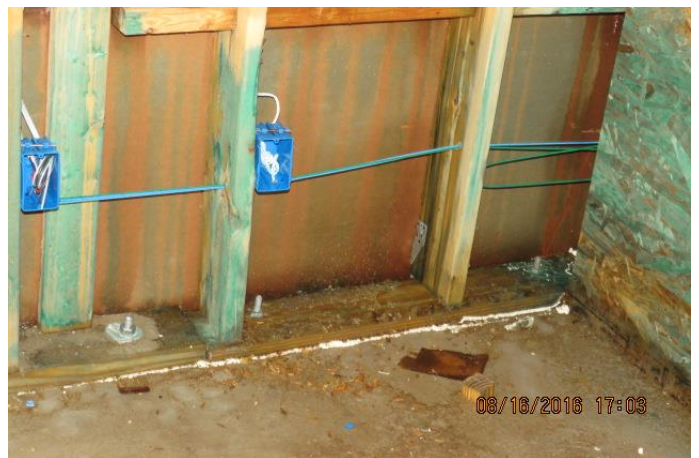
7. There were several stair studs those were unsecured at top or bottom.
8. There were large holes cut out in the roof decking allowing rain water on the floor decking of third sheathing & floor causing ponding and permitting water to travel down to second floor decking and wall sheathing, and then to 1<sup>st</sup> floor sheathing. This affected structural integrity, load carrying capacity and decay of the decking, framing and the sheathing. See seventh to ninth row of photos.

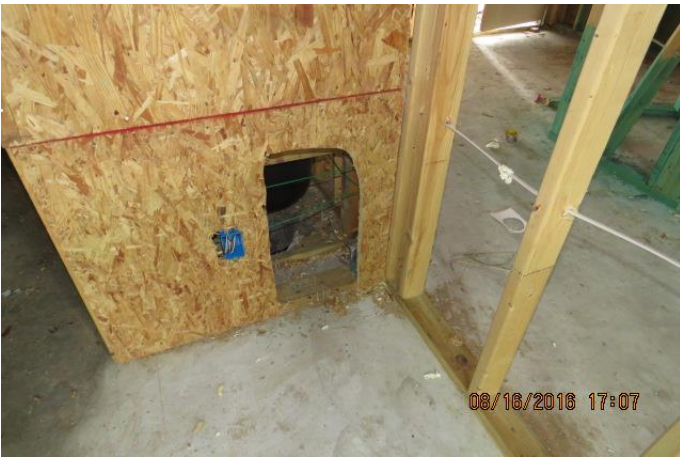
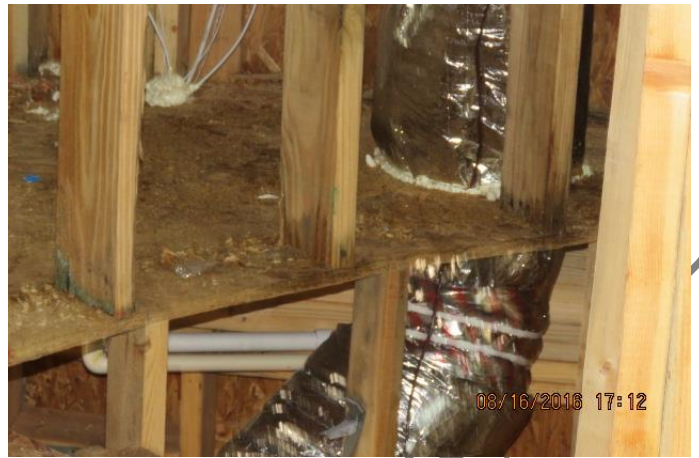
9. Plumbing access was blocked by wiring. See tenth row left photo.
10. Studs were improperly transferring load on to thin sheathing. See tenth row right photo.

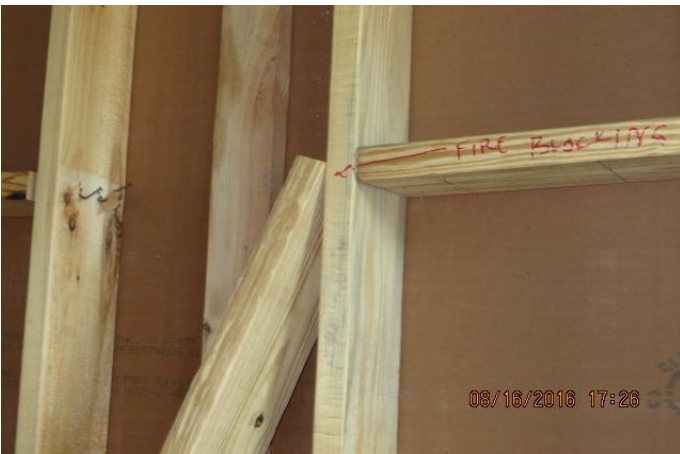
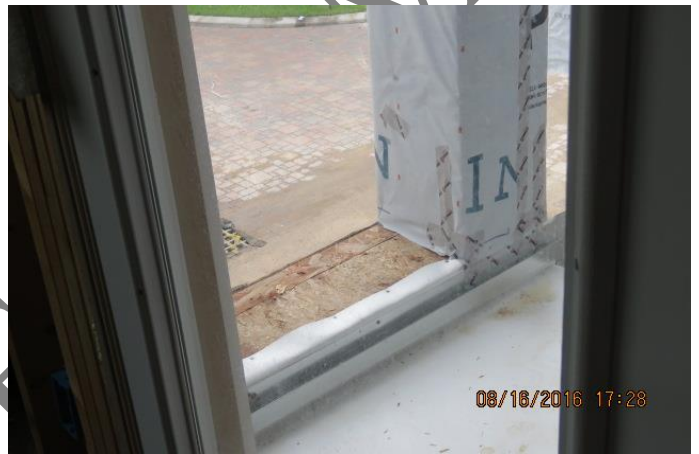
11. Fire blocking was removed in several places. See eleventh row left photo.
12. Hurricane strapping on balcony posts could not be checked as the door to balcony was locked. See eleventh row right photo.

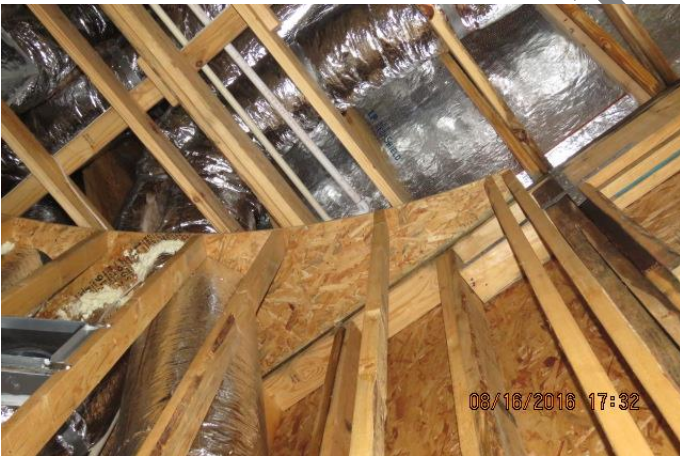
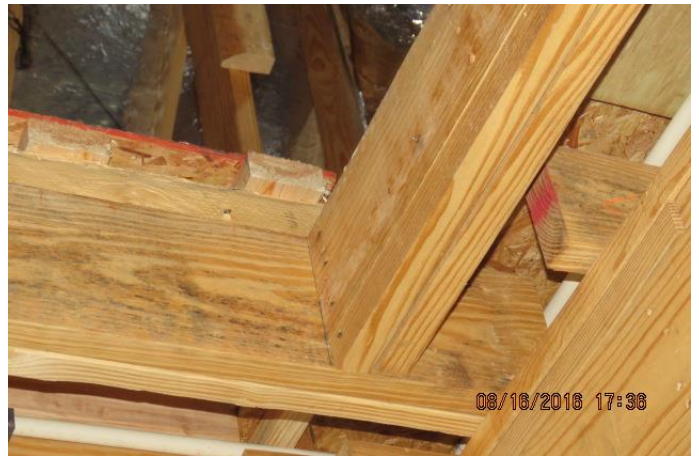
13. Third floor ceiling joists supported on OSB decking. See twelfth row left photo.
14. Drop down ladder joists were not supported on joist hanger. See twelfth row right photo.

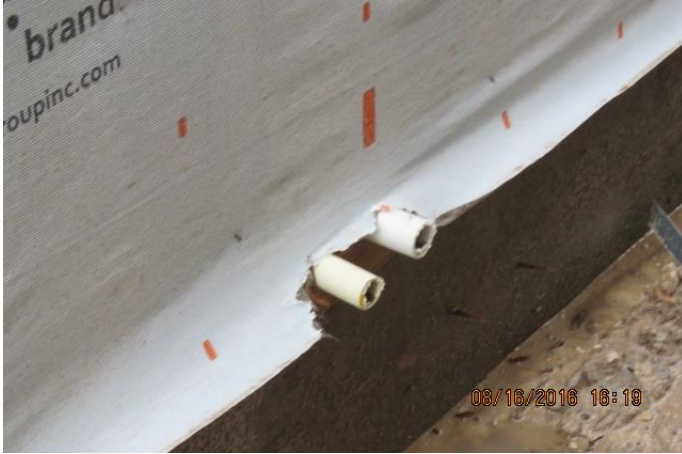
1. Temperature & pressure relief (TPR) &/or pan drain lines not terminating to within 6" of the ground and not pointing down. P2803.6.1.6 and P2803.6.1.10. See first row left photo.

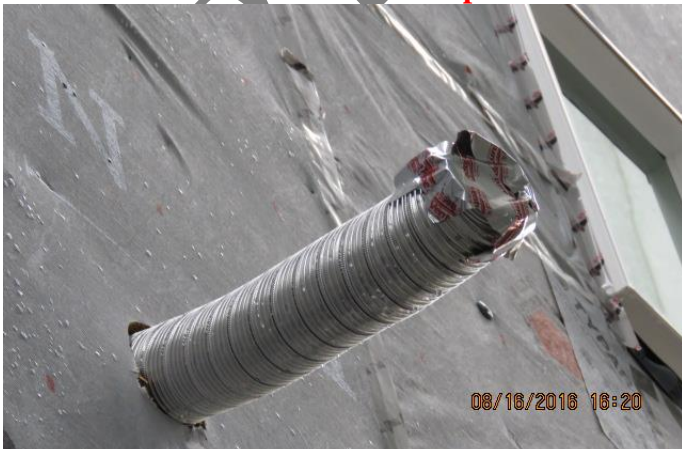
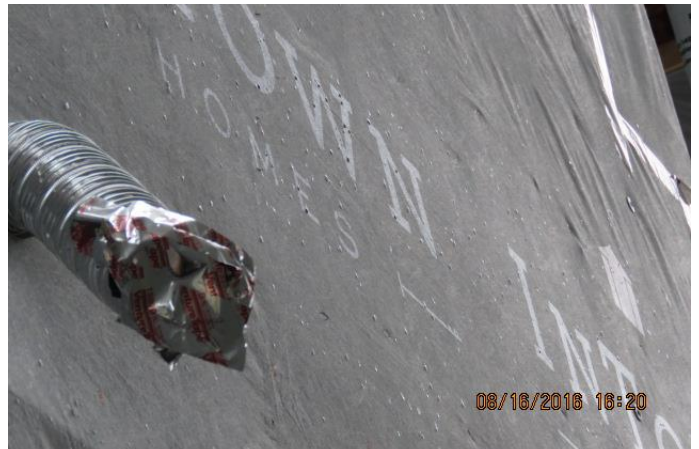
1. Backdraft damper was missing on the exhaust vent as required by common industry practice (IRC 1503.1). See photos.
2. Vents unsealed at the wall penetrations. See photos.

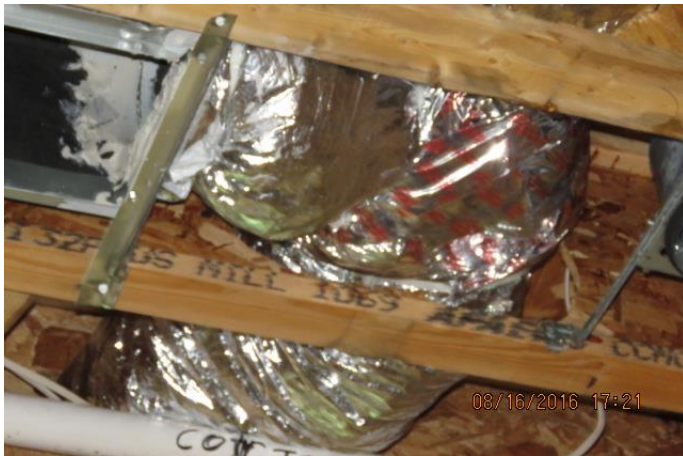
1. Flex ducts were touching and are missing required 1" clearance from other ducts to prevent condensation between ducts that touch.
