# PROPERTY INSPECTION REPORT ©2016

REPORT # SMC XX-03007BP

A SINGLE FAMILY RESIDENCE AT  
22861 XYZ DRIVE, PORTER, TX 77000

BY:  
JITENDRA M. VARMA, Professional Inspector # 3864

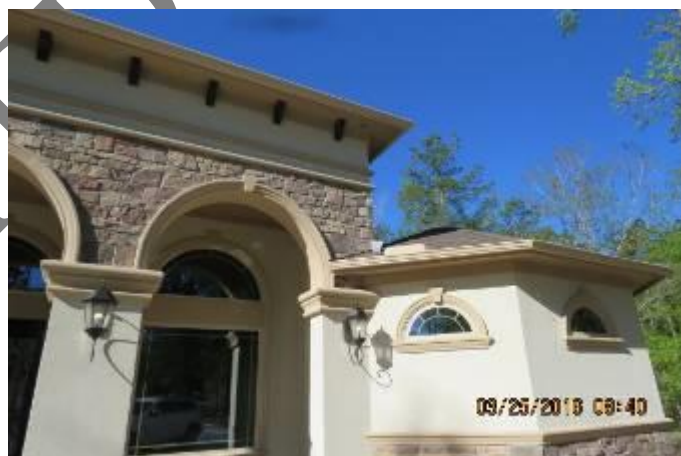
3. Downspout(s) &/or gutter drop(s) that were discharging onto the roof should be extended to discharge directly into the gutters below. This condition, if left unattended, can result in premature deterioration &/or failure and staining of the roofing, as the rain water washes the protective grit of the shingles which protects the roof from weather and ultra violet rays of the sun, on the downstream side of the downspout(s) &/or gutter drop(s). See left photo.
4. Missing kick out flashing at the junction of walls to divert rain water to gutters below or roof. See top right illustration. See right photo.

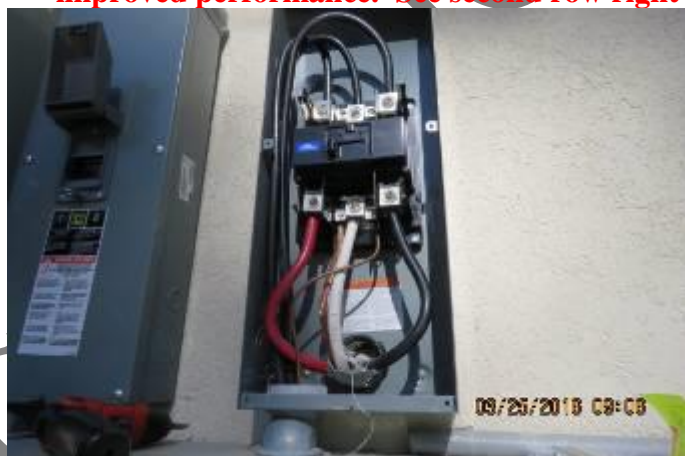
3. The neutral wires (with white insulation) used as second hot were not re-identified or were not properly & permanently on 220 volt circuit(s) in sub panel. When using such wires as hot wires, they should be re-identified permanently for safety. All hot (ungrounded) conductors are required to be identified by the use of any color other than white, gray or green or bare copper. See second row left photo.

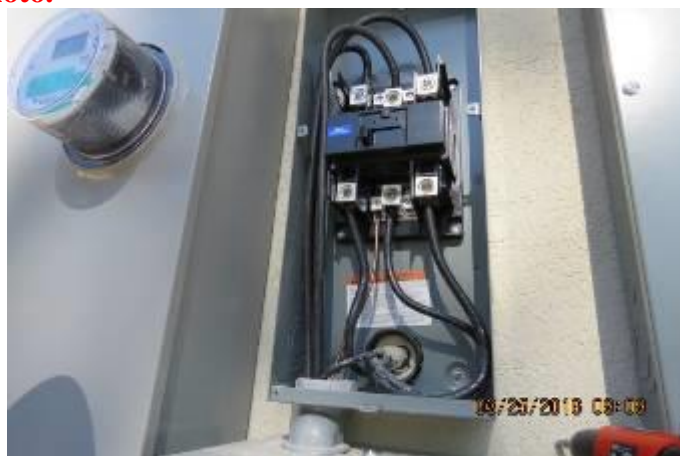
4. AFCI breakers were stacked in sub panel. These should be separated as they generate heat for improved performance. See second row right photo.

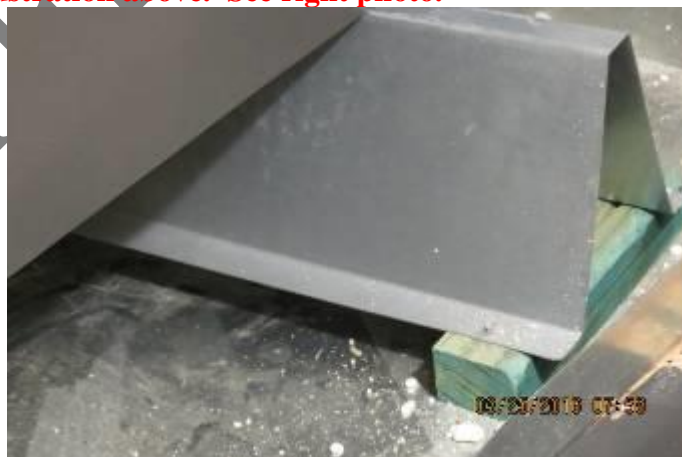
1. No proper size, unobstructed, safe and solid access and service platform was noted to furnace(s). A solid & unobstructed access 24" wide with a maximum length of 20' (50' if passageway 6' high), and a solid & unobstructed service platform minimum 30" deep and length equal to equipment width on the service side of the horizontal unit (& 30" deep all way around of a vertical unit) are recommended for safety purposes per IRC R1305.1.3. See top left illustration above. See left photo.
2. Step too high to service unit-unsafe.
3. No service disconnect within sight (IRC T4101.5) &/or service receptacle within 25' (IRC 3901.12) were discovered of the near unit(s)-potentially unsafe.
4. Furnace units sit directly on secondary drain pans. Manufacturer's installation instructions call for units to be elevated off of drain pans. See left illustration above. See right photo.

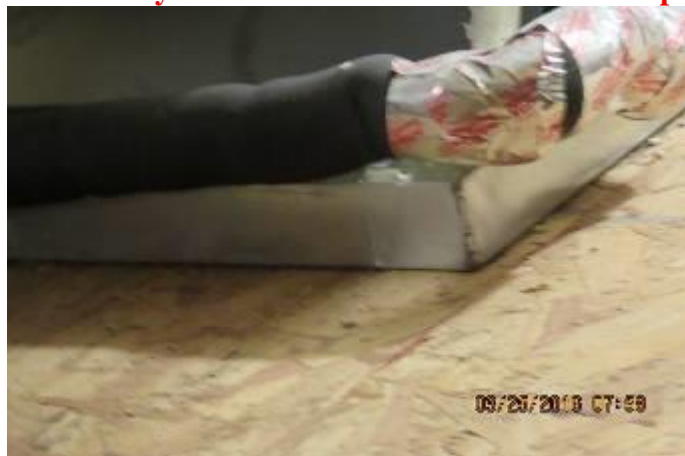
1. Insufficient cooling was observed on one or more units as noted above. This condition should be investigated and corrected for personal comfort, energy savings and efficiency of unit(s).
2. Auxiliary drain pan was not sloped to drain. Water can build up and overflow onto attic flooring which can leak down to ceiling below causing damage to interior and fungal growth. See photo.
3. Primary condensate drain did not have a slope of 1/8" per foot.

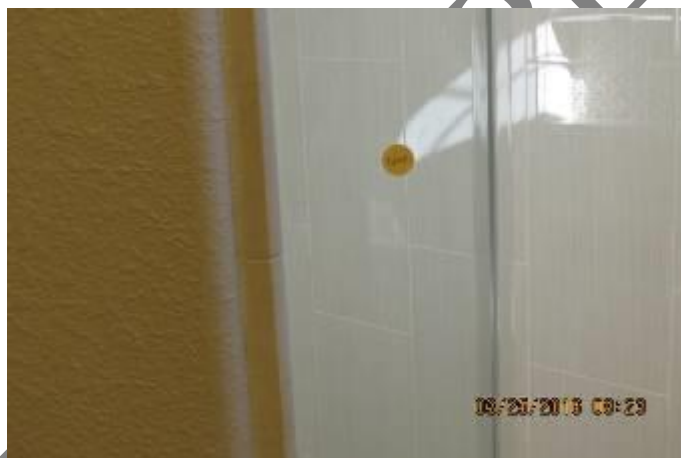
2. No tub access was provided in one or more bathroom(s). Service access is required for the piping and valves to plumbing fixtures. Service access of not less than 12"X12" is recommended by common industry practice (and IRC P2704.1). See middle illustration above.
3. Safety glass etchings were not observed on the glass within the master shower fixed glass and is recommended for safety by common industry practice (and IRC R308.4.1). Safety glass is required on any door with a glass 3" round or larger in size and is generally identified by an etching in the corner of the glass pane. Regular glass breaks into large pointed pieces upon impact which could cut and badly hurt any individual upon contact. See top right illustration in "WINDOWS" section above. See right photo.

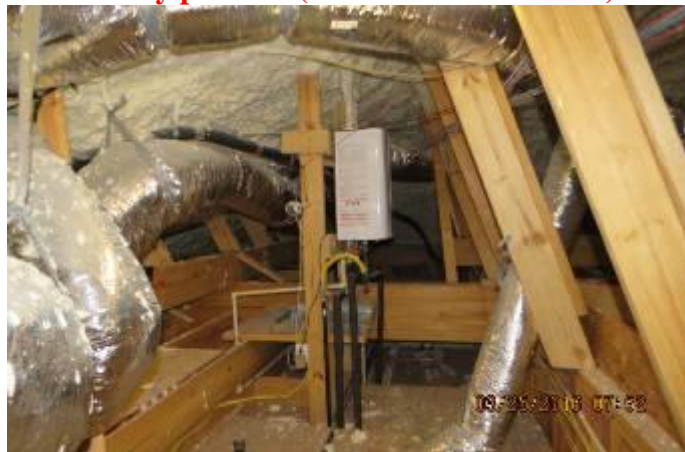
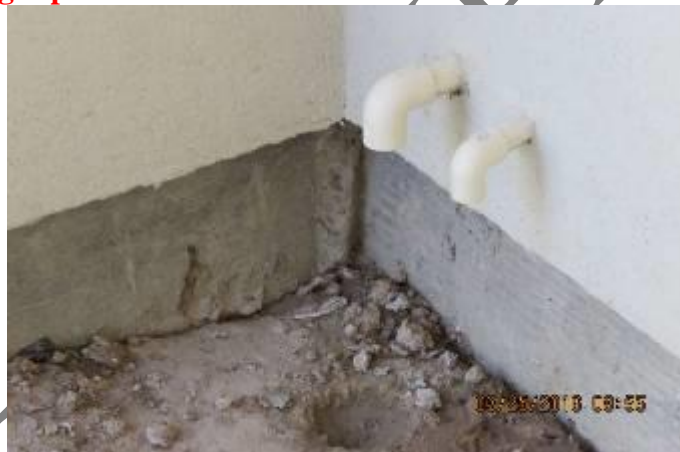
1. Tankless water heater did not have an auxiliary pan properly located under the unit. See left photo.
4. Temperature & pressure relief (TPR) drain(s) was(were) reduced by use of 3/4" outside diameter CPVC pipe-unsafe. It cannot be smaller than the diameter of the TPR valve served and should run full size to the air gap. P2803.6.1.3. See photos.
5. Temperature & pressure relief (TPR) and pan drain lines were not terminating to within 6" of the ground. TPR drain(s) cannot terminate more than 6" above floor or waste receptor per common industry practice (and IRC P2803.6.1.10). See right photo.

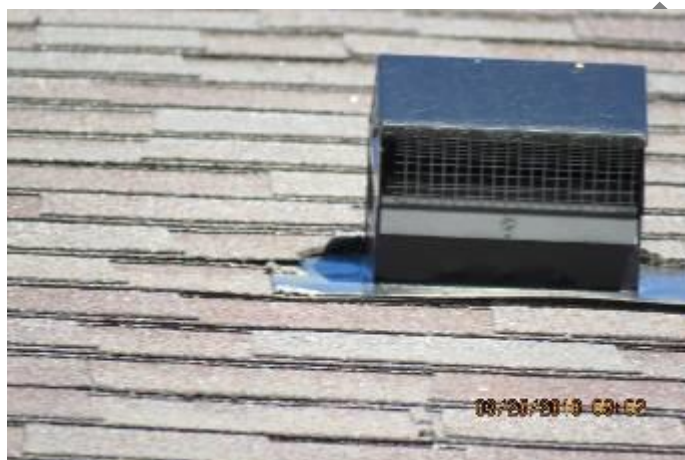
1. Backdraft damper was missing/damaged on the exhaust vent as required by common industry practice (IRC 1503.1). See illustration above. See photo.
2. Screens not allowed on exhaust fans. See illustration above. See photo.
