REPORT # YYLGL-MMDDP

A RESIDENTIAL PATIO HOME LOCATED AT

FOUNDATION INVESTIGATIVE REPORT

Subject Property: 5678 Anywhere, Any City, TX 77123

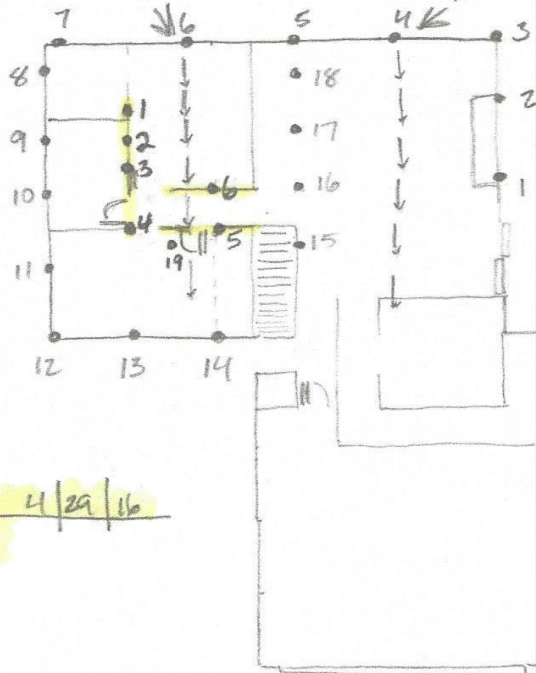
EXHIBIT 'B'

1. Exhibit "B" indicated that piers 1 through 19 were installed on MM DD, YYYY, however, upon inspection there were no signs of such repairs were observed on the exterior or interior.
2. The quality of workmanship was poor.
3. Use of improper materials was observed.
4. The brick/mortar rack on the backside did not close as it should have by proper leveling work.
5. Improper leveling (if it was ever done), also, indicated by micro-elevation survey. See page 7.
6. Improper leveling (if it was ever done), also, indicated by sticking and ghosting doors. See page 7.

Work done 3/16/16
Added 4x6 beam

Piers #1-19 installed 3/16/16
more or less

New Work done 4/29/16
Added 5 piers
and 4x6 beam
(Highlighted)

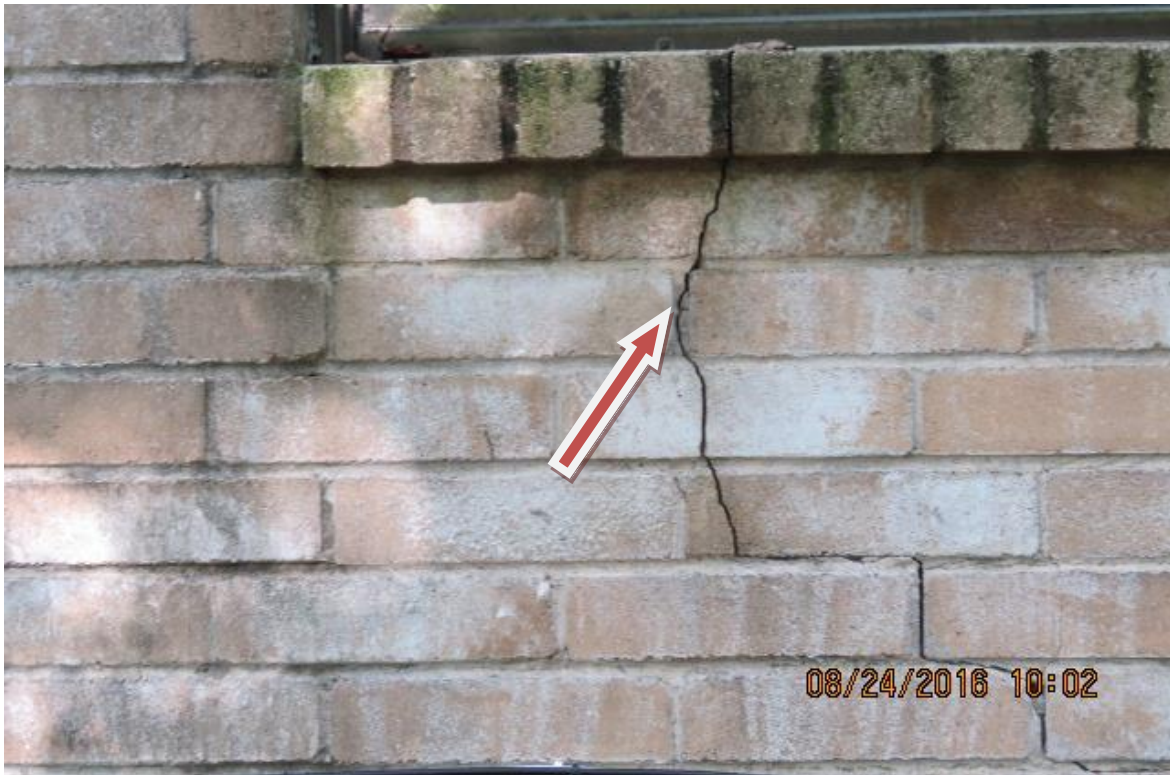
PHOTO 01

1. Trees were observed too close to foundation on backside with roots under the foundation.
2. There was a 1/4" crack stepped crack in brick veneer under the back bedroom window. See photo #01.
3. Photo #02 showed access opening to crawl space which measured 18"X18", which could not be entered as the access opening in floor or perimeter wall was not sufficient to safely enter the crawl space. Common industry practice (and also current IRC Code References: 408.4 Access) recommends a minimum size of 18" high X 24" wide.
4. Perimeter wall was present on all 4 sides of the house supporting the structure. See photo # 03.
5. Storage and decking prevented survey of the foundation in some areas, however, exposed areas were discovered to be in fairly good condition.

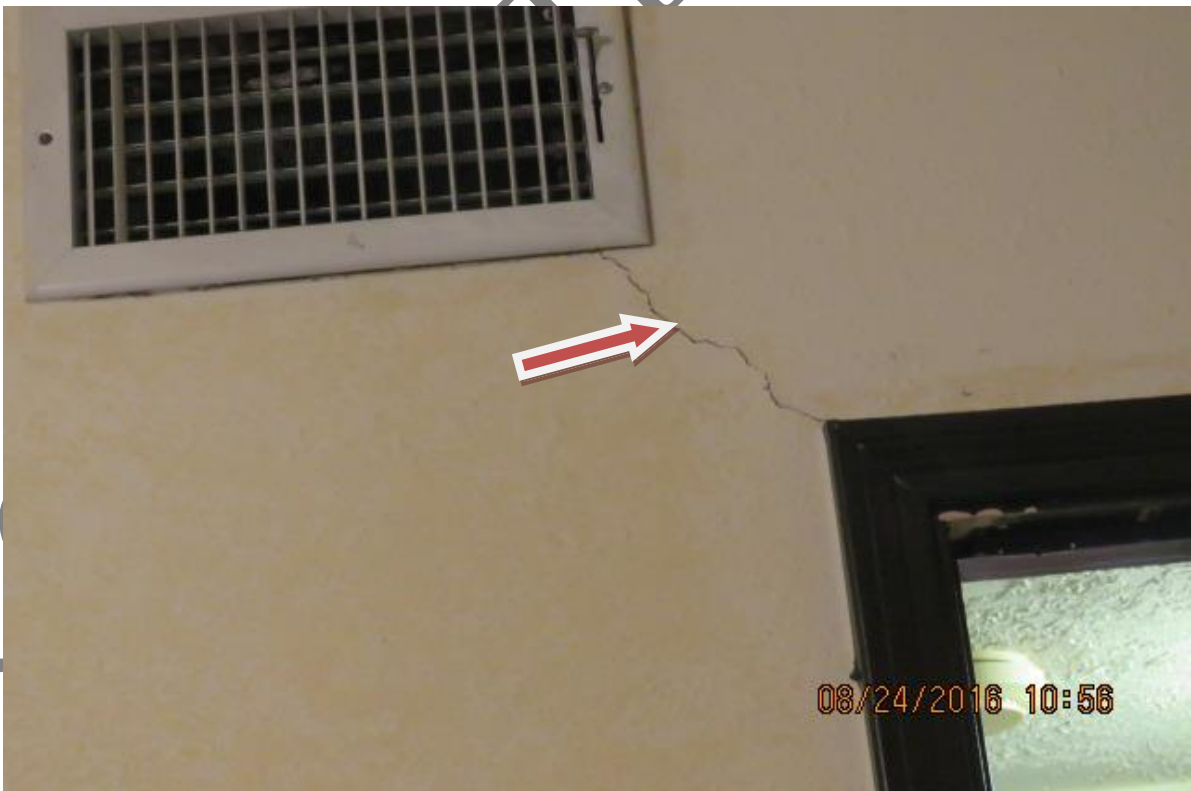
PHOTO 04

1. Front door was binding and was hard to open and close.
2. Passenger door to garage was ghosting.
3. Drywall cracks around door openings and vertical tape warping were observed in front bedroom.
See photo # 04.
4. Flooring appeared be spongy soft under the front bedroom door. See photo #5.

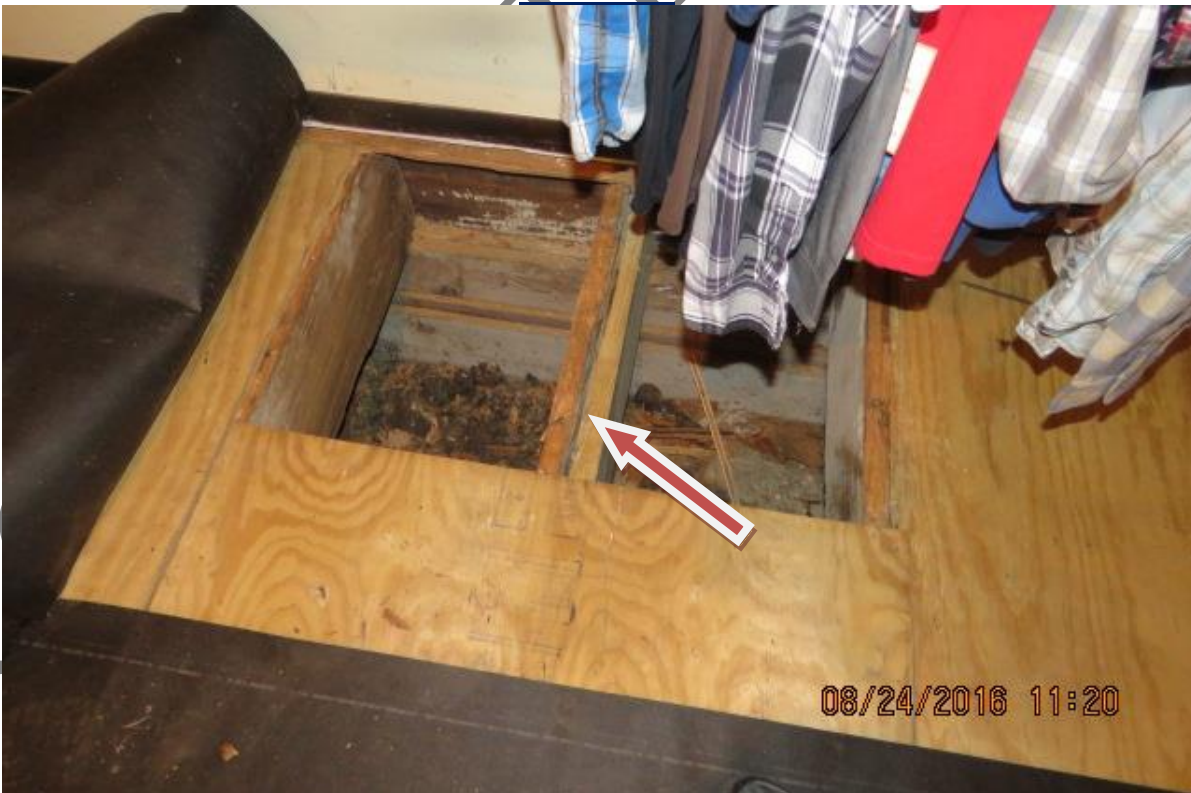
PHOTO 06

Condition of slab could not be ascertained due to presence of flooring materials in the house except in front bedroom where subfloor was removed in front bedroom where a new floor joist was installed butting up against the existing floor joists (photo #6), and the garage slab which appeared to be in good condition with only star like non-structural cracks in the slab.

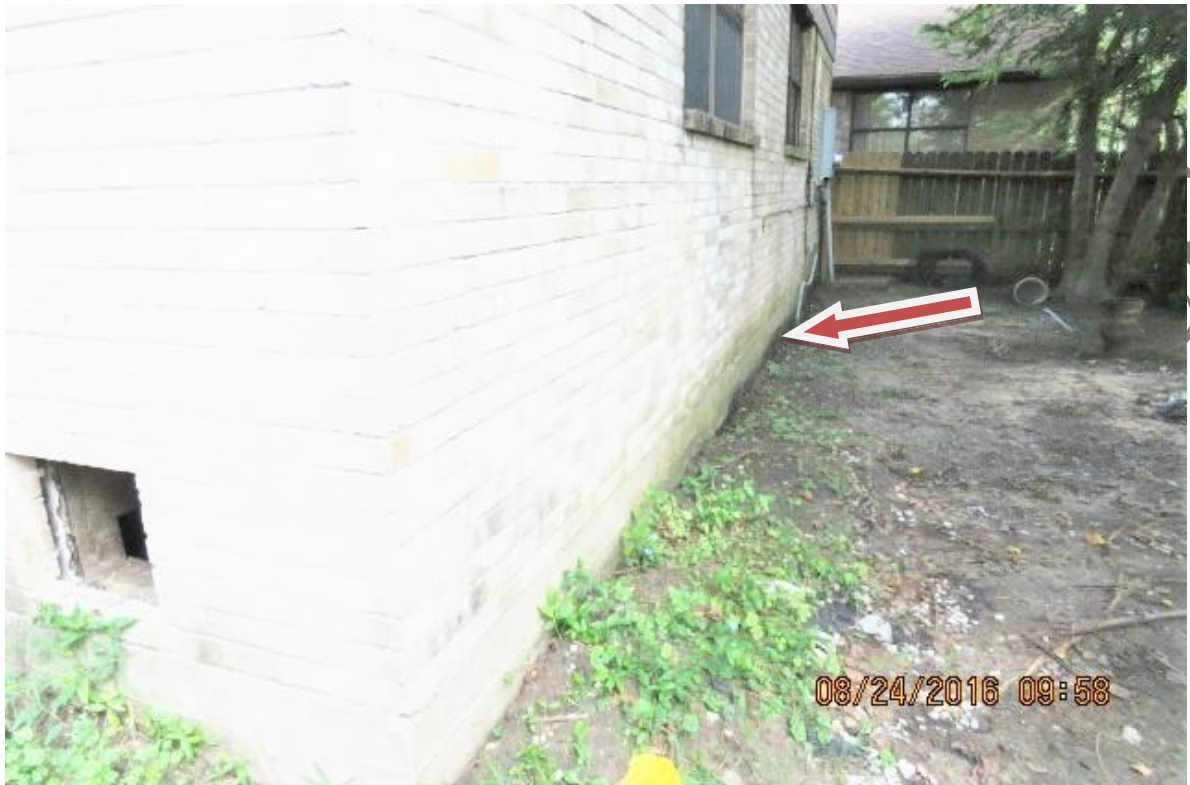
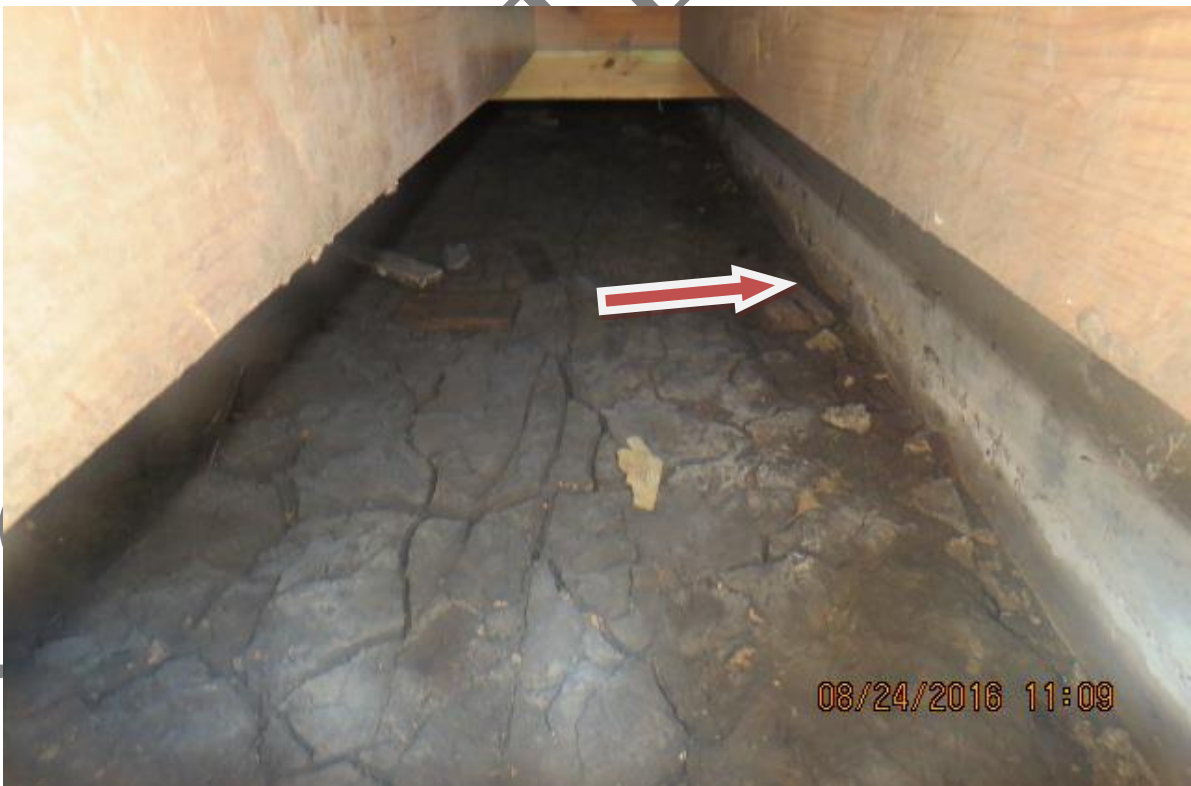
1. No signs of foundation repairs, such as disturbed soil or humped fill, were observed along outside or inside of back wall of the house. See photo #s 7 and 8. There should be at least 5 such locations along this wall.

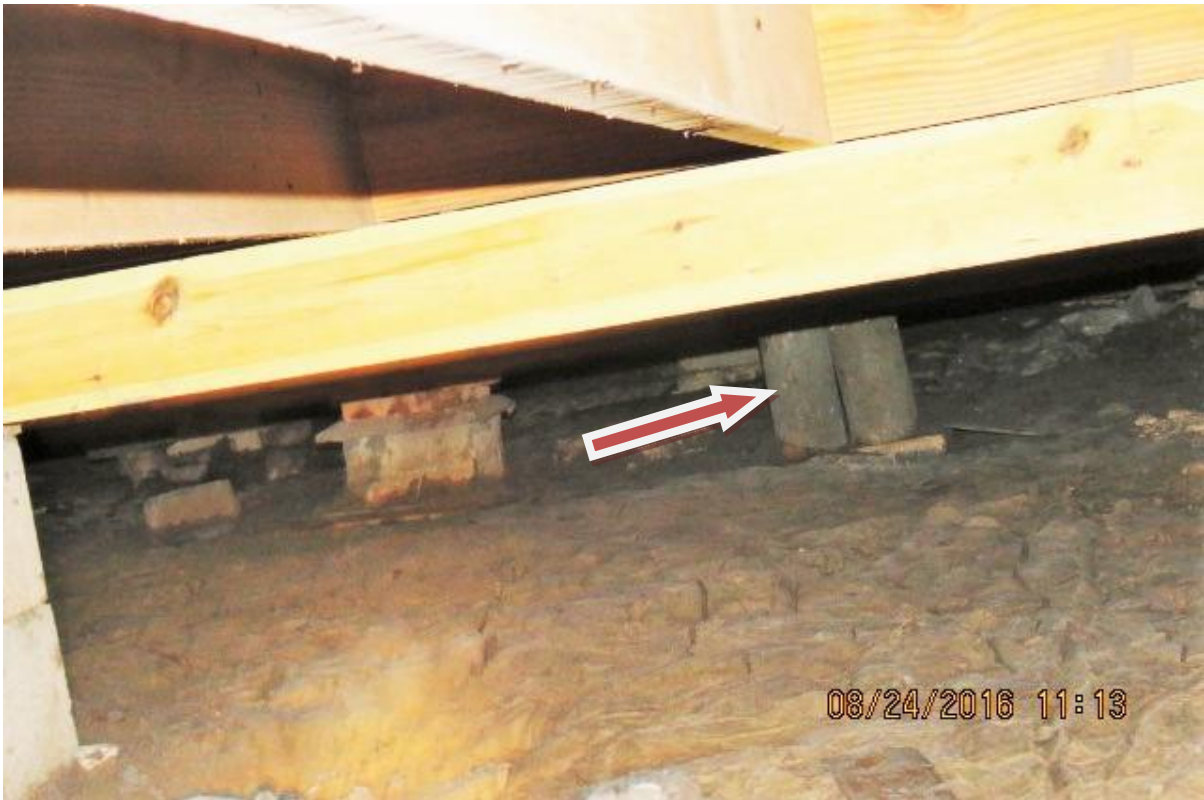
PHOTO 09

2. Improper supporting material used for the blocks. See photo #09. 6"X12" cylinders used with arrows pointing to them, instead of conventional 8"X16" solid concrete blocks in other areas.

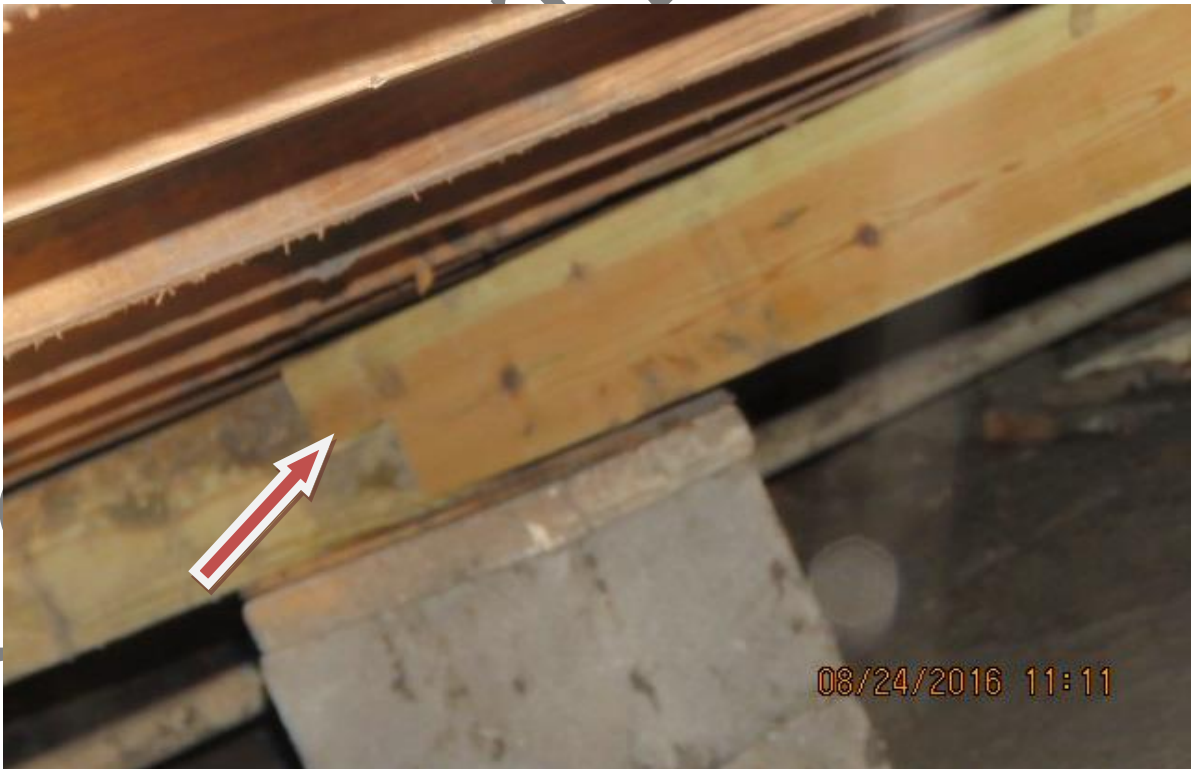
PHOTO 10

3. Beam joint was not properly braced from the sides with like size short pieces to prevent from getting separated and twisted. See photo #10.
4. End of the beam was overhanging the support on the side. See photo #11.

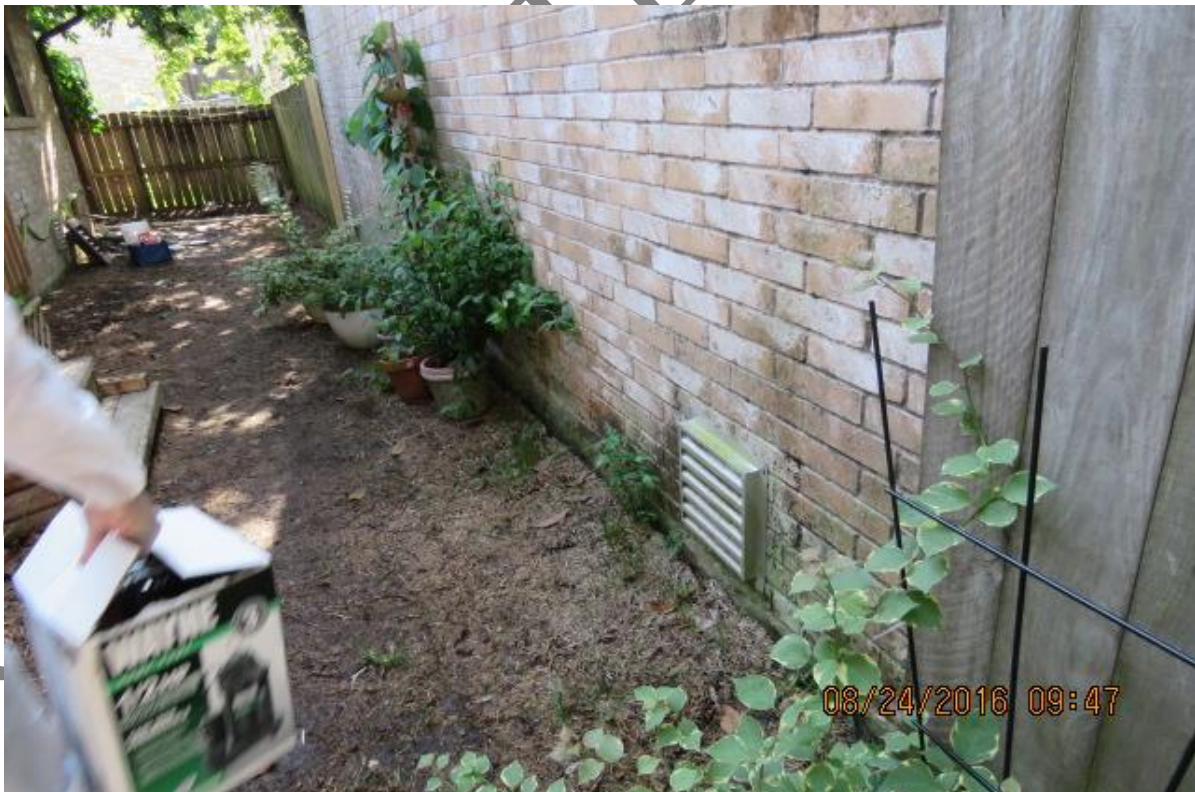
PHOTO 12

5. No signs of foundation repairs, such as disturbed soil or humped fill, were observed along outside right & left walls of the house. See photo # 12 along left wall. There should be at least 5 such exterior locations along the left wall and 2 along right wall.

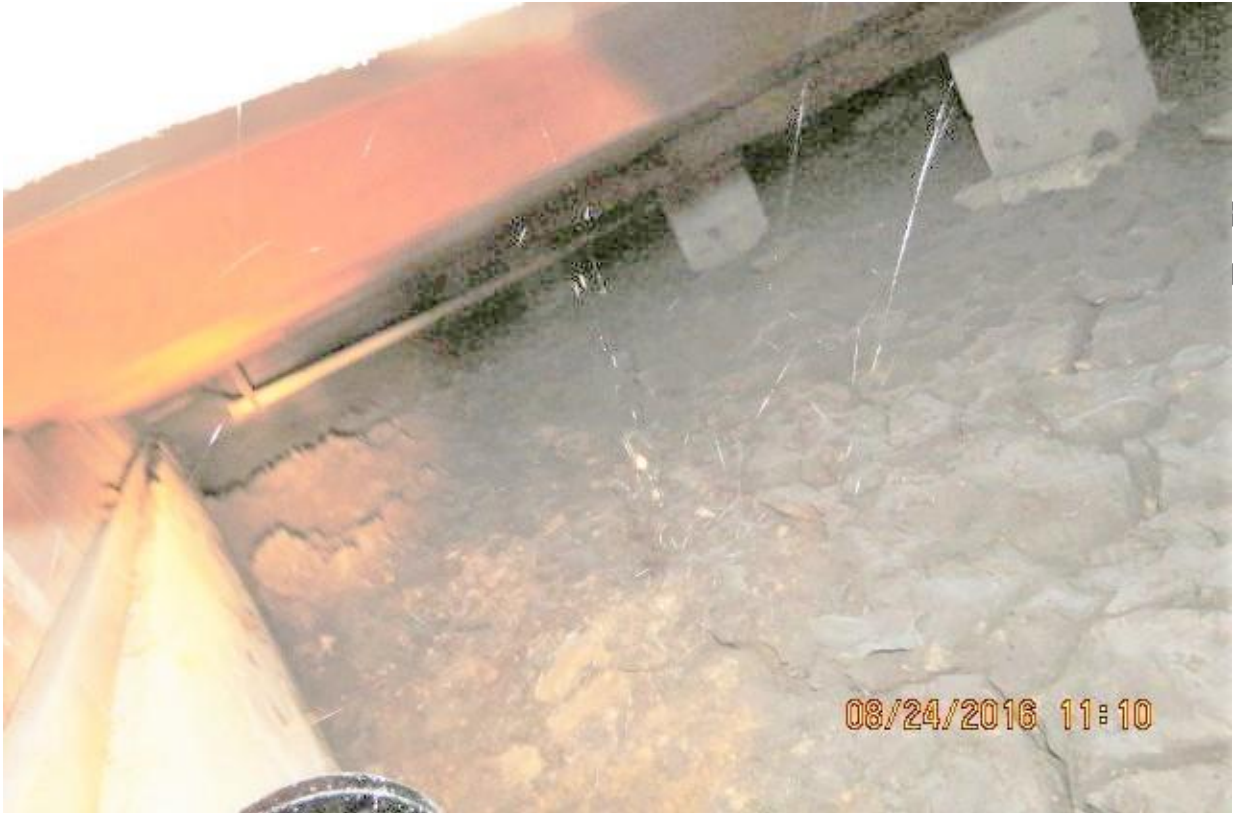
PHOTO#13

6. No signs of foundation repairs, such as disturbed soil or humped fill, were observed along inside of right wall of the house. See photo # 13. There should be at least 2 such locations along interior this wall.
