REPORT # XXLGL-MMDDP

A RESIDENTIAL TOWNHOUSE PROPERTY LOCATED AT
1234 ANY STREET, HOUSTON, TX 77000

LOSS ASSESSMENT INVESTIGATIVE REPORT

Subject Property: 1234 Any Street, Houston, TX 77000

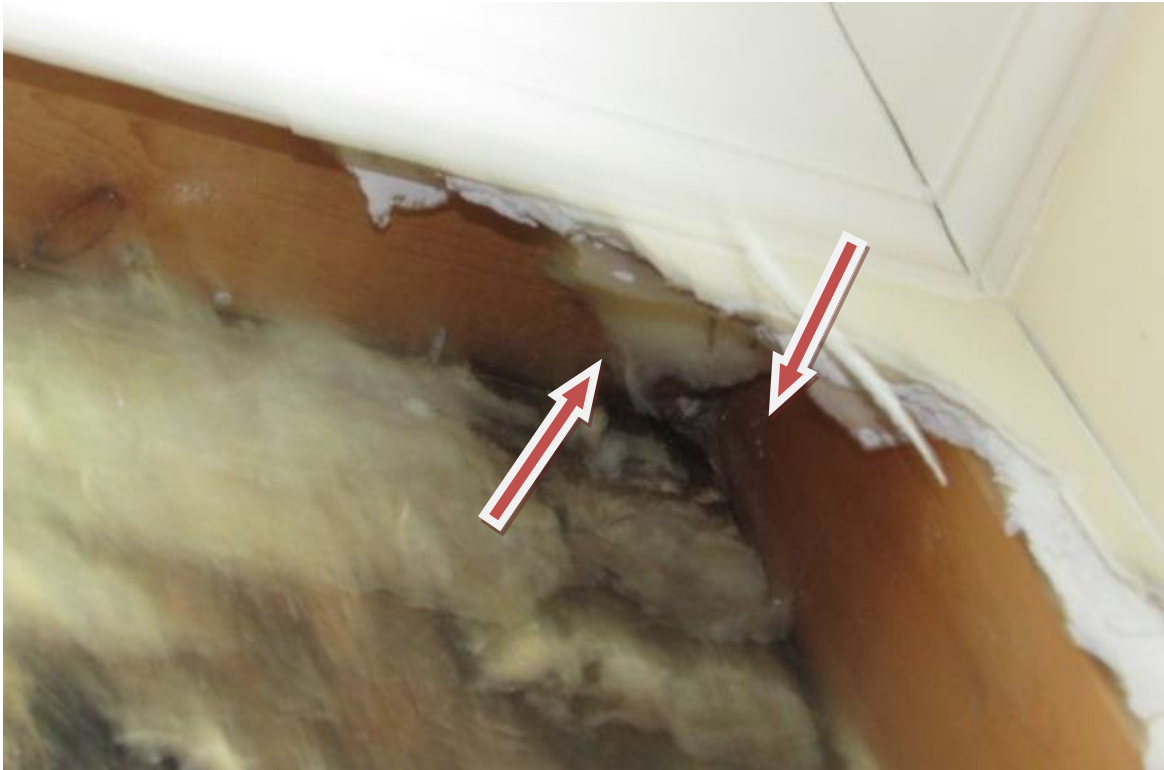
PHOTO 01

1. The photos #01 shows crown molding joint pulled open from the moisture. The two arrows, in this photo, point out to the water logged wood studs causing rotting of the framing members. It also shows condition of the water logged wall insulation.

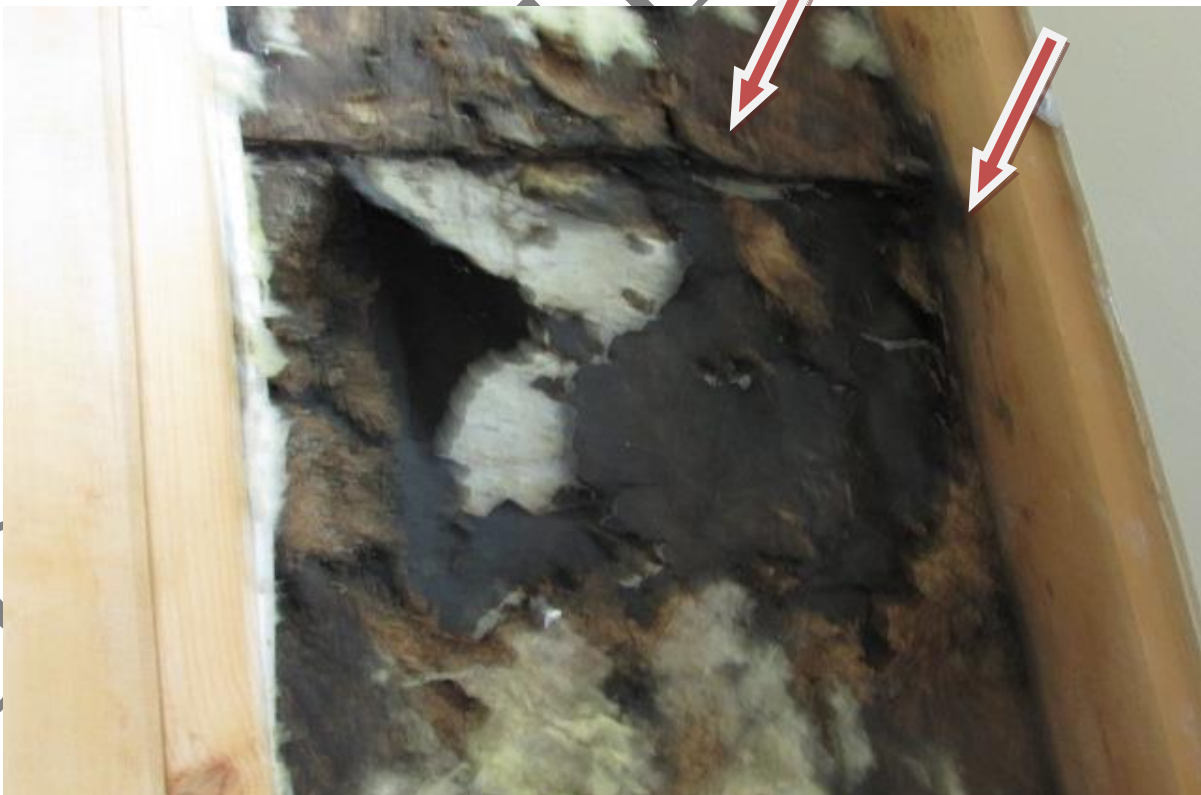
PHOTO 02

2. Photo #02 shows the water logged stud (right arrow) and the wall sheathing delaminating & Warping (left arrow).
3. Three manufactured open wooden web floor joists (4"X18" running from front towards back) got severely deteriorated from the constant pounding of rain water to make them structurally unsafe. Two such joists are shown in photo # 03 with arrows pointing towards them with the third one under the right wall.

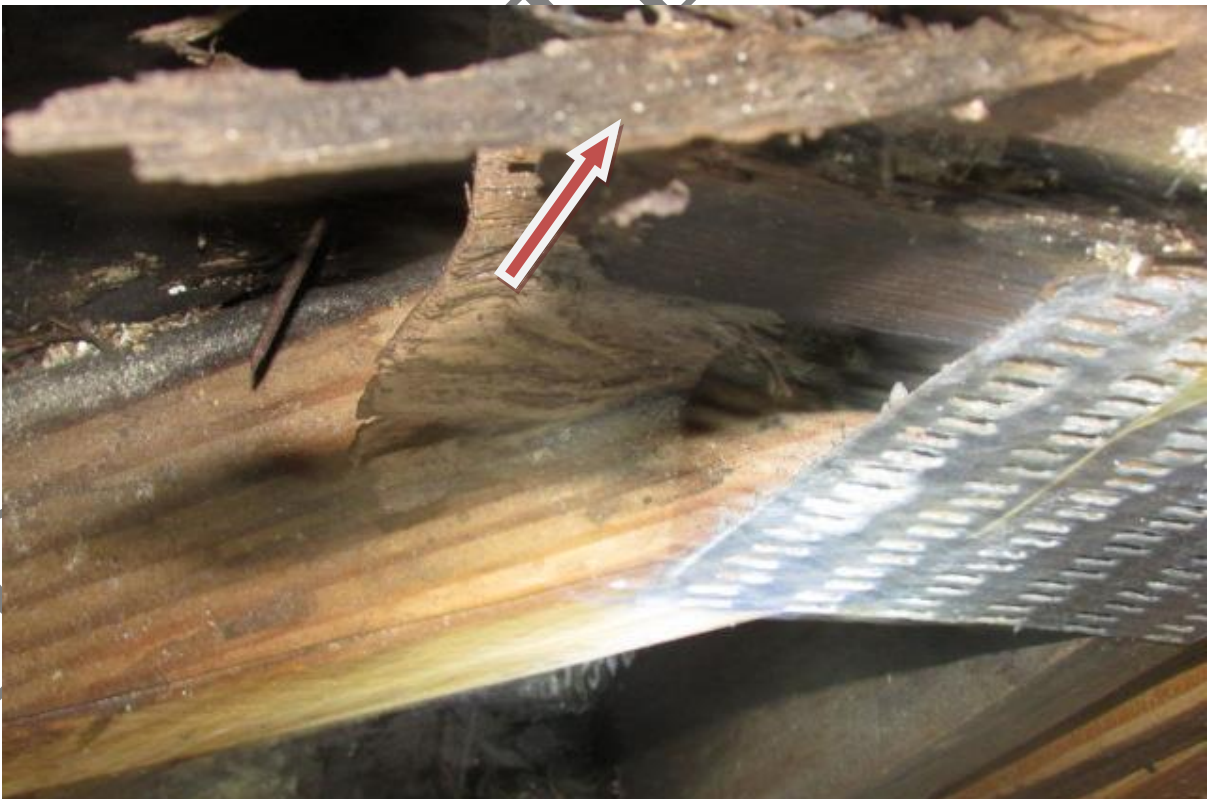
PHOTO 04

4. ¾" decking badly rotted and disintegrated around the chase from rain water travelling down. See photo #04 with arrow pointing to it.
5. A moisture reading shows a reading of 9.2% in photo # 05.

6. All carpets on third floor should be removed and disposed off along with padding.
7. All hardwood floors on second floor should be removed.
8. Wood floor decking should be removed at least four feet beyond the affected deck.

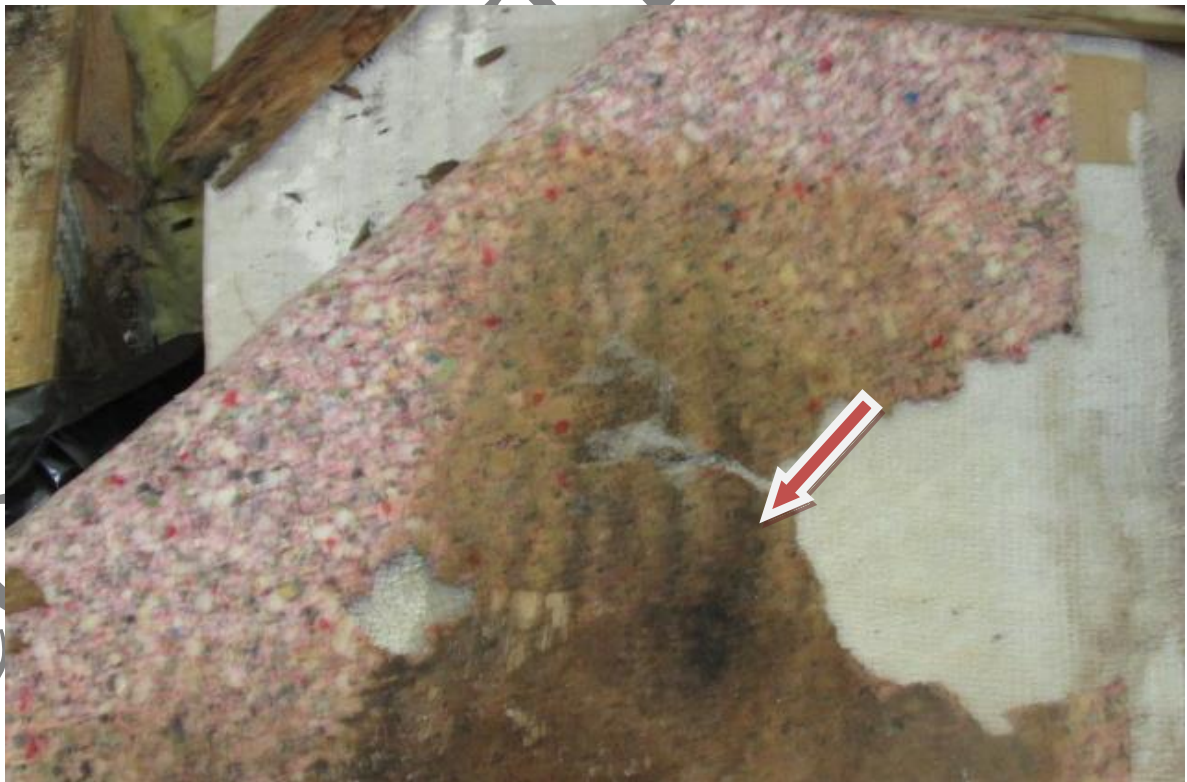
PHOTO 06

6. Photo # 06 depicts condition of the back of the carpet padding from being in contact with floor decking saturated with rain water.
7. Water stains are shown on back of the carpet in photo #s 07 and 08.

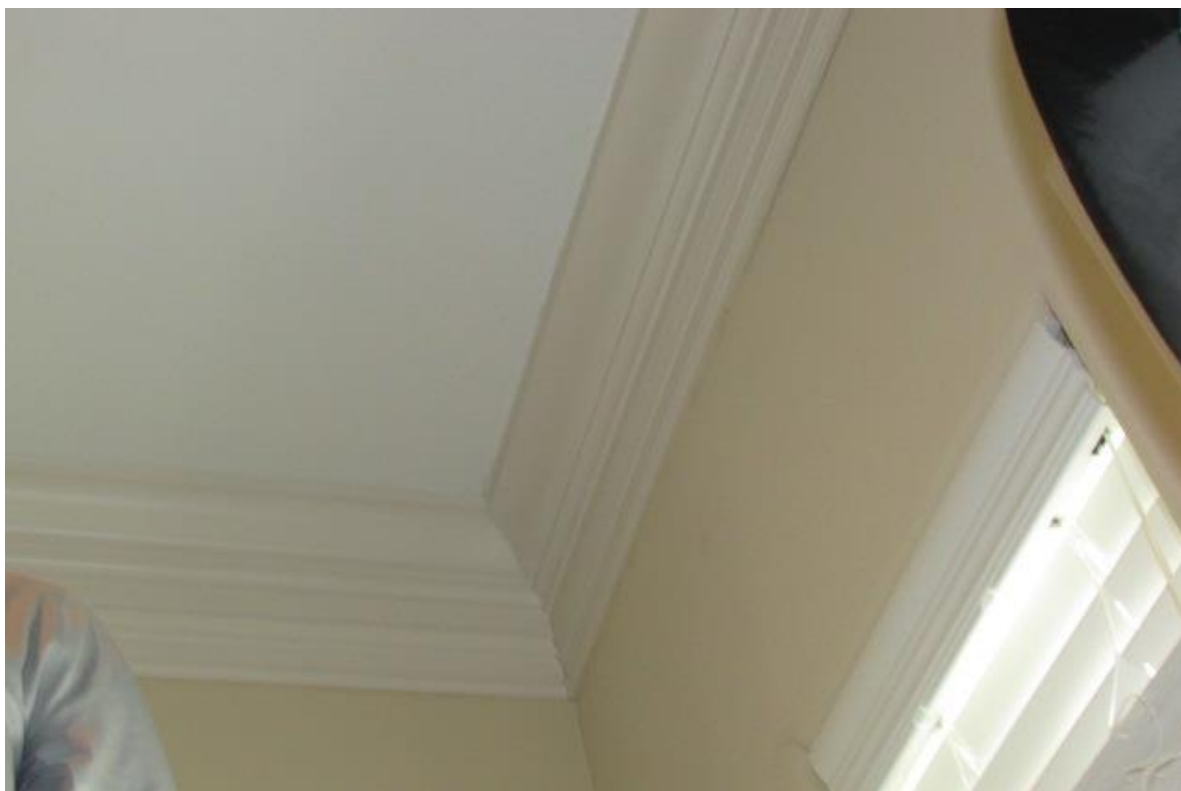
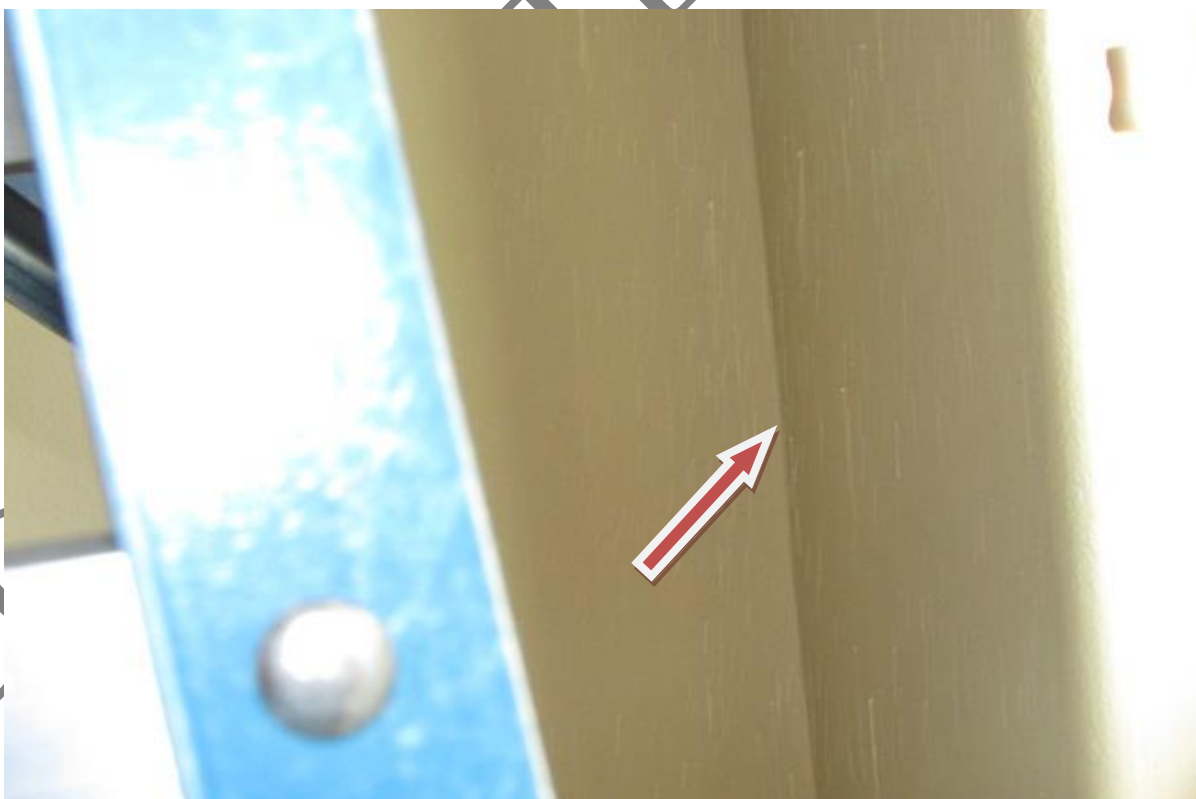
1. The photos #ed 09 through #11 show condition of condition of wall prior to drywall removal. Note the discoloration along the corner and some kind of fungal growth near the window sill on right jamb with arrow pointing to it in photo # 11.

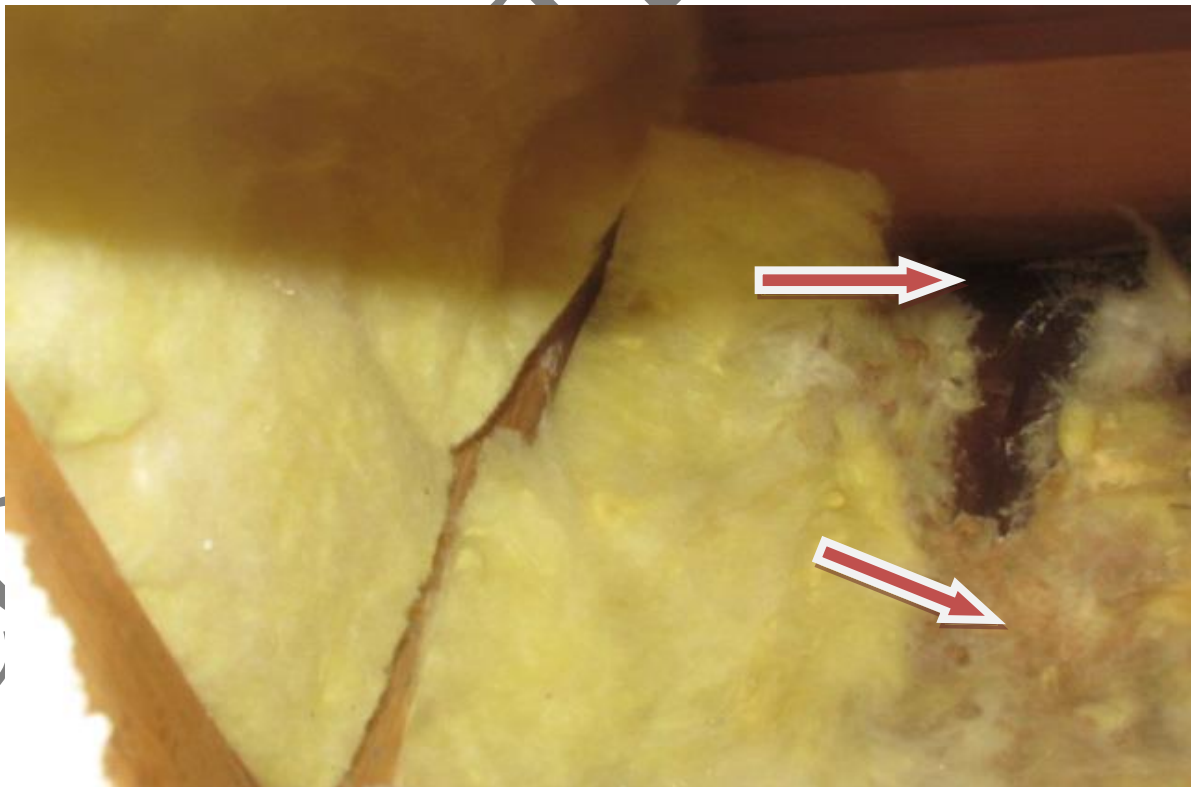
PHOTO 12

2. Notice in photo # 12, with arrows pointing towards the location, the discoloration of the insulation near the ceiling on right wall near front corner.

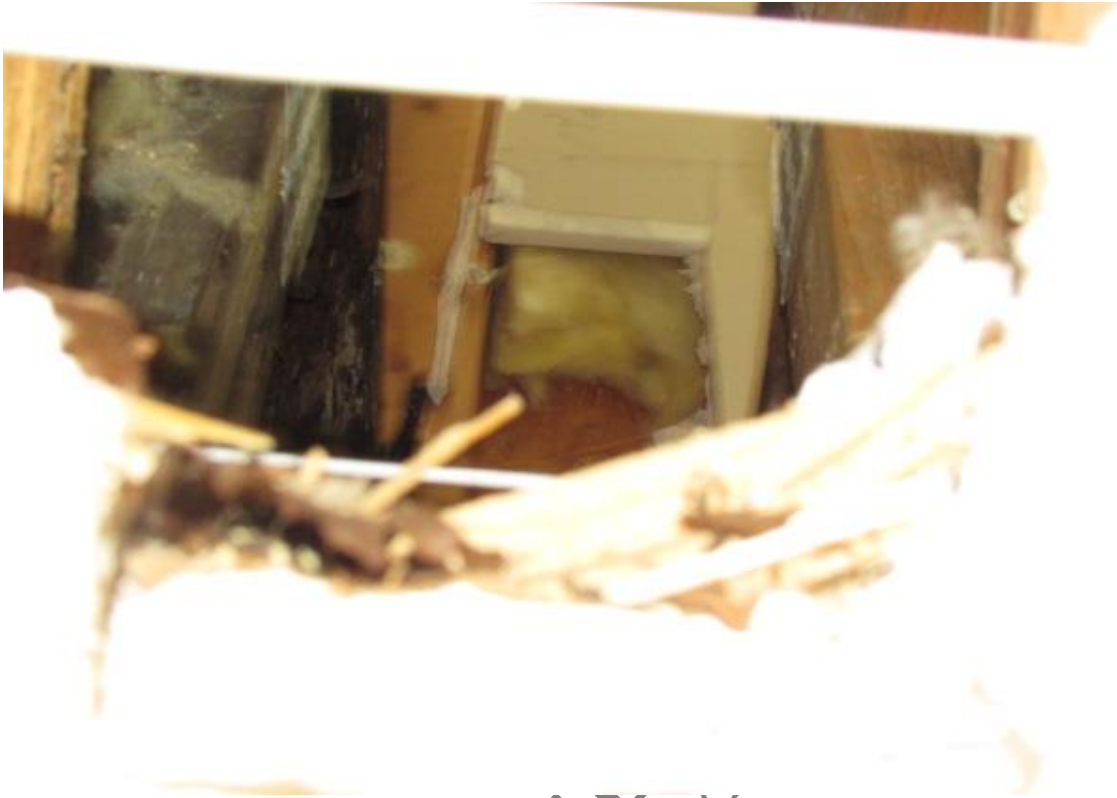
PHOTO 13

3. Photo #13 shows water stains on wood upon removal of insulation near the ceiling on right wall near front corner.
4. Photo # 14 shows water stains and some kind of fungal growth with arrows point to them on the removed drywall near the ceiling.

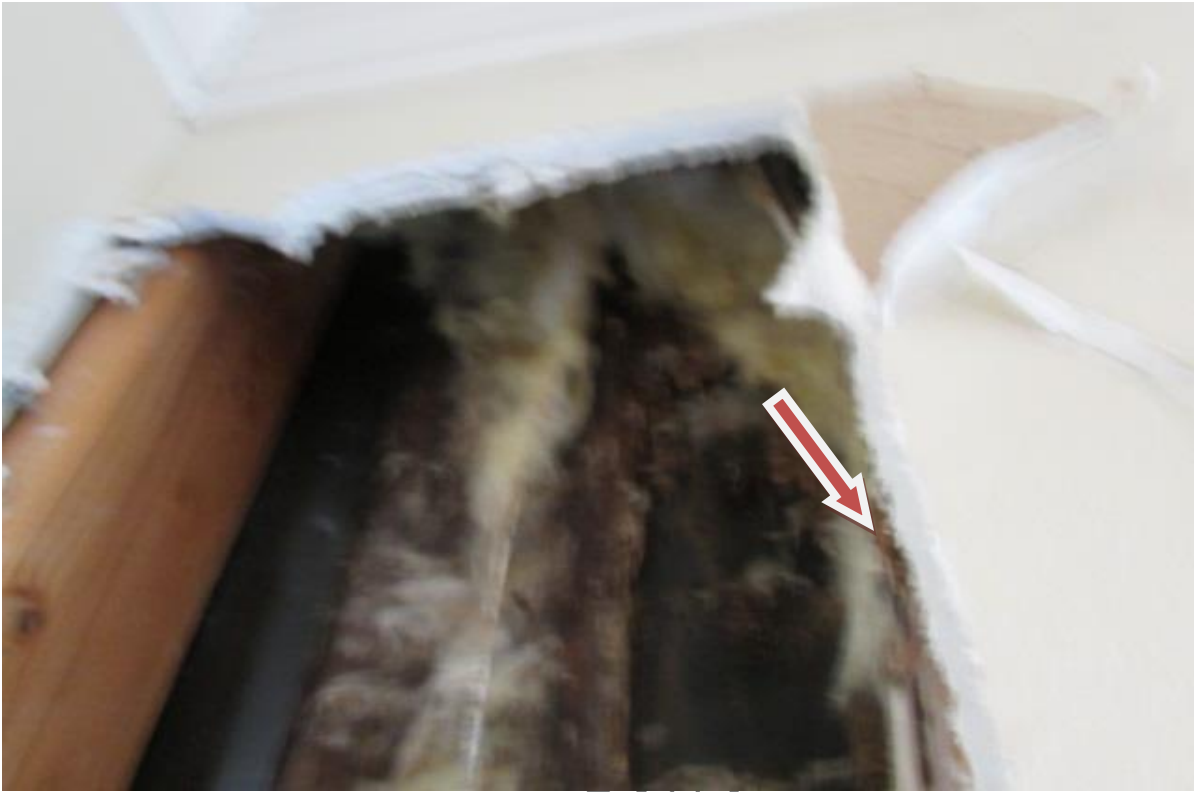
PHOTO 15

5. Photo # 15 depicts condition of deteriorated stud upon removal of drywall and insulation on front wall near ceiling near front right corner from rain water running down.

6. Photo # 15 shows deteriorated and delaminated sheathing behind stucco upon removal of drywall and insulation on front wall near ceiling near front right corner from rain water running down.

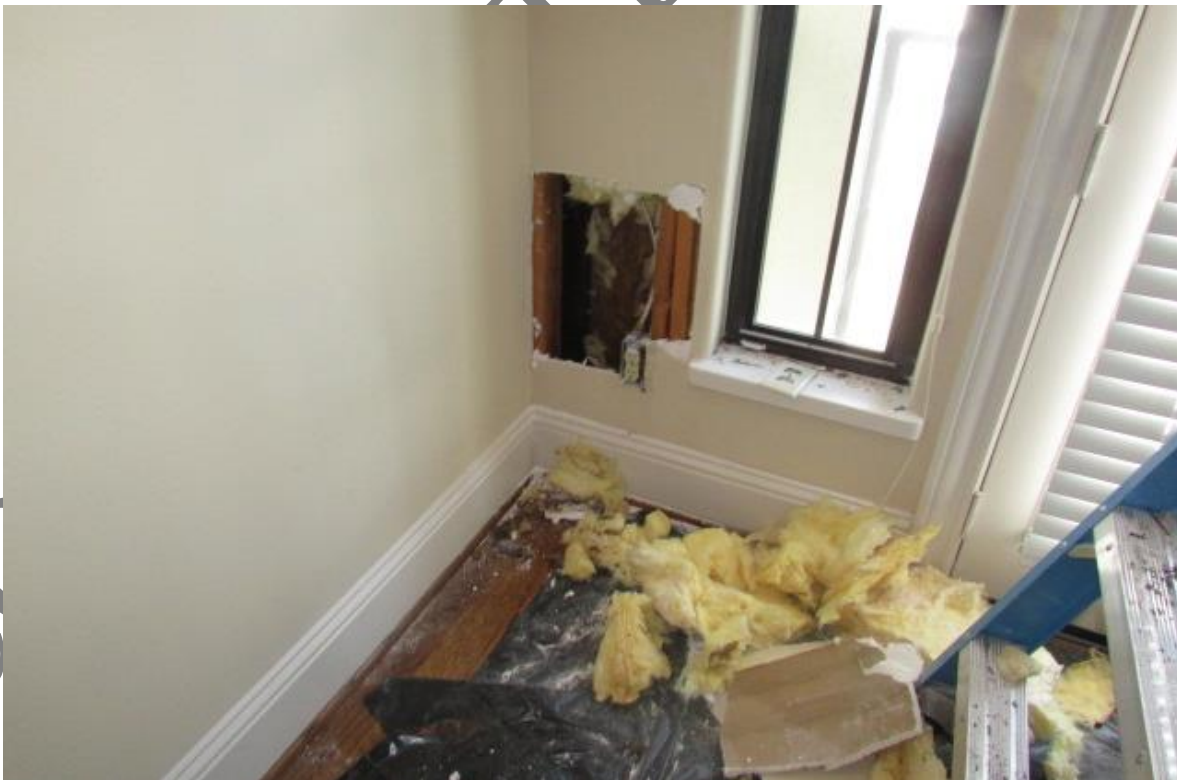
PHOTO 16

8. Photo #16 shows third hole near floor on front wall with close up in photo # 17 upon removal of drywall and insulation. Note disintegration and discoloration of sheathing with fungal type growth.

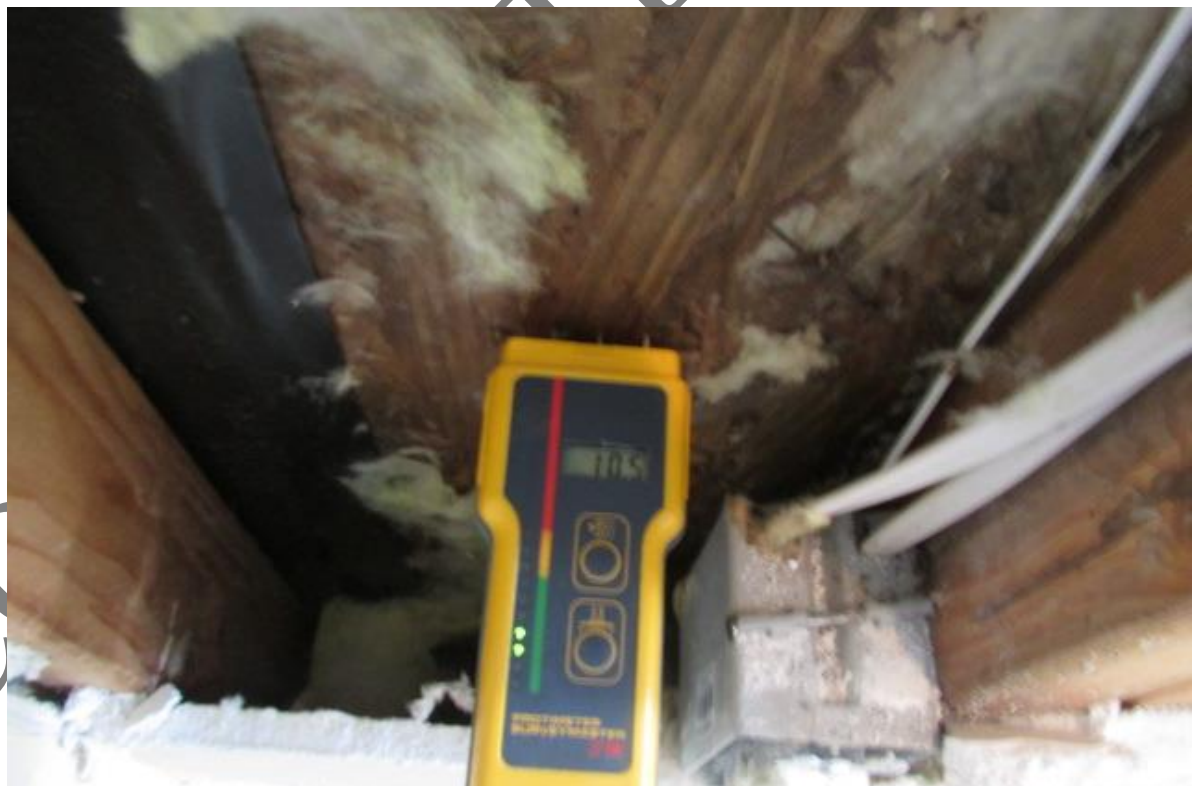
PHOTO 18

9. A moisture reading of 10.5% is shown in photo # 18 in the stud near the floor.
10. Hardwood floor warping can be seen in photos #ed 19 and 20.

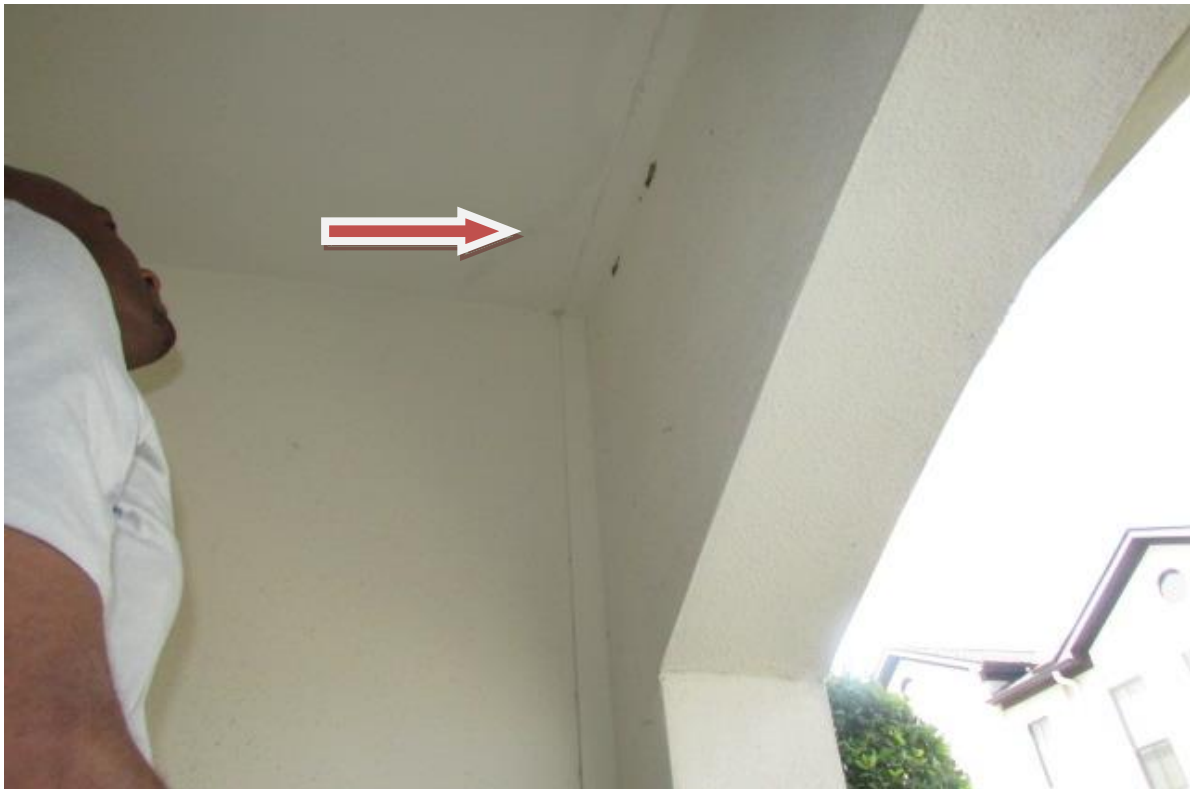
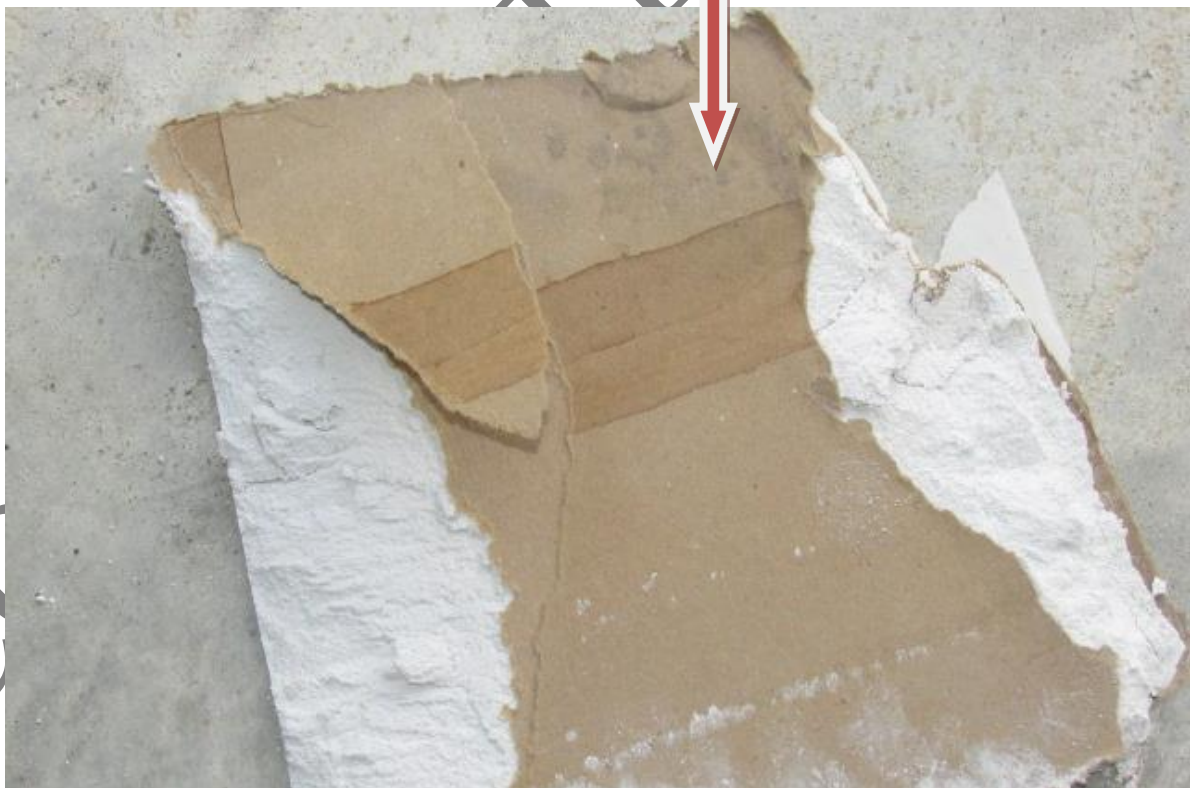
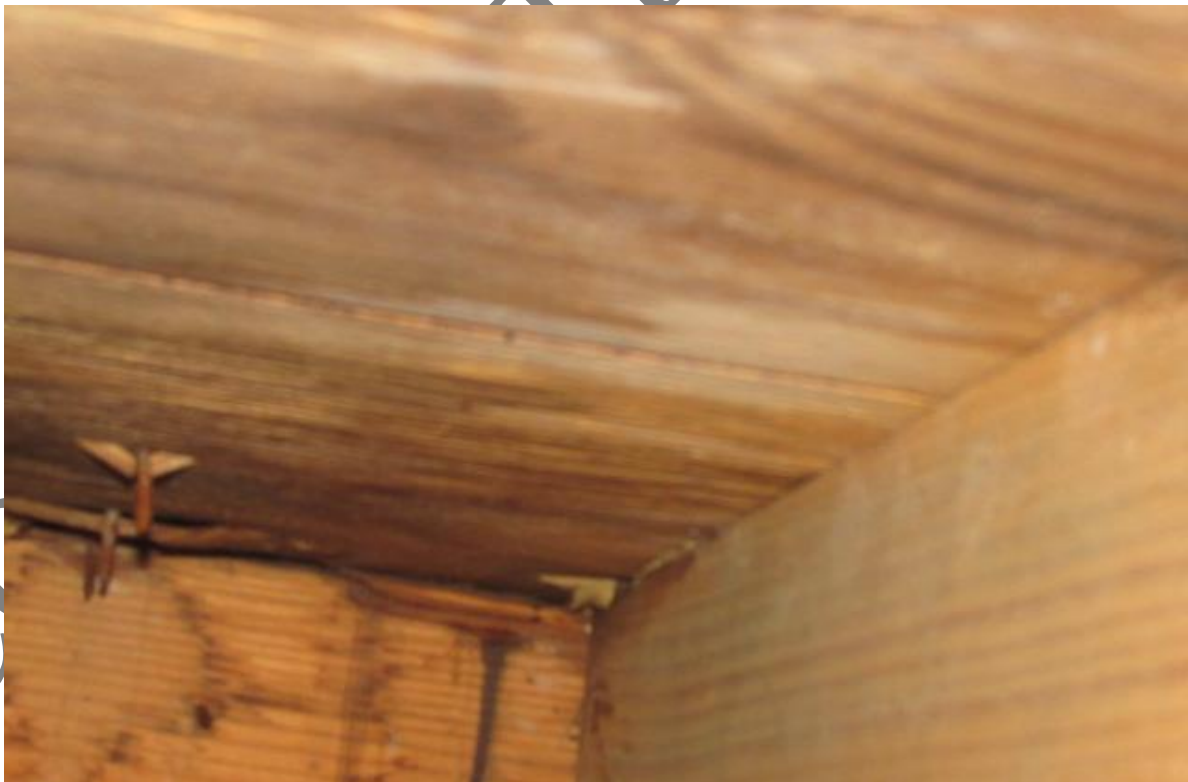
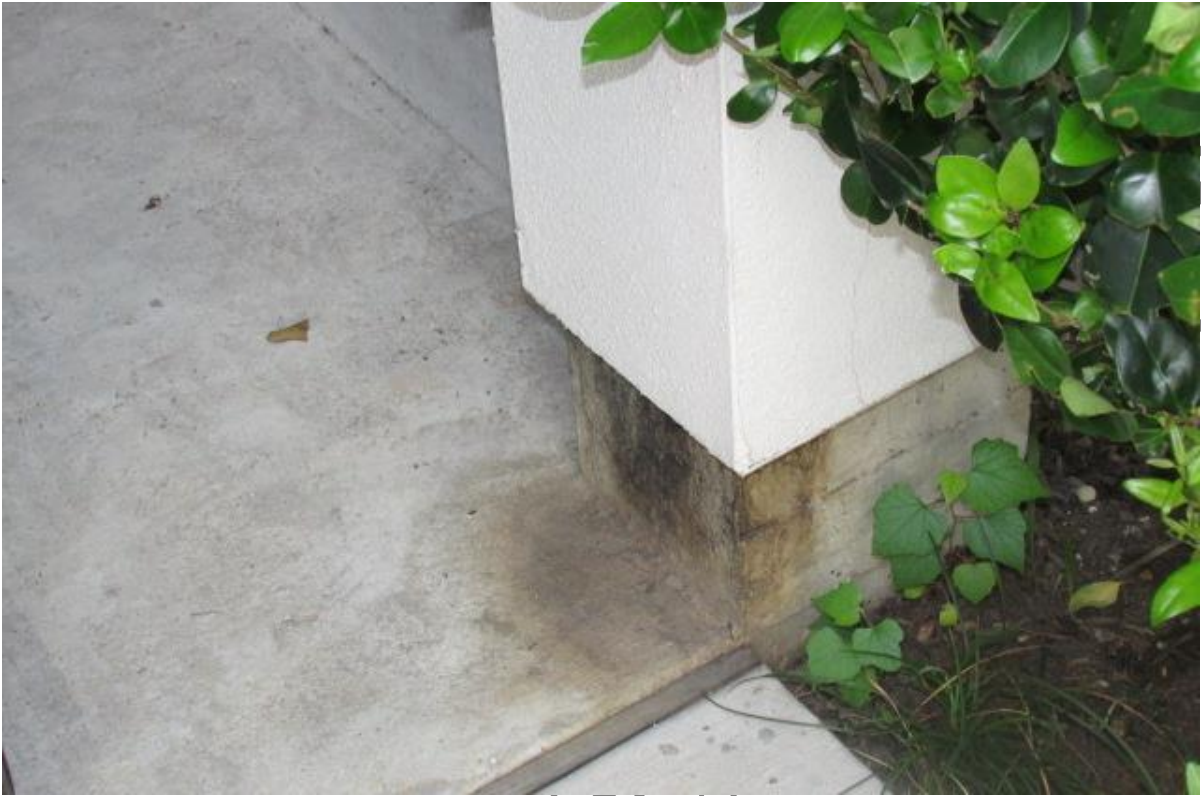
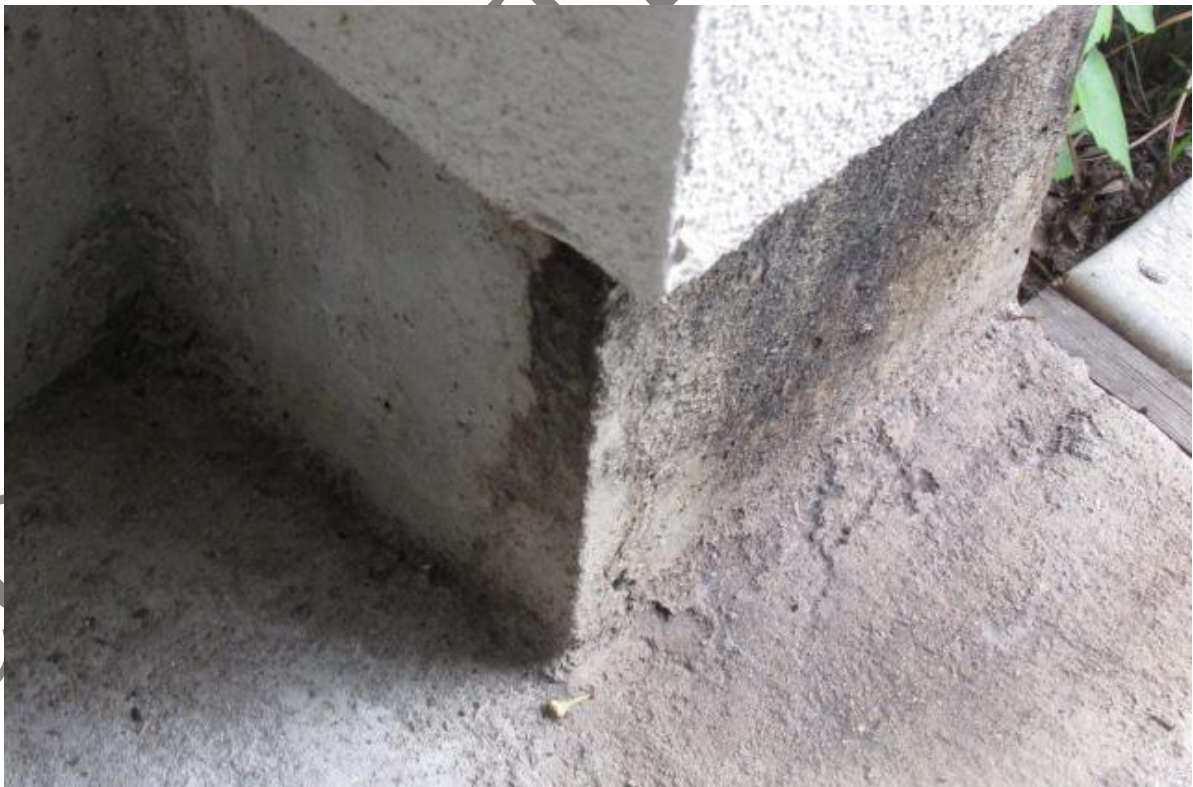
1. Photo #21 depicted the condition of ceiling and wall prior to removal of drywall with arrow pointing to a water stain on the ceiling.
2. Water spots can be seen on removed drywall near ceiling on the inside surface in photo # 22.
3. Photos #ed 23 and 24 depict condition of water logged second floor decking and ceiling joists.
4. Water stains can be seen on three sides of right post of the carport in photos #ed 25 and 26.
