REPORT # 23LGL-CONST-1107P DATE OF INSPECTION: 11/07/23 (10:00 AM) & 11/13/23 (09:30 AM)

123 ABC COURT, CONROE, TX 77385

CONSTRUCTION QUALITY REPORT

Subject Property: 123 ABC Court, Conroe, TX 77385

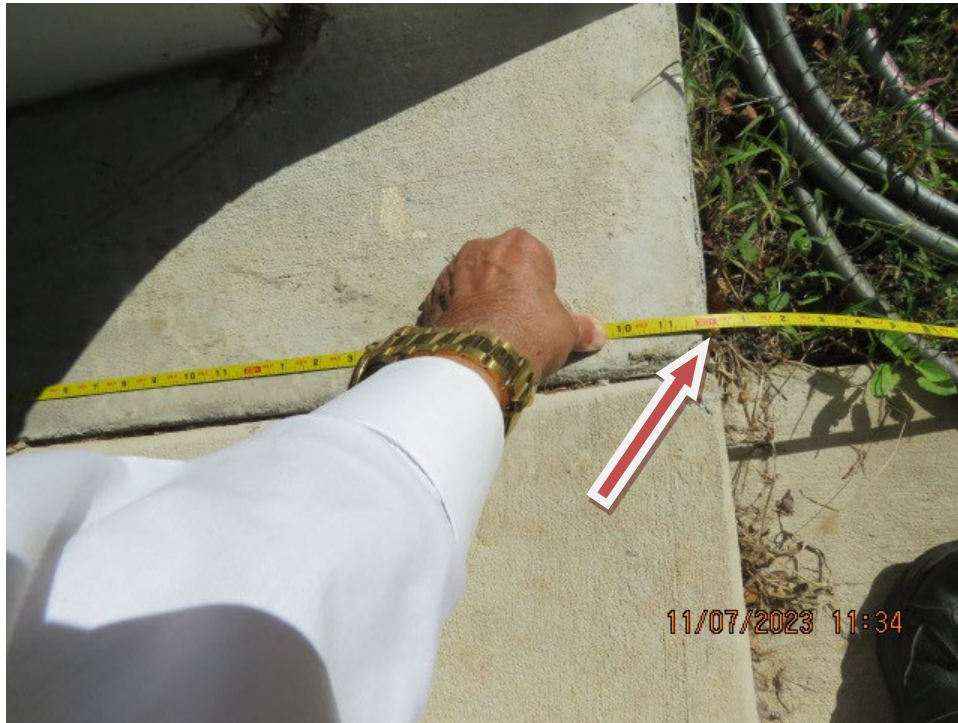
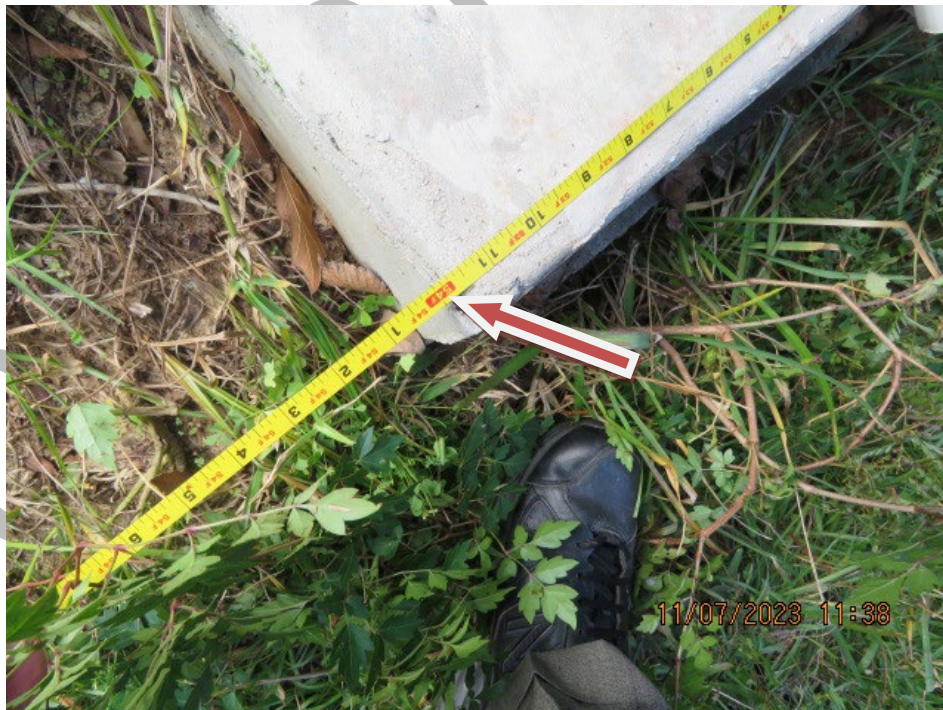
1. The structure was a straight up two-story box building. See cover photo.
2. Concrete pad around the building was measured at 30'-0" on front and back, and 54'-0" along sides. See photos #ed 01 and 02.
3. The building was measured, at the ground level, to be 28'-4" by 52'-4". See photos 03 and 04.
4. The concrete pad extension was observed to be 10" all the way around $\{(30'0"-28'4")/2$ and $(54'0"-52'4")/2\}$. See photo #05.

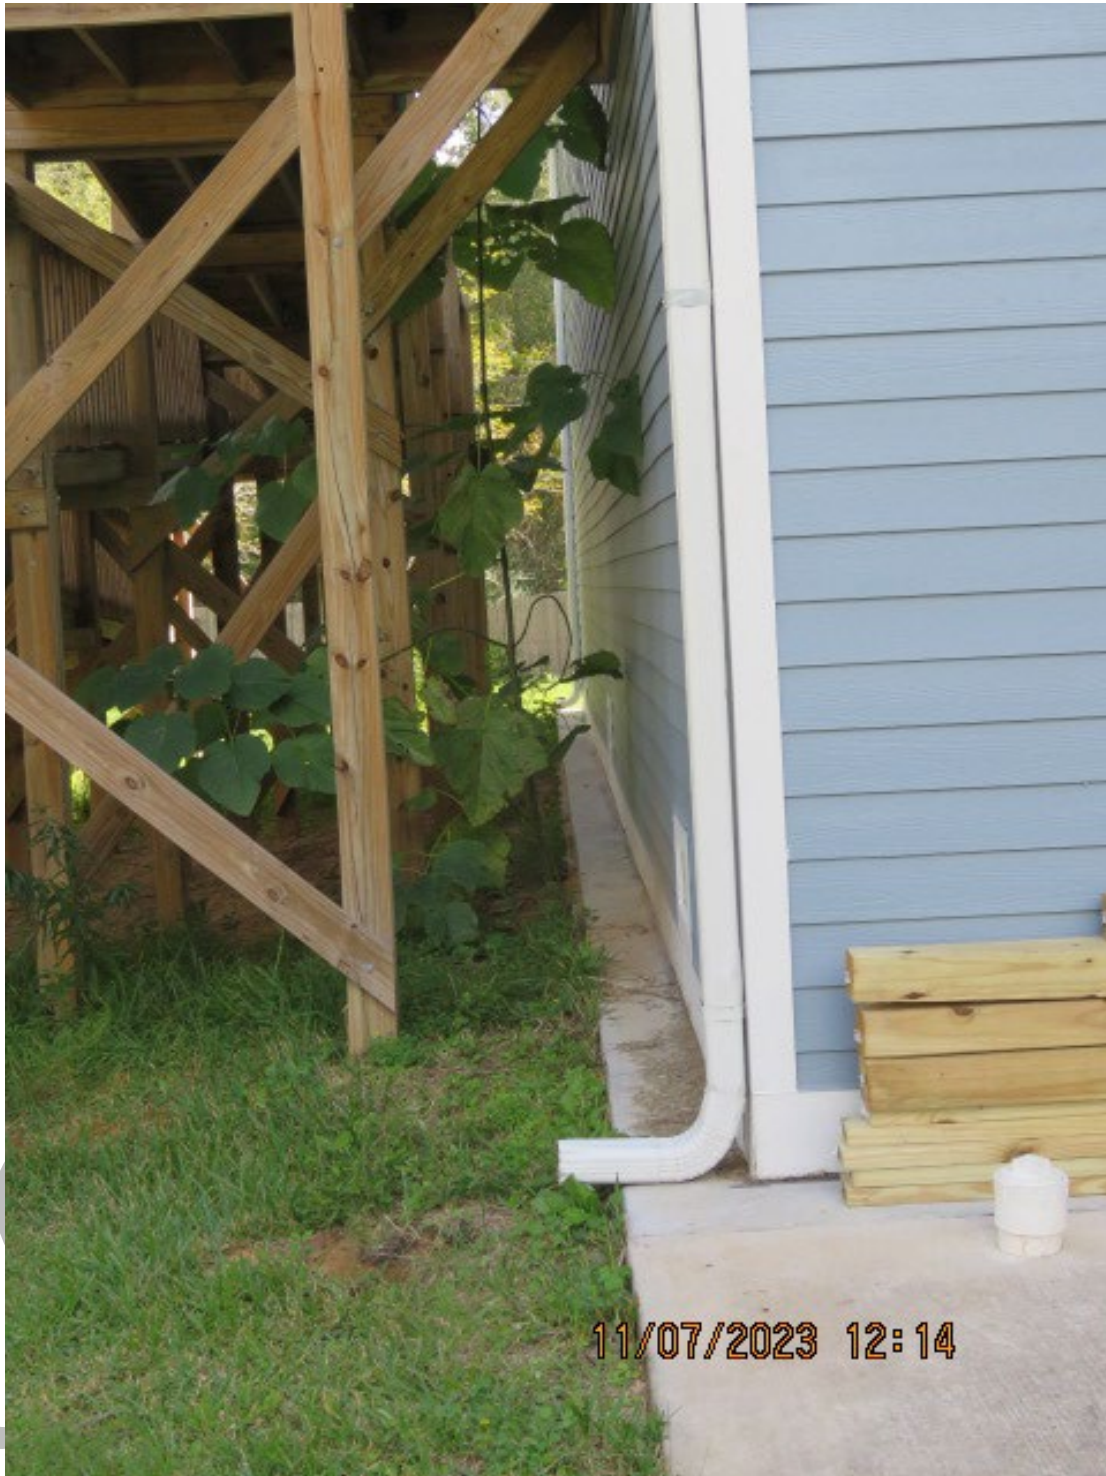
PHOTO #05

Since the pad extension was level on all 4 sides, it was directing rain water to the interior of the property and damaging owner's belongings.

6. Downspouts can be seen discharging rain water near the foundation. Please see photo #05.

Large volumes of rainwater at &/or near foundation has the potential of causing soil erosion (seen in photo #05), and uneven &/or too much moisture around foundation can be conducive to foundation problems or may cause differential foundation movement. The downspout(s) should discharge water at least five (5) feet from the foundation. Storm water should be encouraged to flow away from the building at the point of discharge. See soil erosion at the point of discharge in Photo #05.

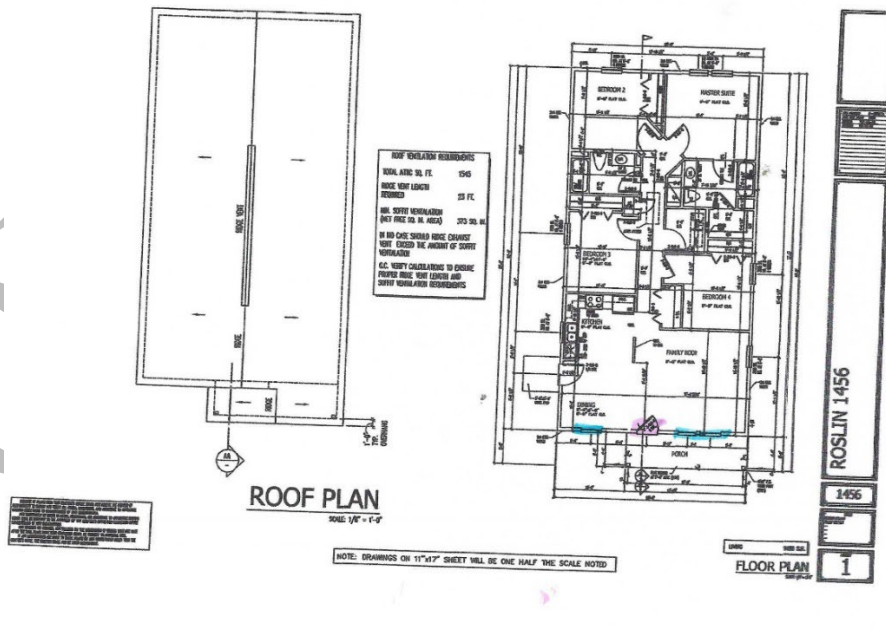
PHOTO #09

8. The Floor Plan Drawing 1 showed one window on left of the door and 2 window on right of the door. (high-lighted). See photo # 09.

Door and window were flipped.

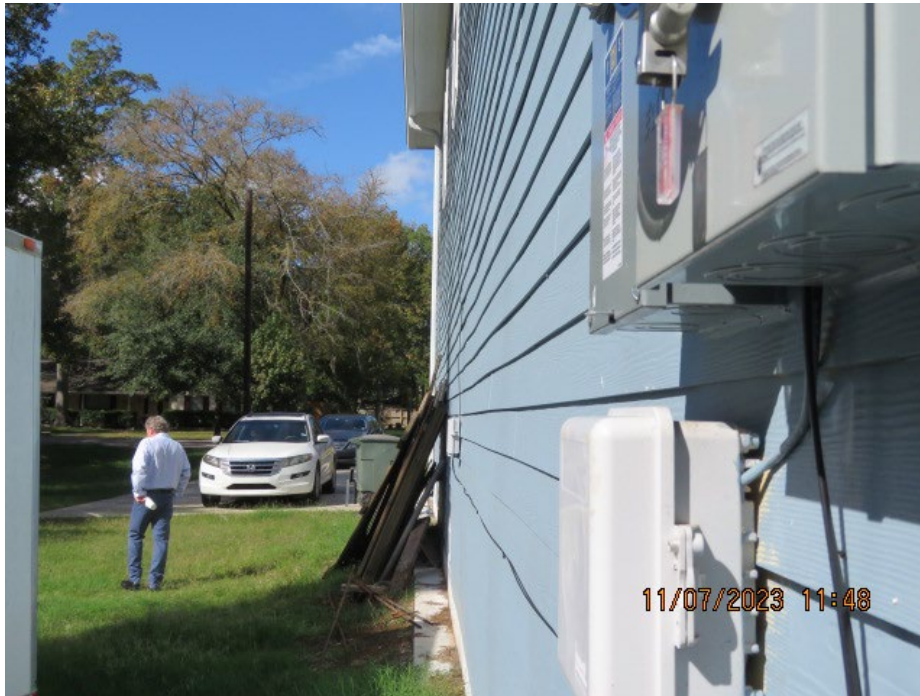
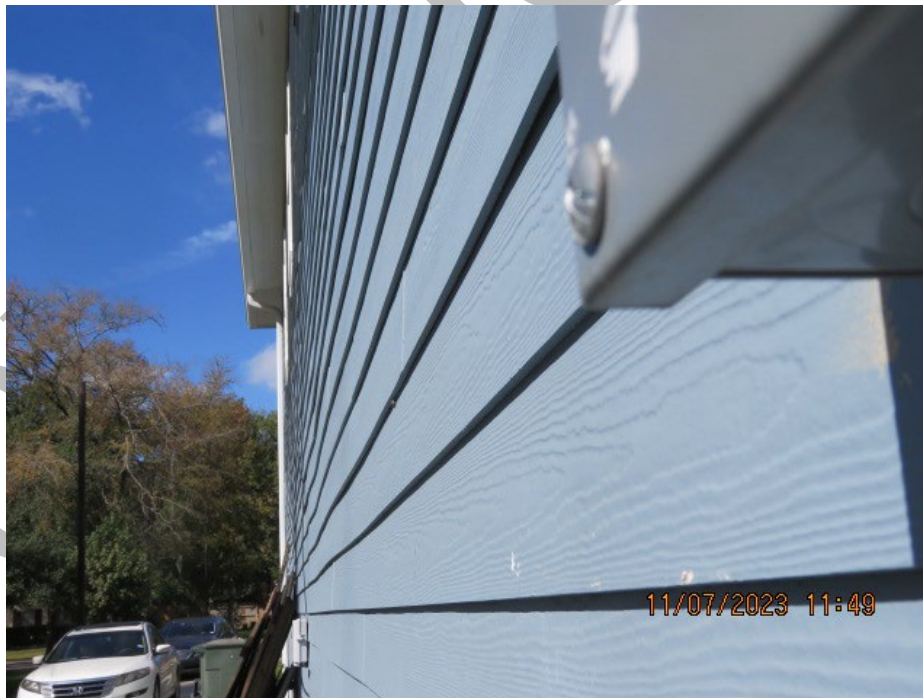
9. Waviness was discovered on siding all around. See photos #ed 10 and 11.

It is an indication of not having enough/proper securing to structural framing and poor workmanship.

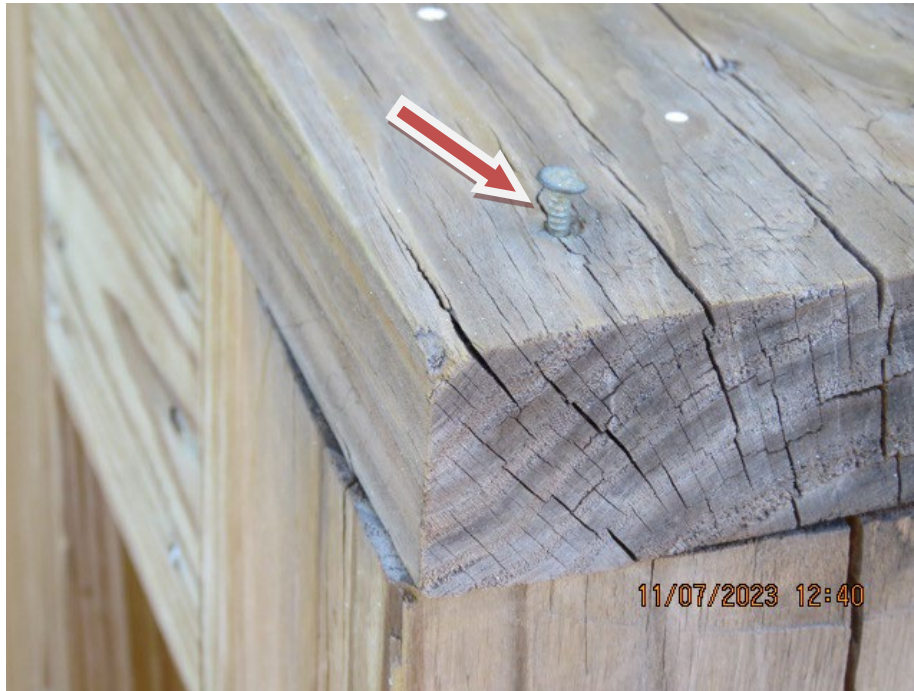
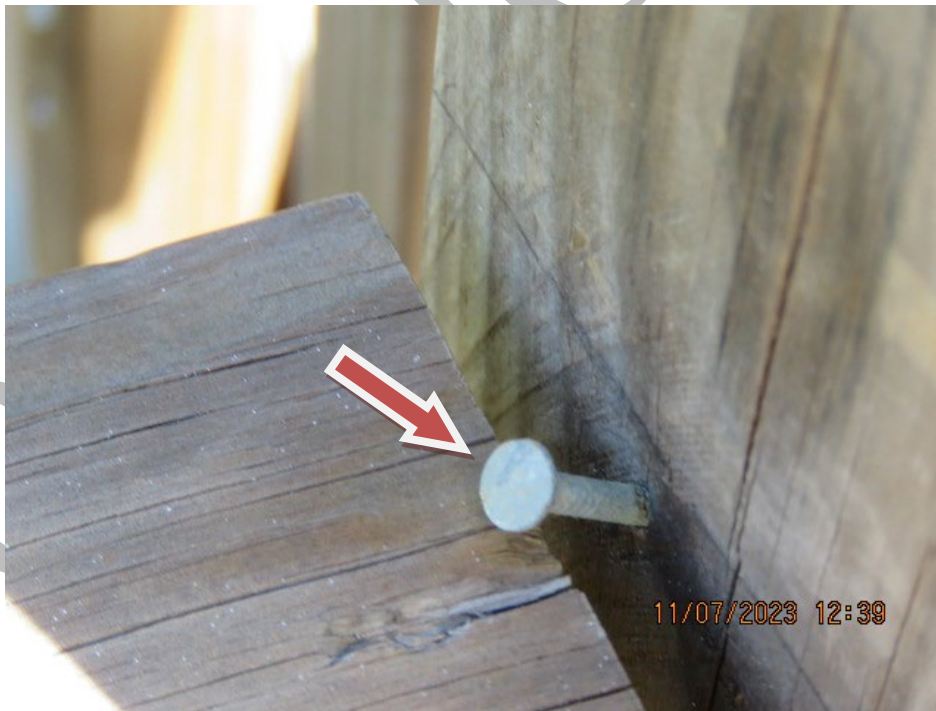
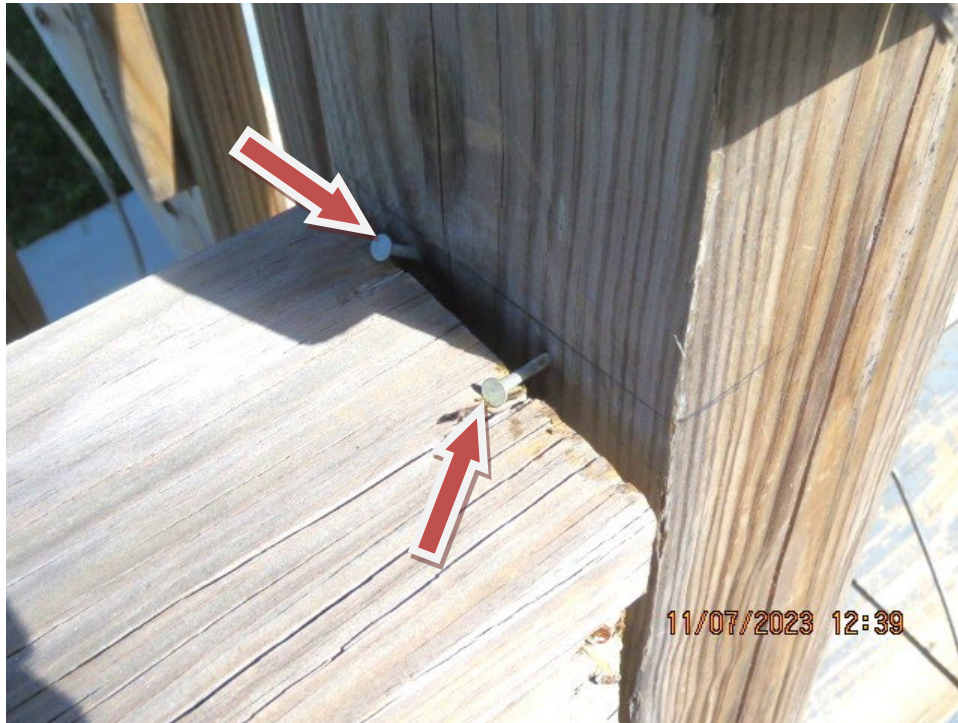
10. Nails were popping out. See photos #ed 12 through 14.

This condition was happening as the builder did not use shanked nails or wood screws which bite into the meat of the wood and prevent them popping out.

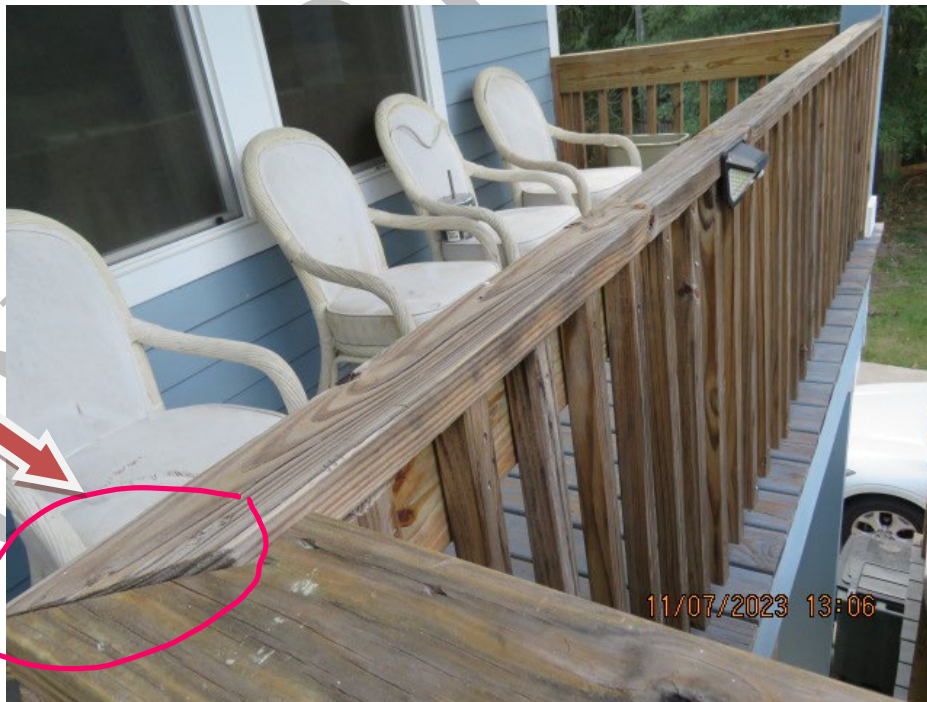
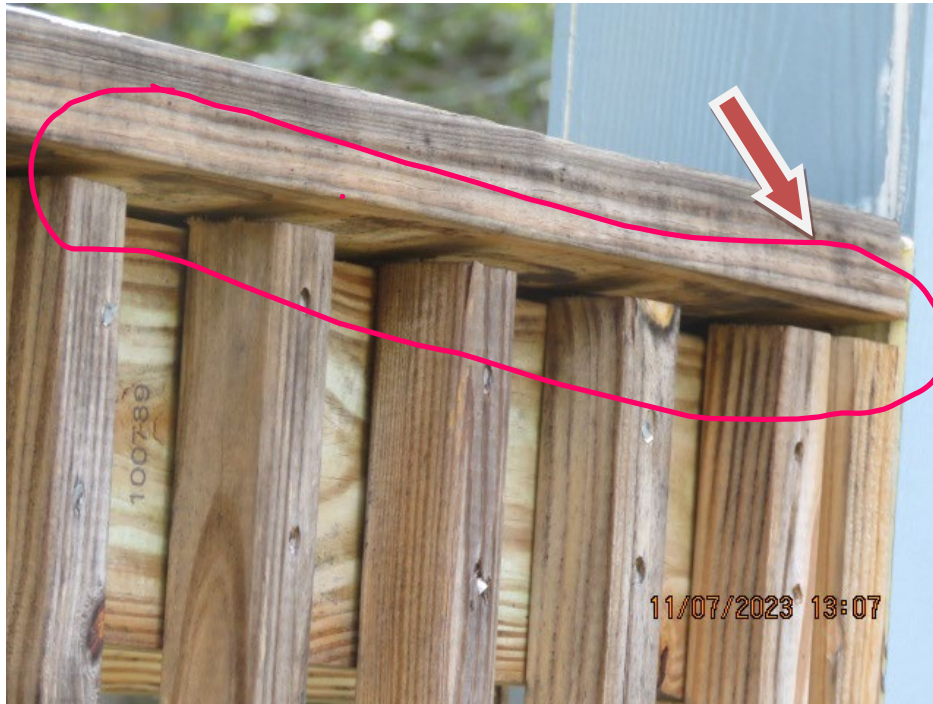
11. Hand rail was warped, twisted and lifted off the supports. See Photos #ed 15 and 16. Photo #16 depicted a closer view of the far end.

This condition was happening as the builder did not use shanked nails or wood screws which bite into the meat of the wood and prevent them popping out.

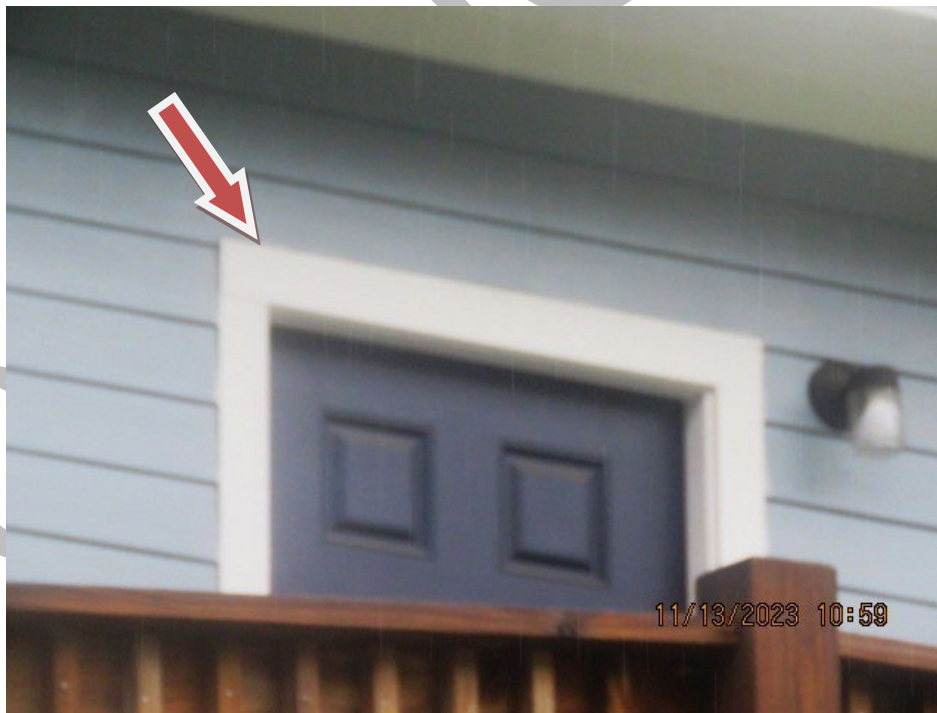
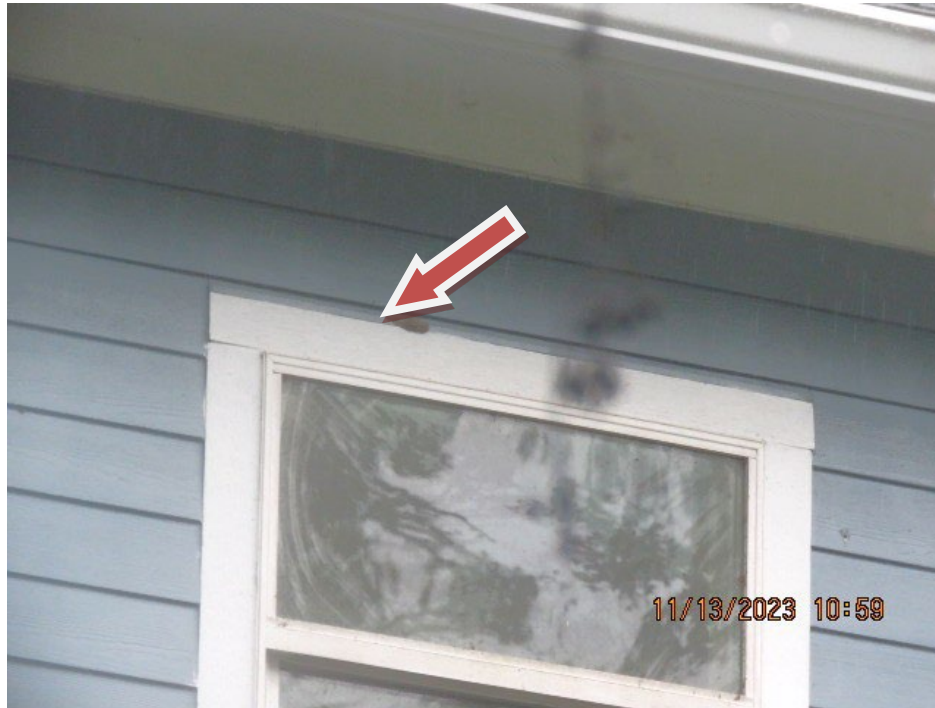
12. Header flashing was missing on several exterior openings. See photos #ed 17 and 18.

This is an unsafe condition as the rain water will find its way in and can cause fungal growth and structural disintegrity of framing lumber. See illustrations as Photos #ed 19 and 20.

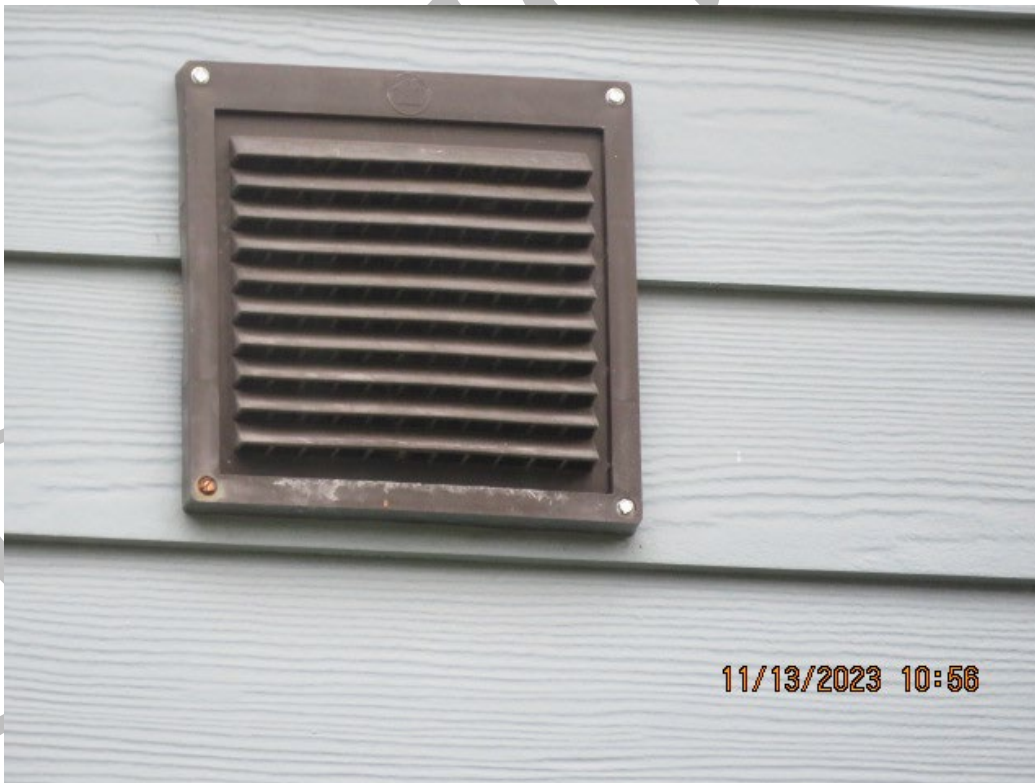
PHOTO #21

13. Fixed louvers were discovered on clothes dryer vent. See photo #21.

Backdraft damper should be used on the exhaust vent as required by 2021 IRC 1502. Fixed louver allows rats and vermin entry into the dryers through the exhaust ducts. See illustration as photo #22.

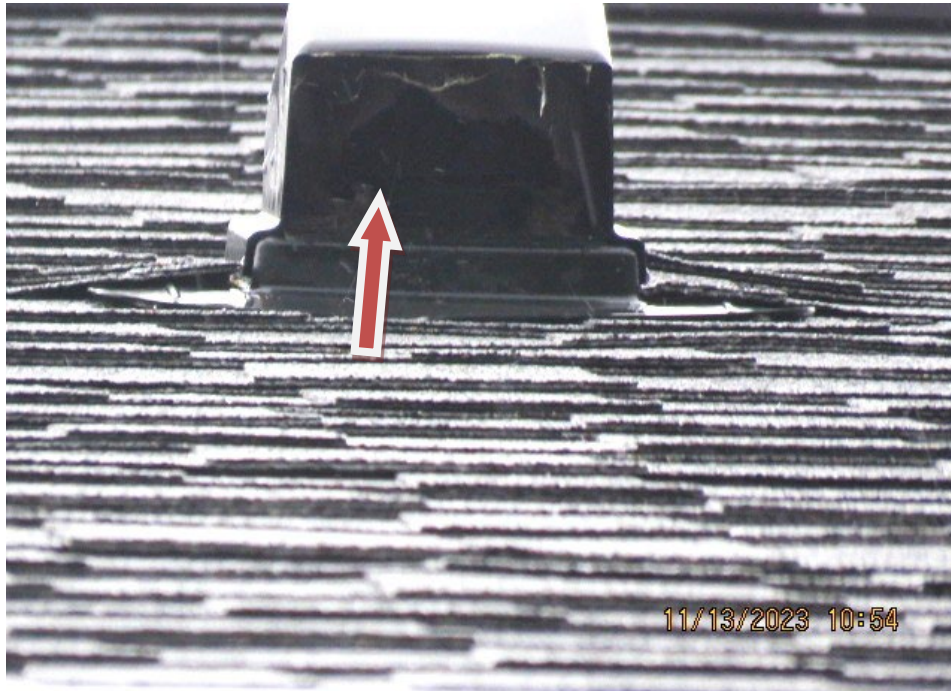
PHOTO #26

18. Screen on one of the bathroom exhaust vents was damaged. See photo #26.

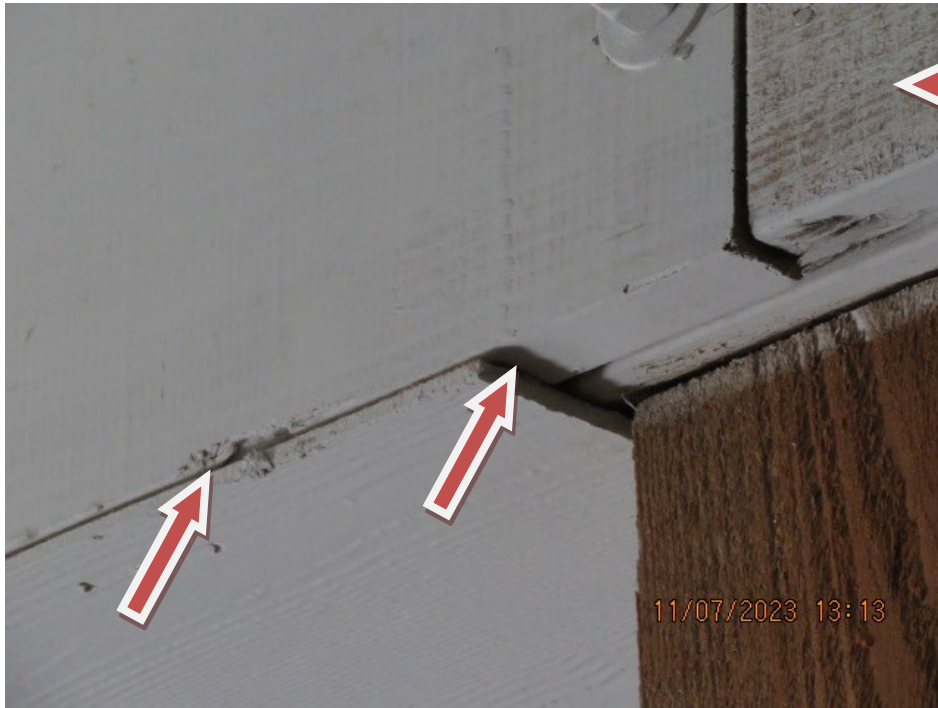
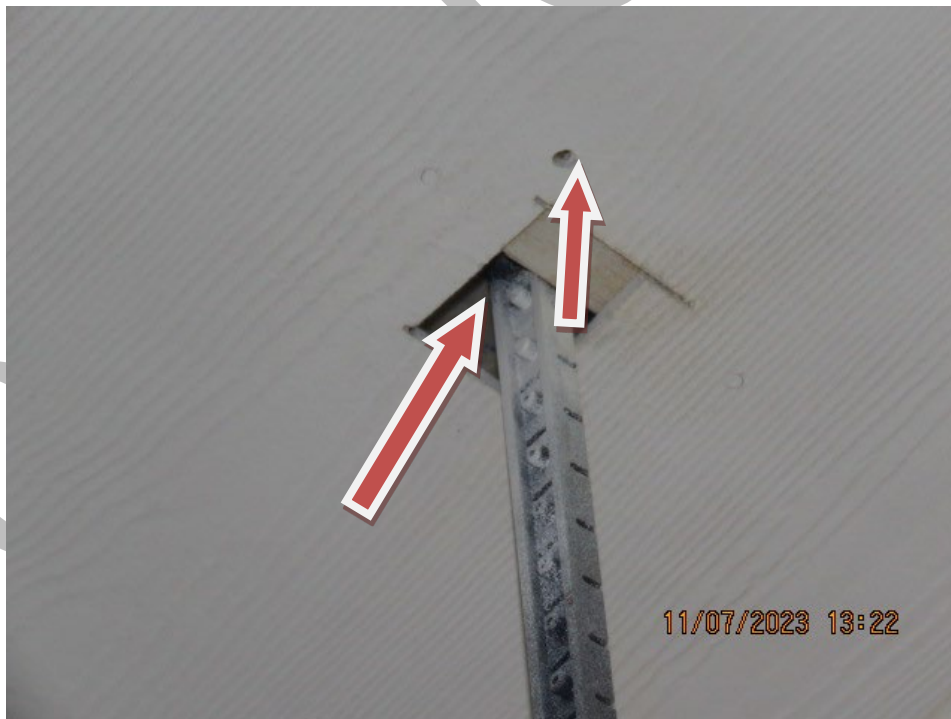
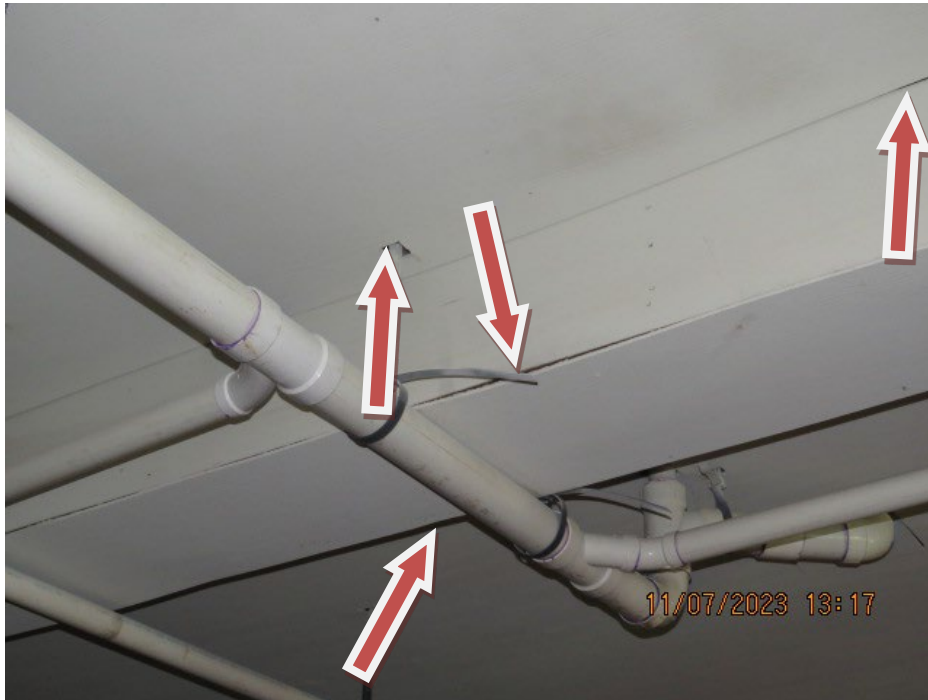
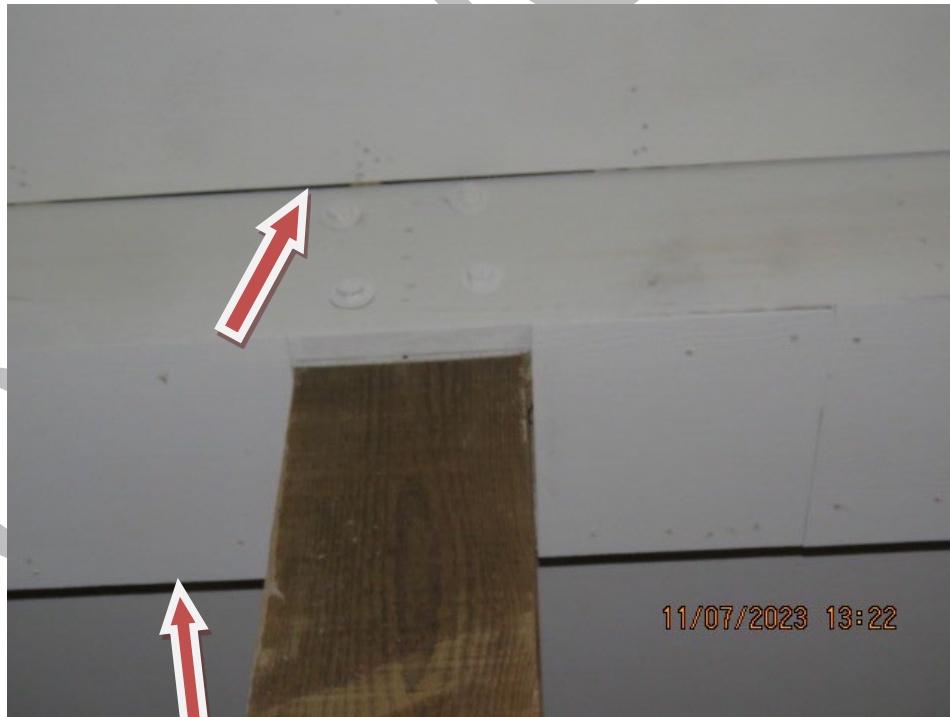
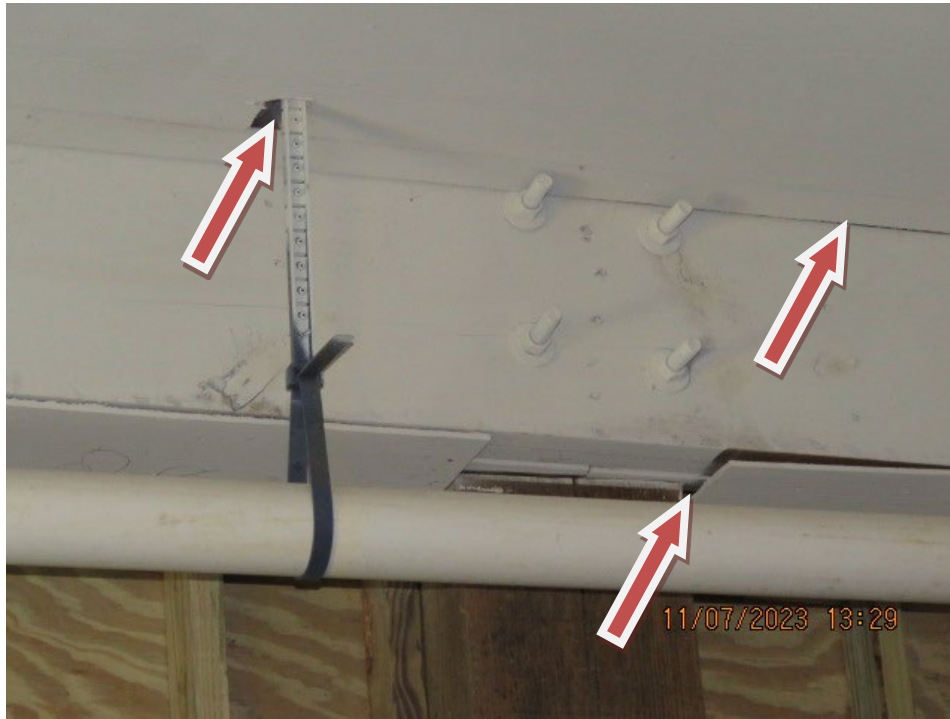
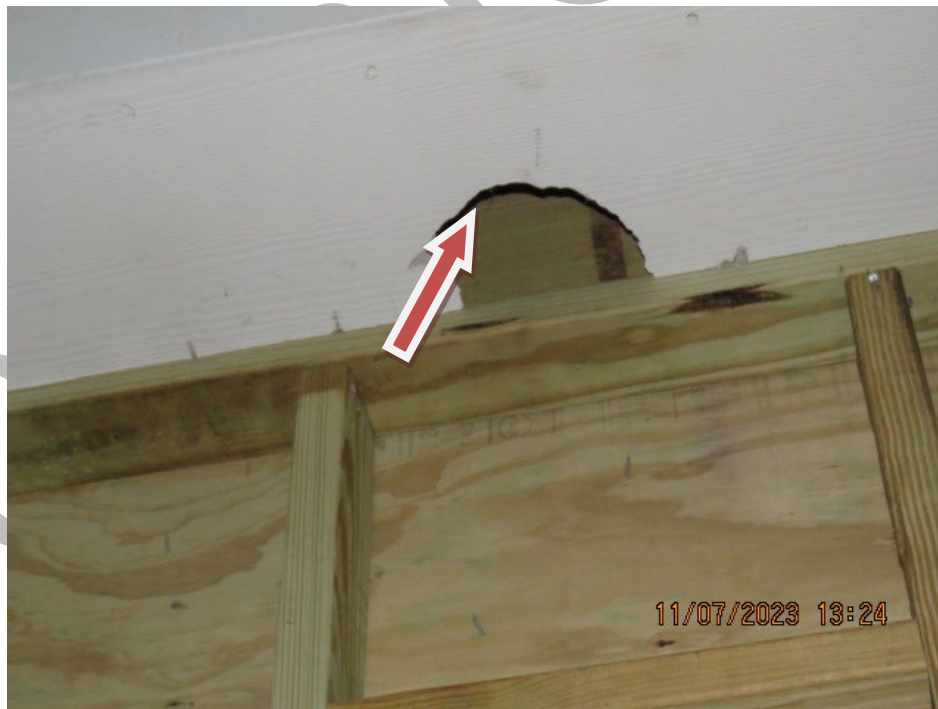
6. Joints, gaps and damaged areas in cement-based material were not sealed. Some arrows pointed to such locations in photos 38 through 43.

Fire barrier joints, gaps and damaged areas were not taped and sealed on the ceiling. This presented a potentially unsafe condition as such openings can provide a quick and easy pathway for fire to travel to the living quarters upstairs, even if cement based was fire-rated (which it is not), for any fire originating in the storage below.

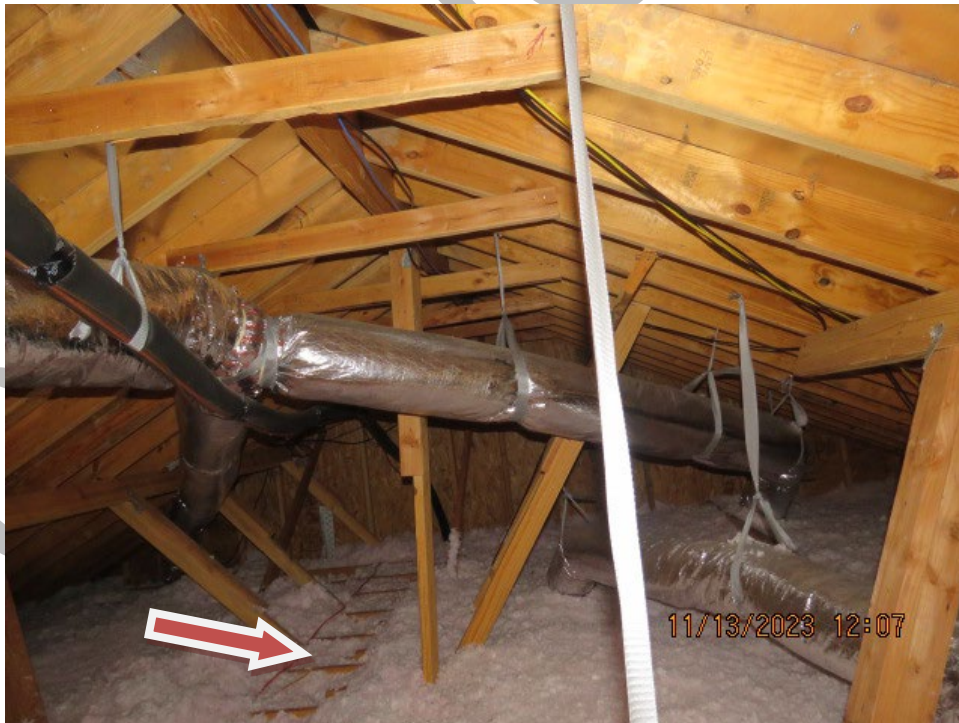
PHOTO #47

2. Insulation was partially missing towards backside. See photo # 47.

It appeared that the insulation was intentionally removed to have an accessway path for accessing or repairing something, but was never put back.

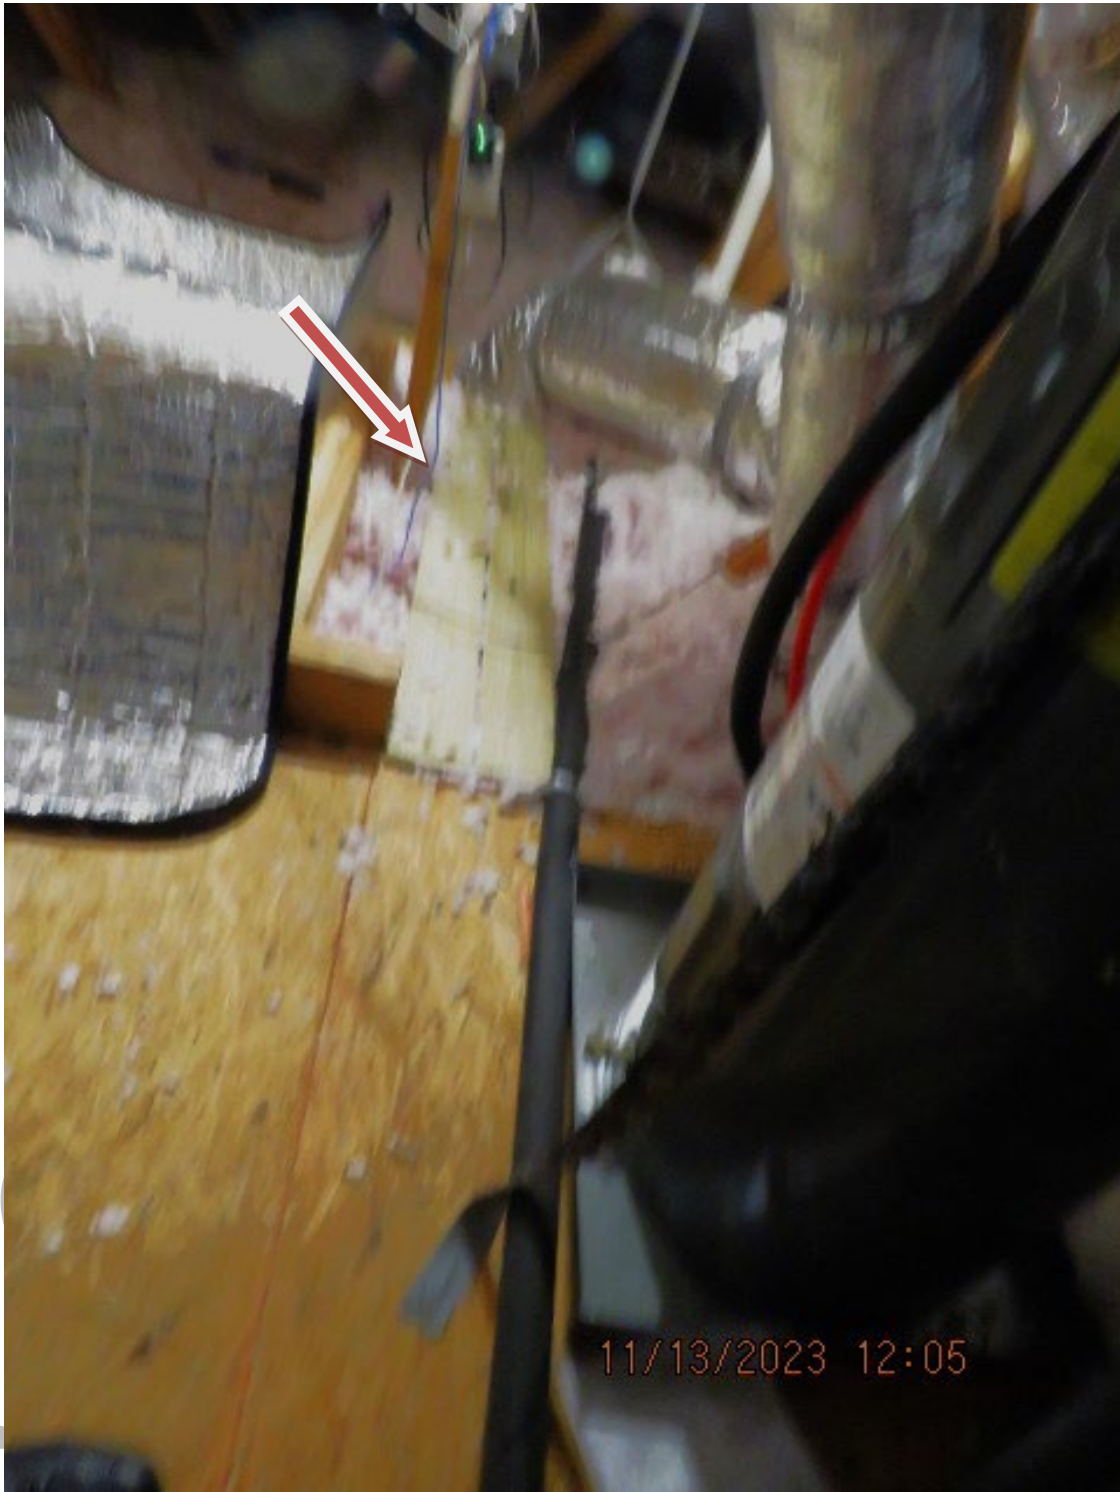
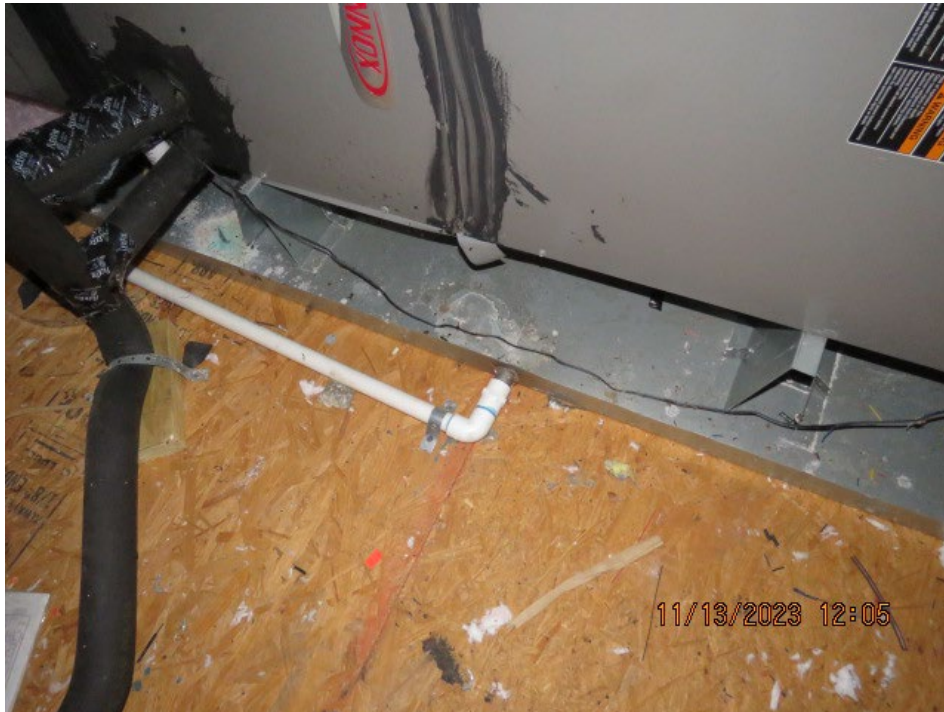
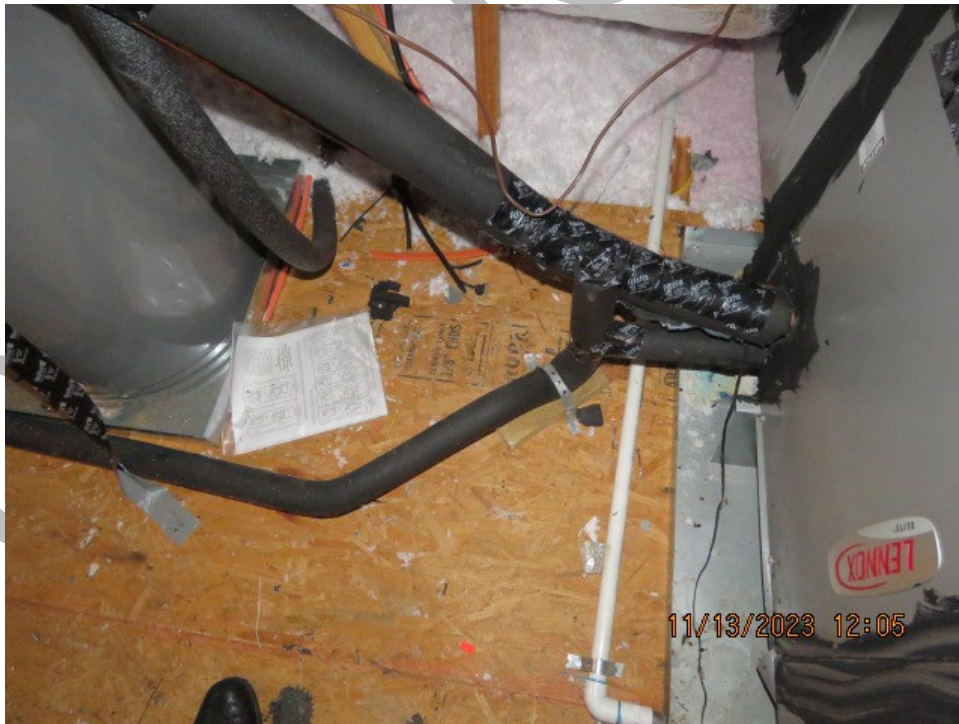
3. No proper size, unobstructed, safe and solid access and service platform was noted to furnace and the water heater. See photos #ed 48 through 50.

A solid & unobstructed access 24" wide with a maximum length of 20' (50' if passageway 6' high), and a solid & unobstructed service platform minimum 30" deep and length equal to equipment width on the service side of the horizontal unit (& 30" deep all way around of a vertical unit) are recommended for safety purposes per IRC R1305.1.2. See code illustration as photo #51.

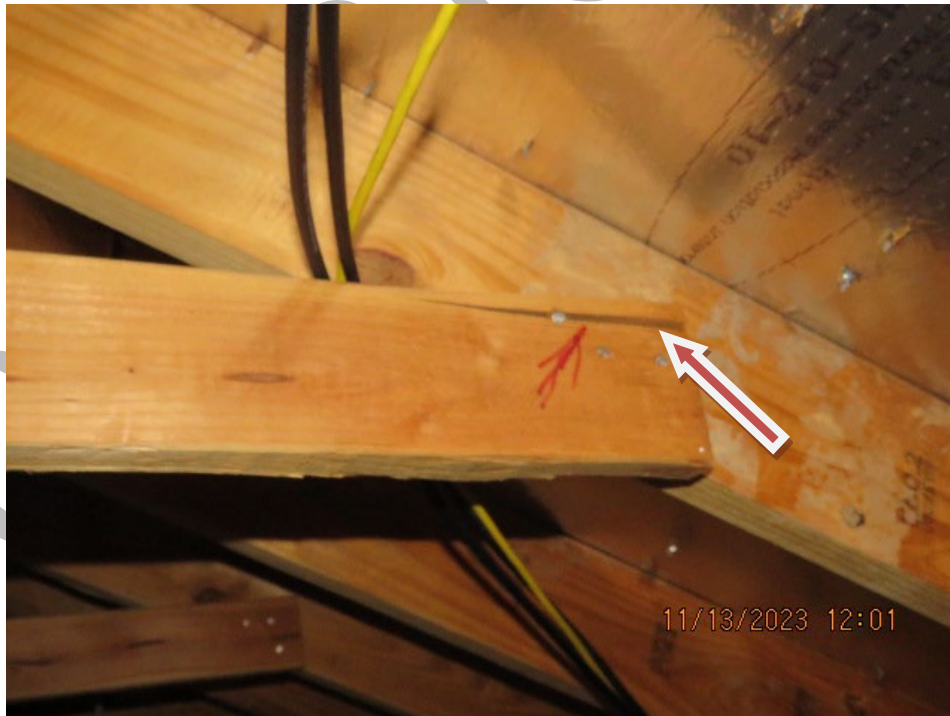
PHOTO #52

4. Collar tie was cracked. See photo #ed 52.

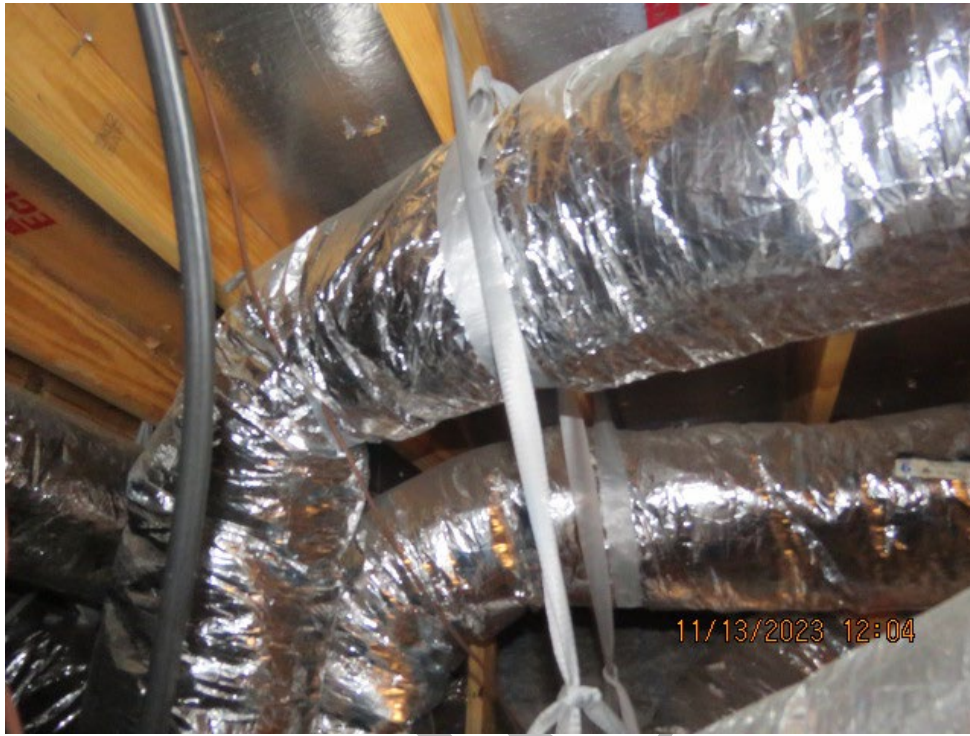
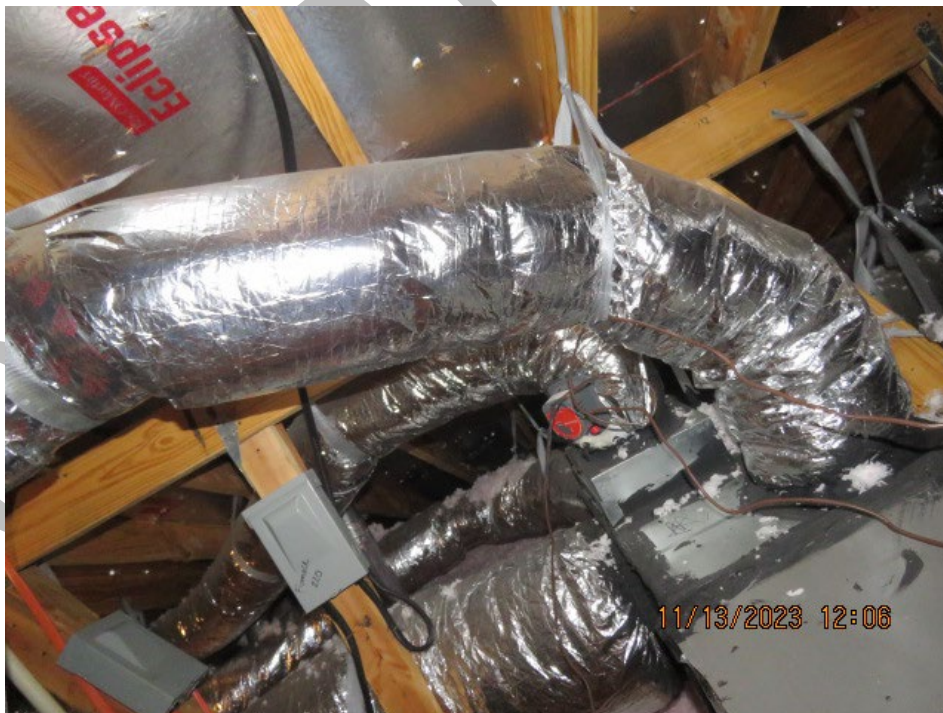
5. There was no safe access to examine purlin struts over the dining room on the left near front and the access was blocked with duct work (photos # 53 and 54). It was observed from a location past the furnace. This location was marked on the collar tie. See photo # 55. It appeared from this location that purlin struts were directly resting on the ceiling joists. See photo # 56 with arrow pointing to struts.
