**123 ABC COURT, CITY, TX 12345**

REPORT NO.: **23LGL-CONST-1107P**

## CONSTRUCTION QUALITY REPORT

Subject Property: **123 ABC Court, City, TX 12345**

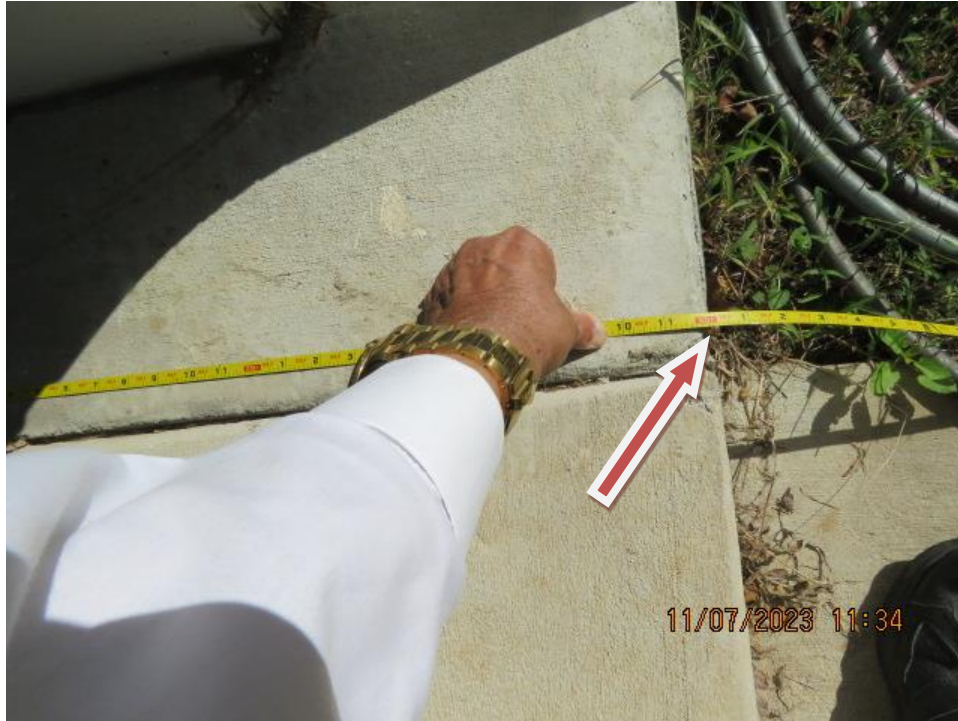
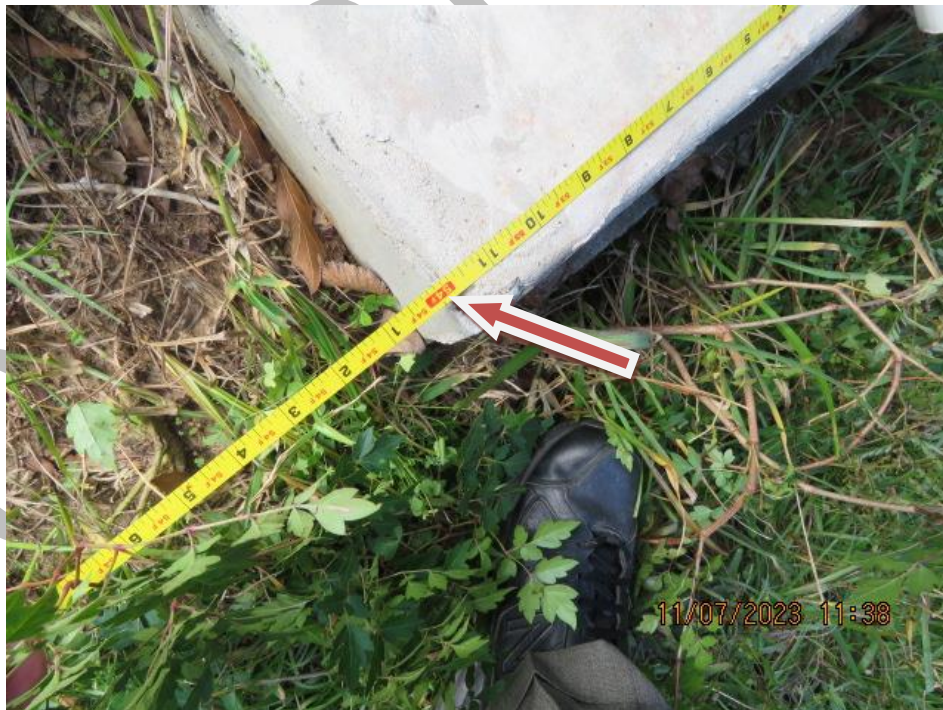
1. The structure was a straight up two-story box building. See cover photo.
2. Concrete pad around the building was measured at 30'-0" on front and back, and 54'-0" along sides. See photos #ed 01 and 02.
3. The building was measured, at the ground level, to be 28'-4" by 52'-4". See photos 03 and 04.
4. The concrete pad extension was observed to be 10" all the way around  $\{(30'0"-28'4")/2 \text{ and } (54'0"-52'4")/2\}$ . See photo #05.

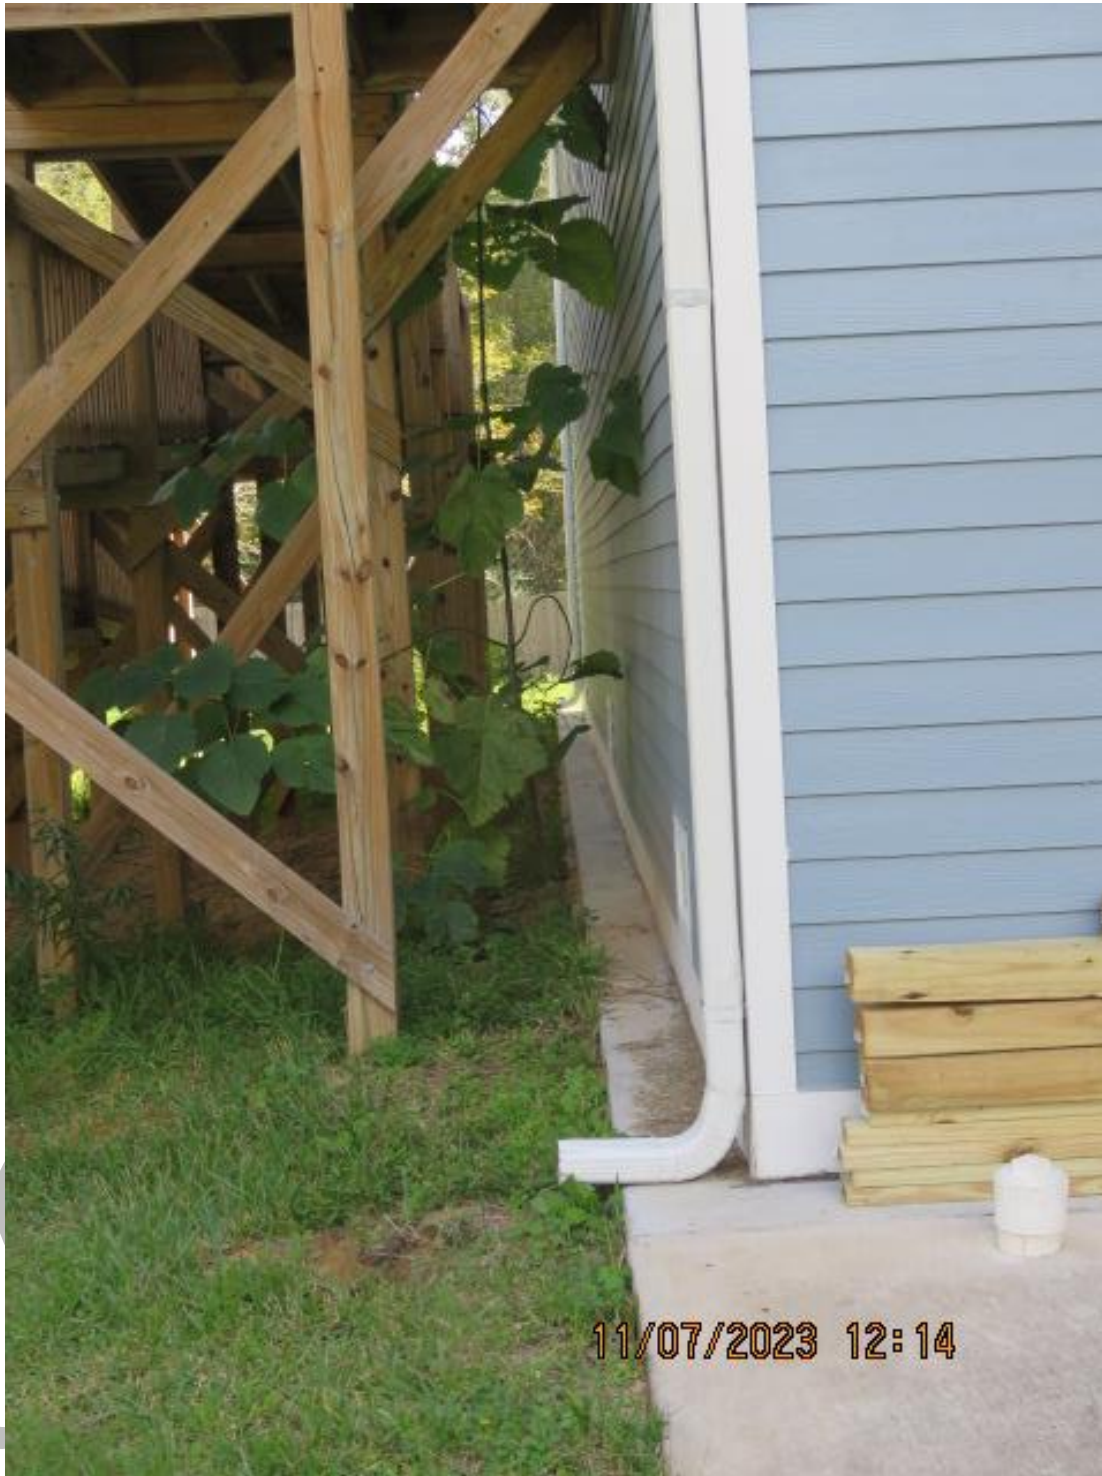
PHOTO #05

6. Downspouts can be seen discharging rain water near the foundation. Please see photo #05.

**Large volumes of rainwater at &/or near foundation has the potential of causing soil erosion ( seen in photo #05), and uneven &/or too much moisture around foundation can be conducive to foundation problems or may cause differential foundation movement. The downspout(s) should discharge water at least five (5) feet from the foundation. Storm water should be encouraged to flow away from the building at the point of discharge. See soil erosion at the point of discharge in Photo #05.**

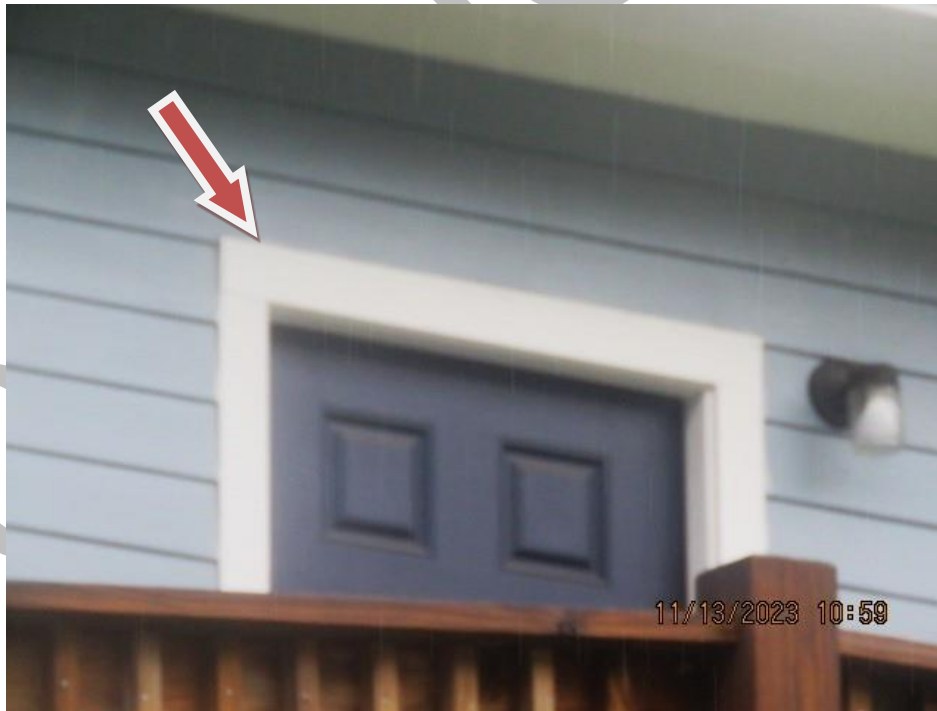
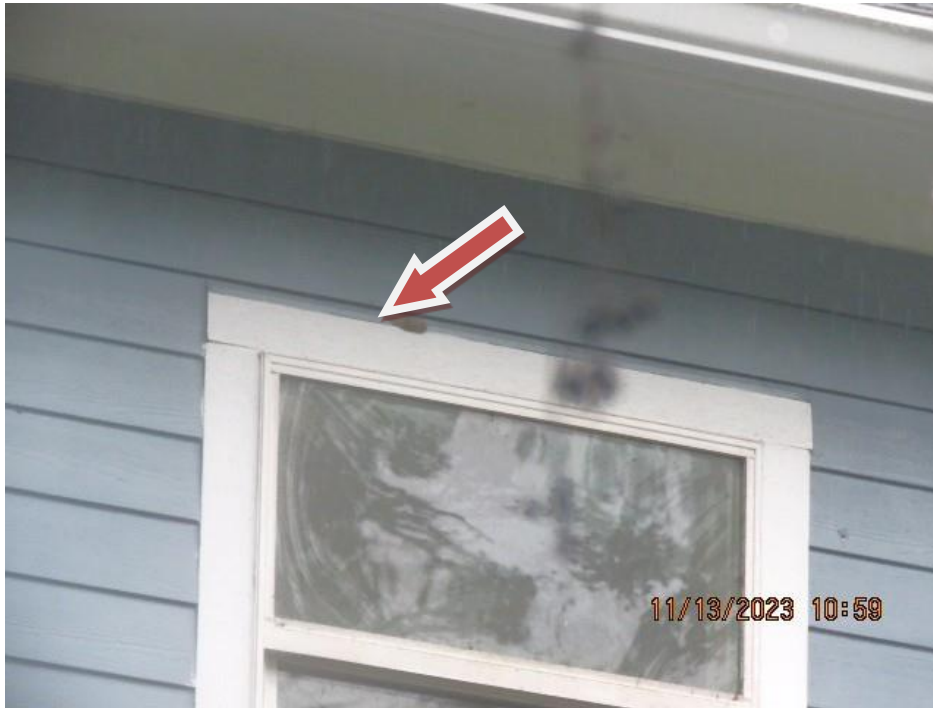
12. Header flashing was missing on several exterior openings. See photos #ed 17 and 18.

**This is an unsafe condition as the rain water will find its way in and can cause fungal growth and structural disintegrity of framing lumber. See illustrations as Photos #ed 19 and 20.**

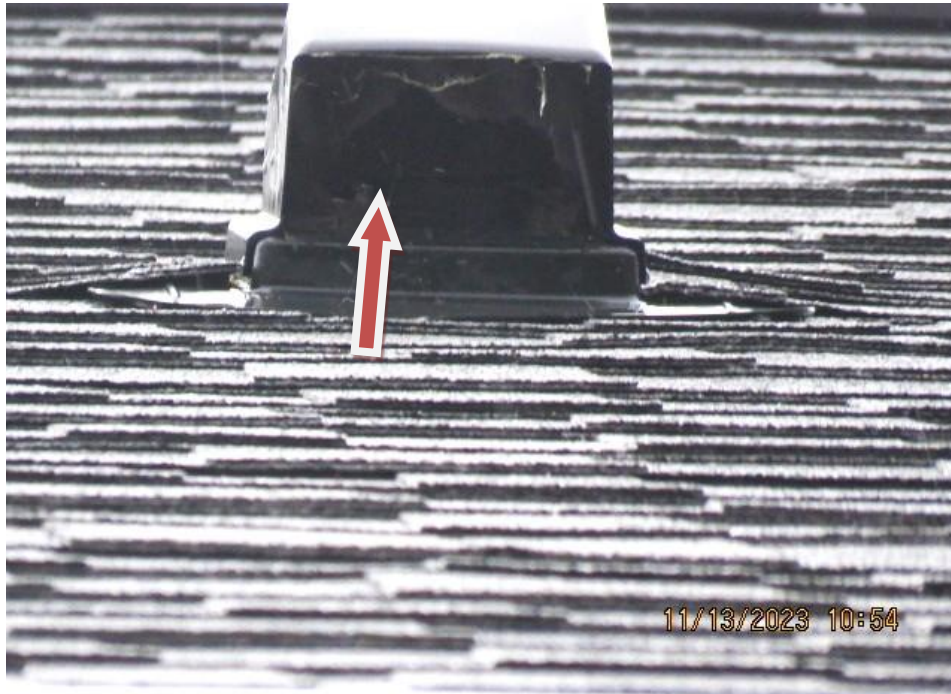
**PHOTO #26**

18. Screen on one of the bathroom exhaust vents was damaged. See photo #26.

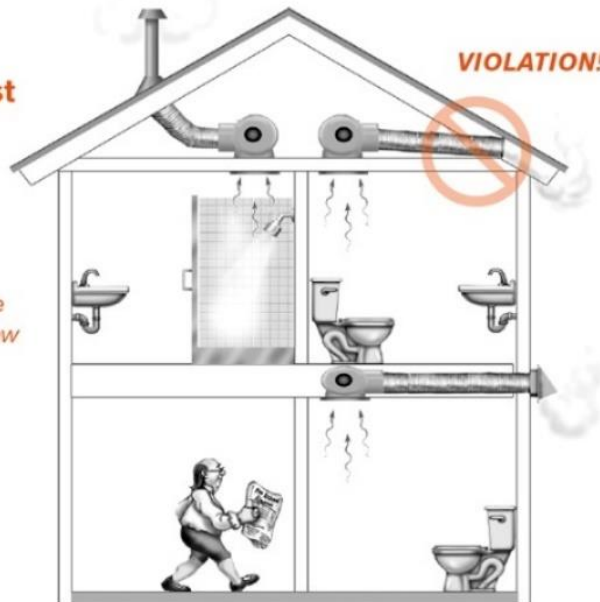
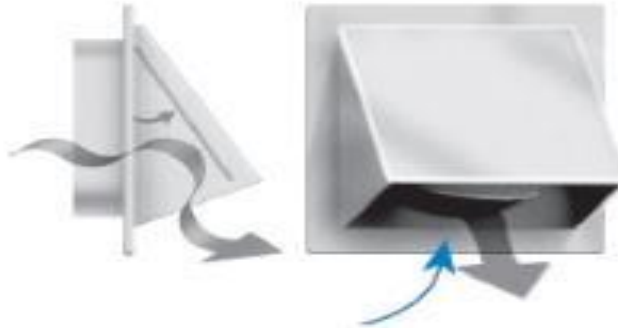
**Backdraft damper was missing on the exhaust vent as required by common industry practice (IRC 1503.1). Screens are not allowed on the bathroom exhausts. See illustrations as photos #ed 27 and 28. This depicted code knowledge of the builder.**

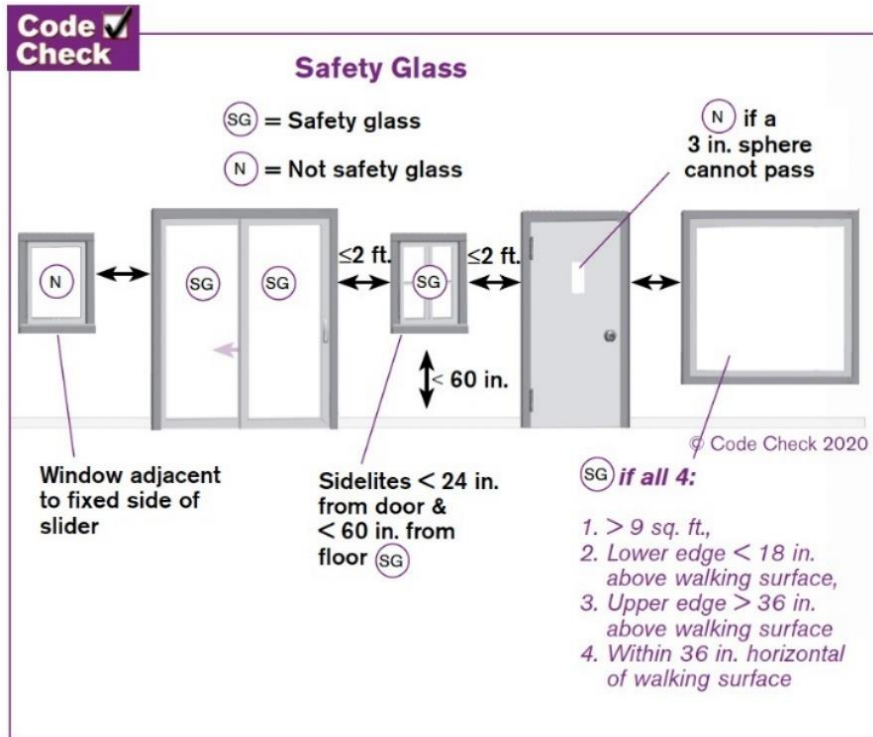
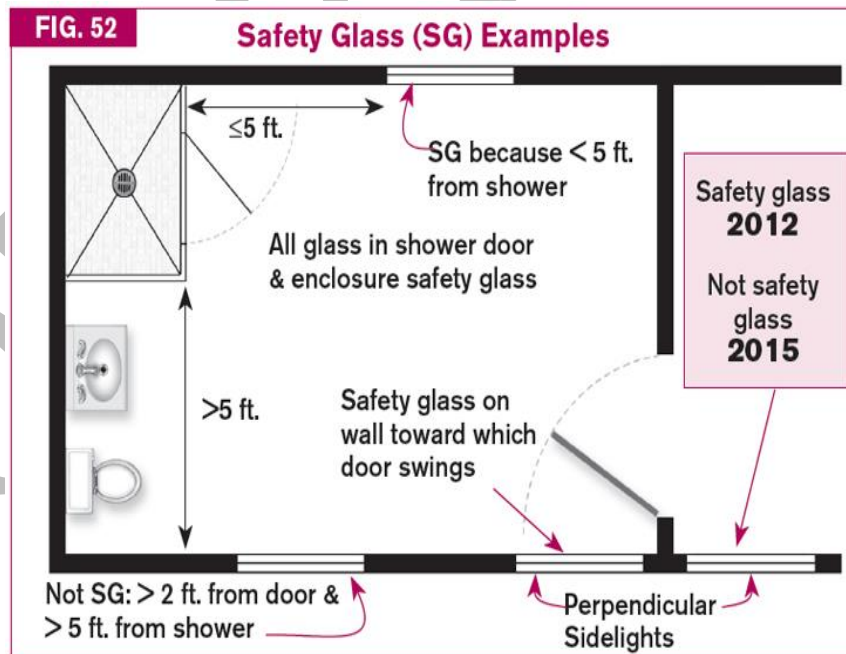
3. Safety glass was not observed on the windows falling within 24" of the front door.

**This was an unsafe work and indicated lack of construction and code knowledge of the builder. See 2021 IRC code Section 308.4.2. See Code illustrations as photos #ed 34 and 35.**

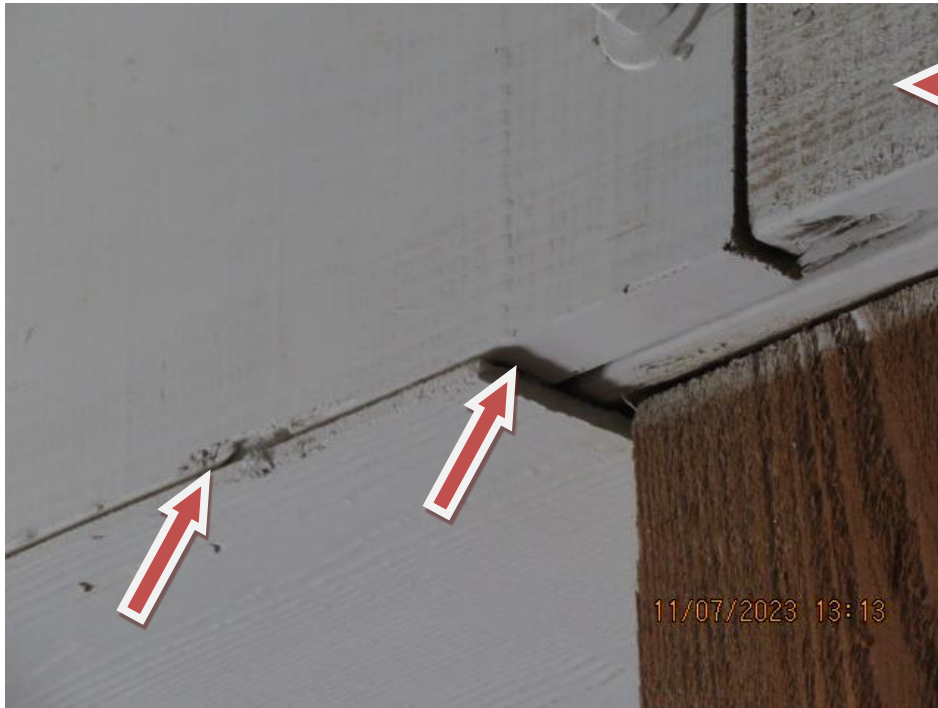
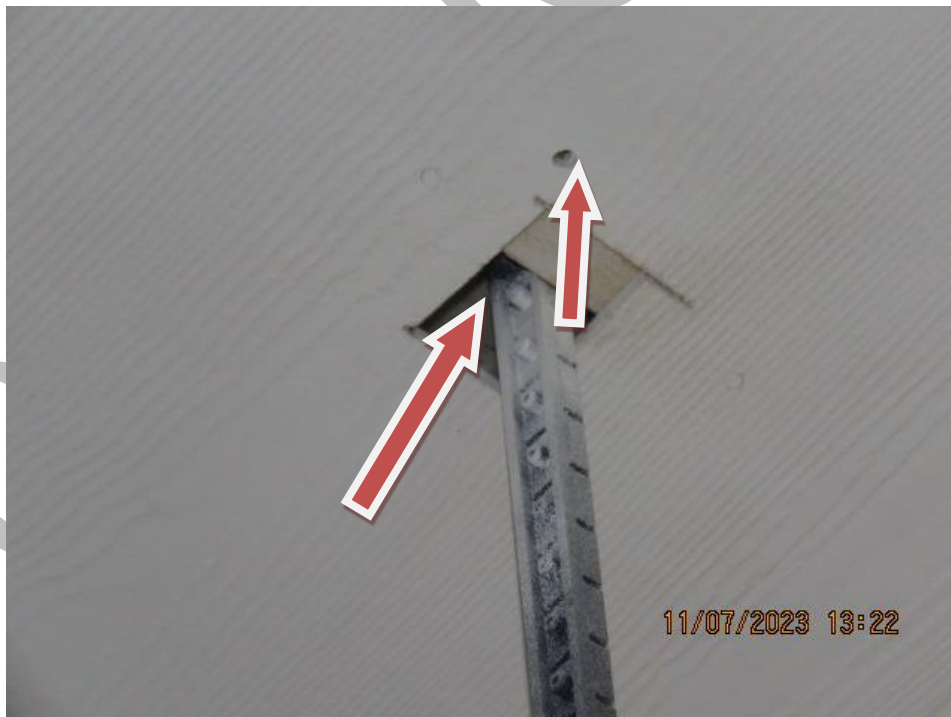
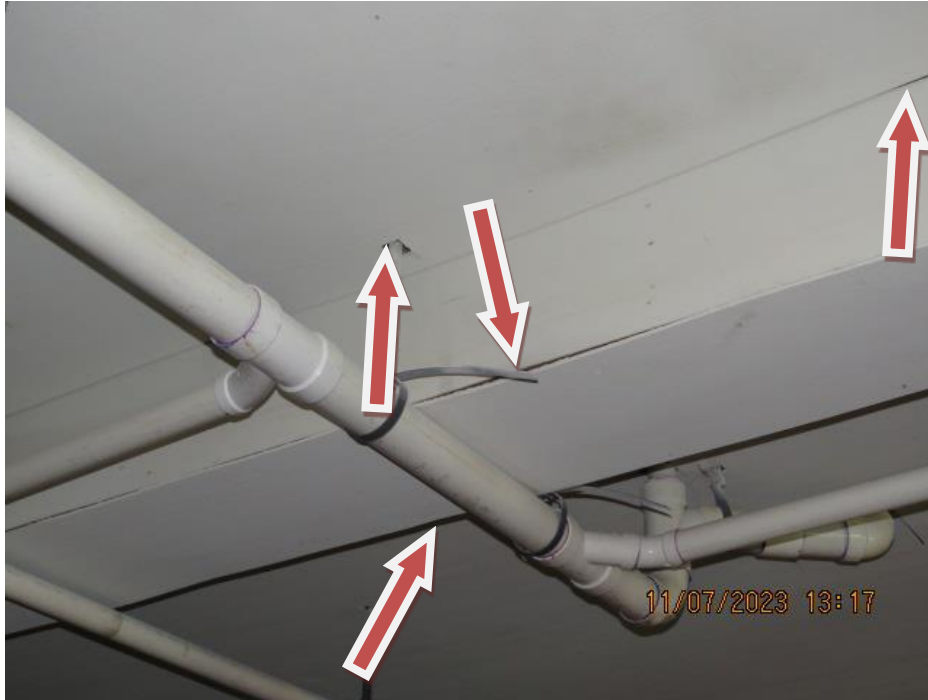
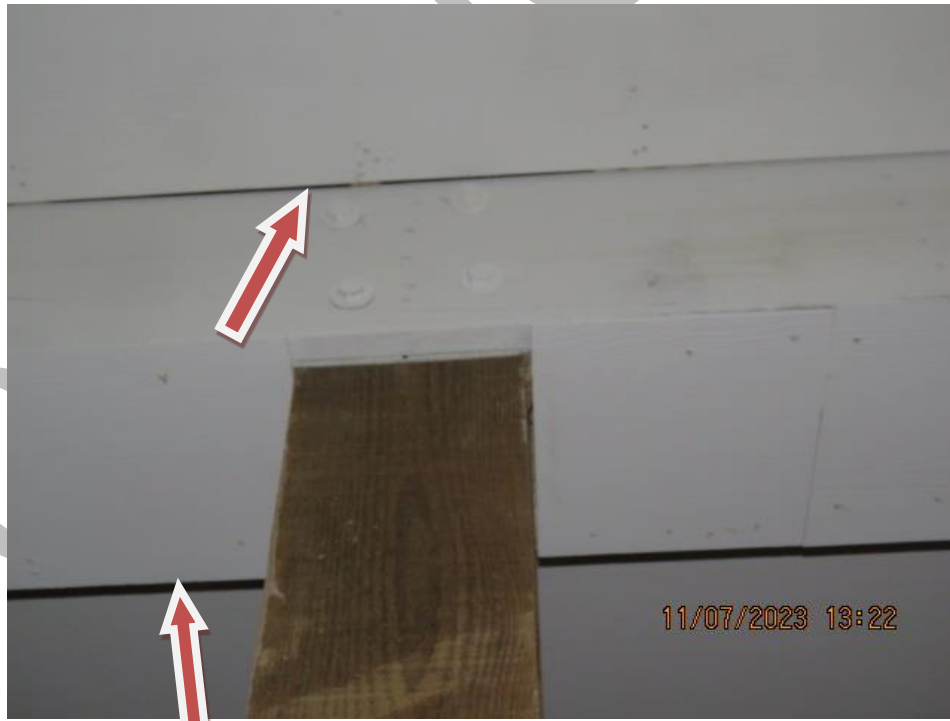
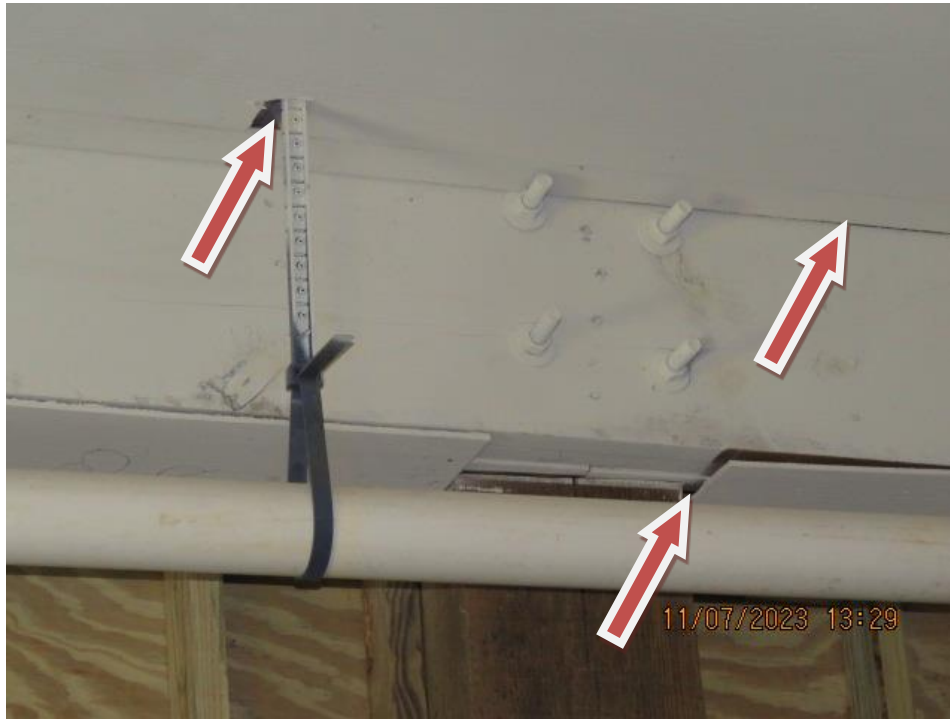
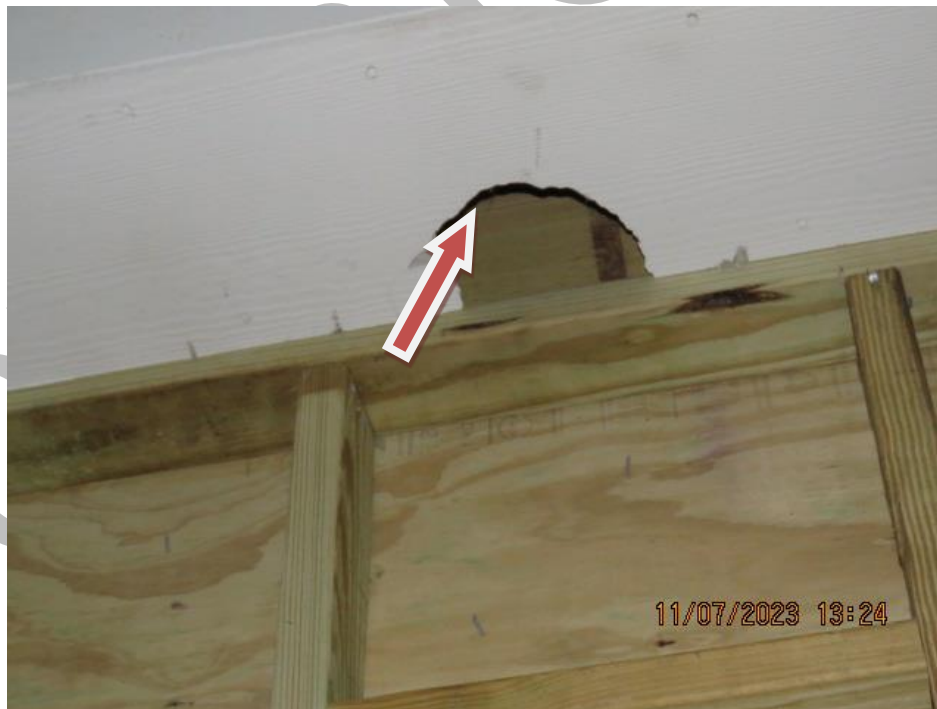
6. Joints, gaps and damaged areas in cement-based material were not sealed. Some arrows pointed to such locations in photos 38 through 43.

**Fire barrier joints, gaps and damaged areas were not taped and sealed on the ceiling. This presented a potentially unsafe condition as such openings can provide a quick and easy pathway for fire to travel to the living quarters upstairs, even if cement based was fire-rated (which it is not), for any fire originating in the storage below.**

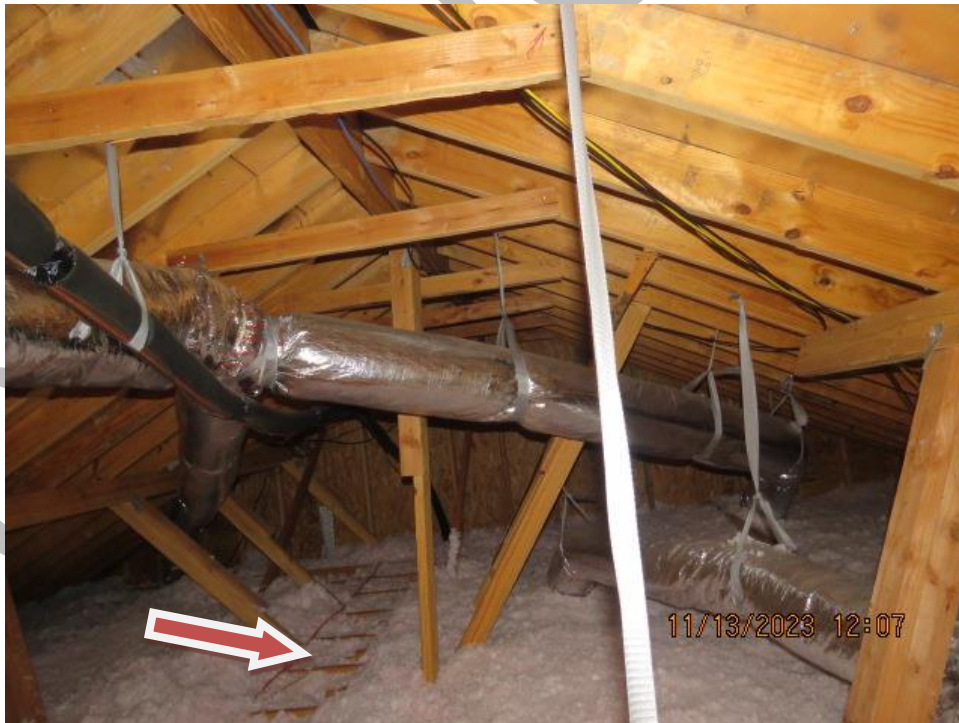
**PHOTO #47**

2. Insulation was partially missing towards backside. See photo # 47.

**It appeared that the insulation was intentionally removed to have an accessway path for accessing or repairing something, but was never put back.**

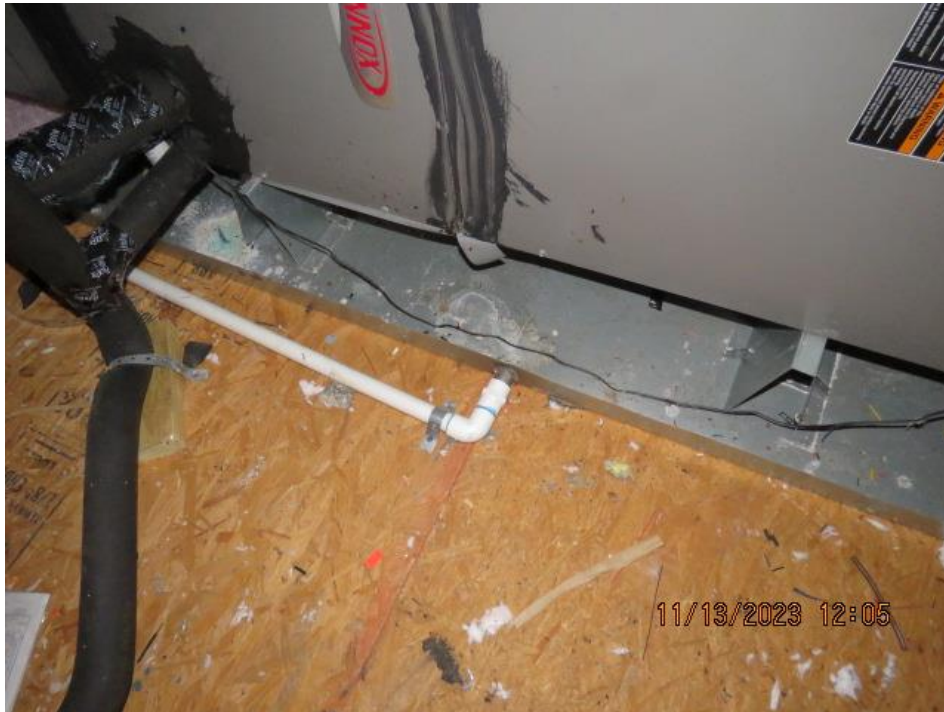
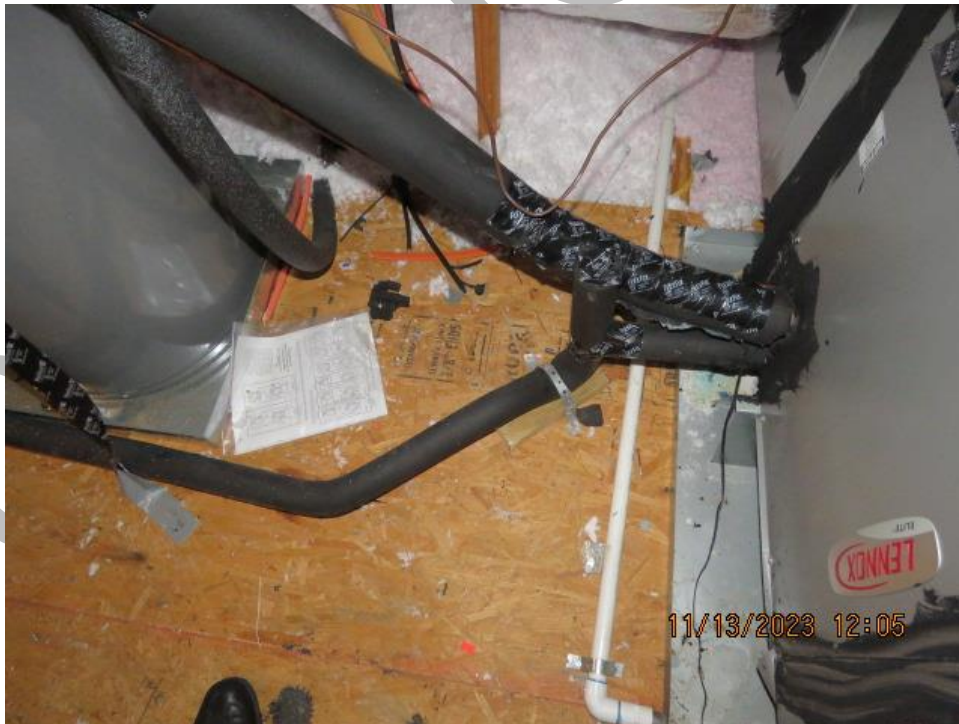
3. No proper size, unobstructed, safe and solid access and service platform was noted to furnace and the water heater. See photos #ed 48 through 50.

**A solid & unobstructed access 24" wide with a maximum length of 20' (50' if passageway 6' high), and a solid & unobstructed service platform minimum 30" deep and length equal to equipment width on the service side of the horizontal unit (& 30" deep all way around of a vertical unit) are recommended for safety purposes per IRC R1305.1.2. See code illustration as photo #51.**

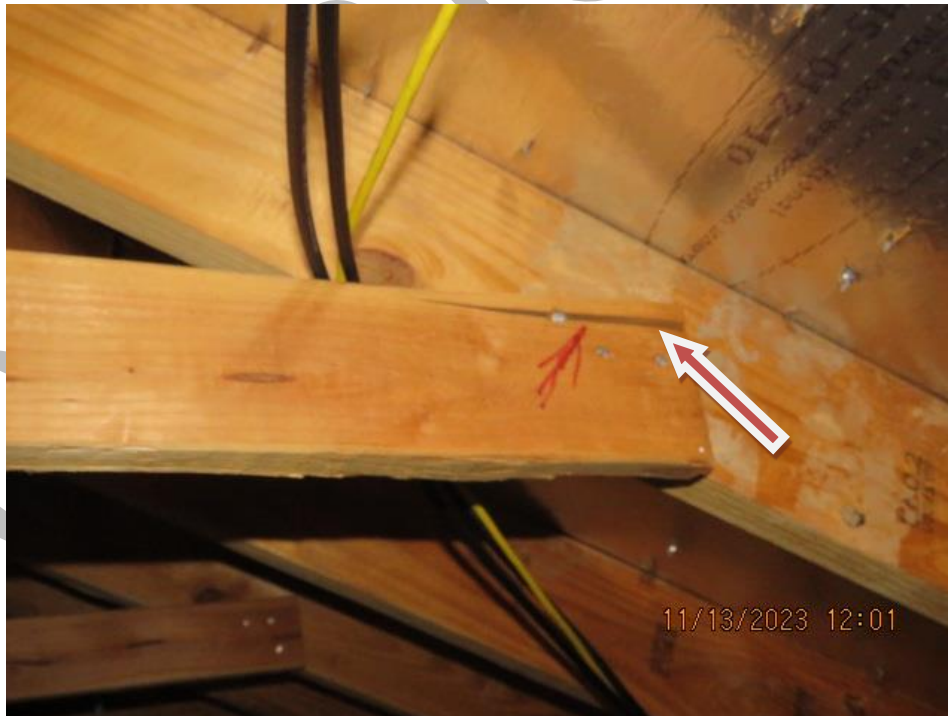
**PHOTO #52**

4. Collar tie was cracked. See photo #ed 52.

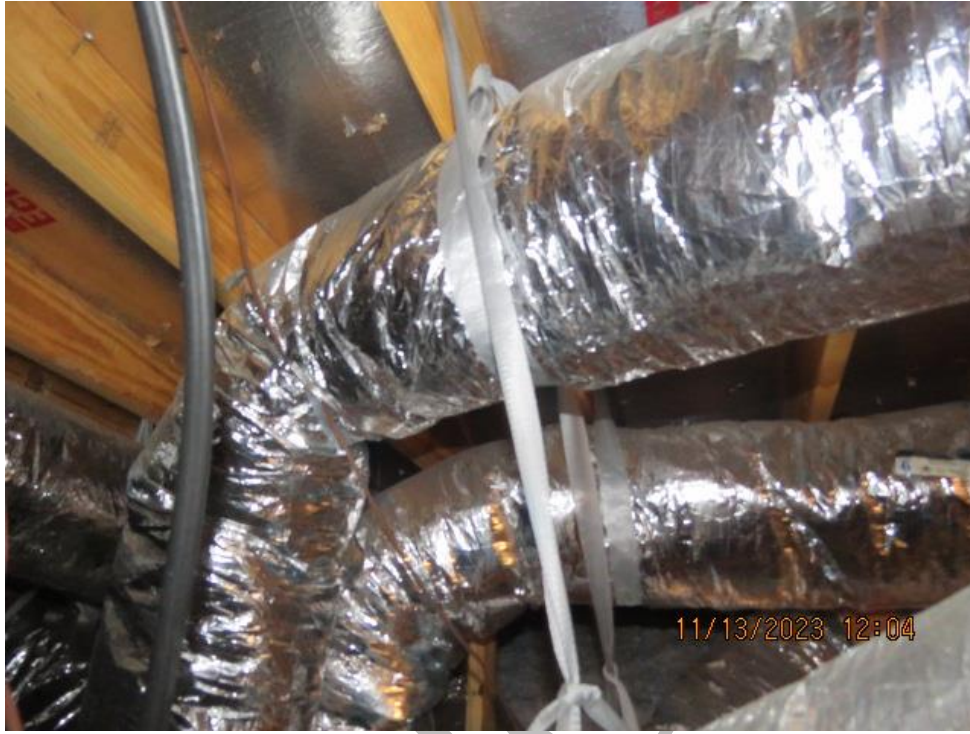
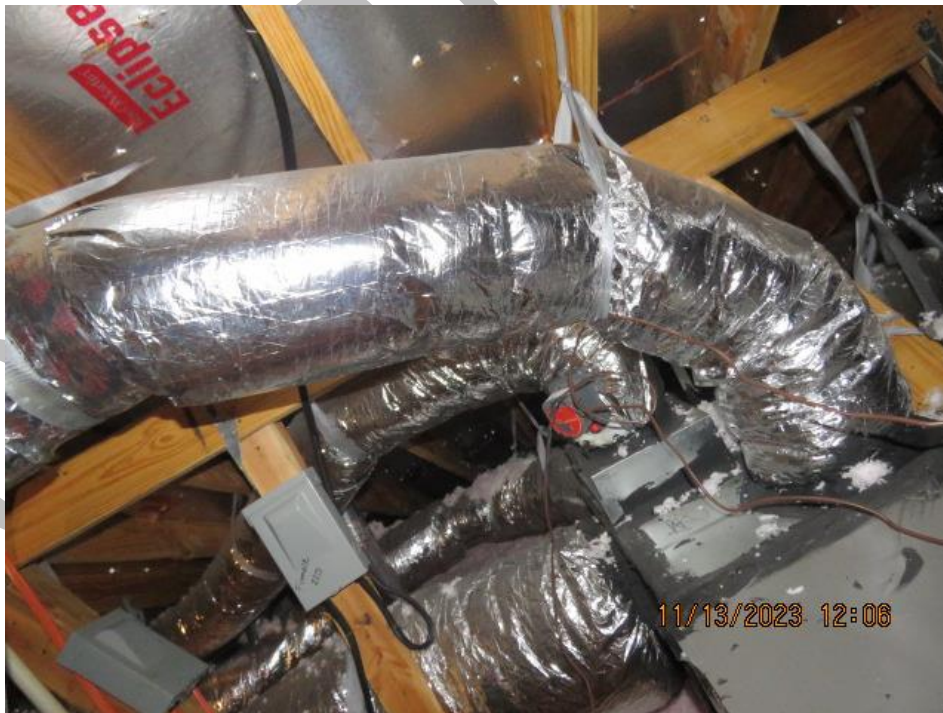
5. There was no safe access to examine purlin struts over the dining room on the left near front and the access was blocked with duct work (photos # 53 and 54). It was observed from a location past the furnace. This location was marked on the collar tie. See photo # 55. It appeared from this location that purlin struts were directly resting on the ceiling joists. See photo # 56 with arrow pointing to struts.
