REPORT NO.: **XXLGL-CONST-XXXXP**

FOUNDATION INVESTIGATIVE REPORT

Subject Property: **123 XYZ Street, Friendly City TX 77XXX**

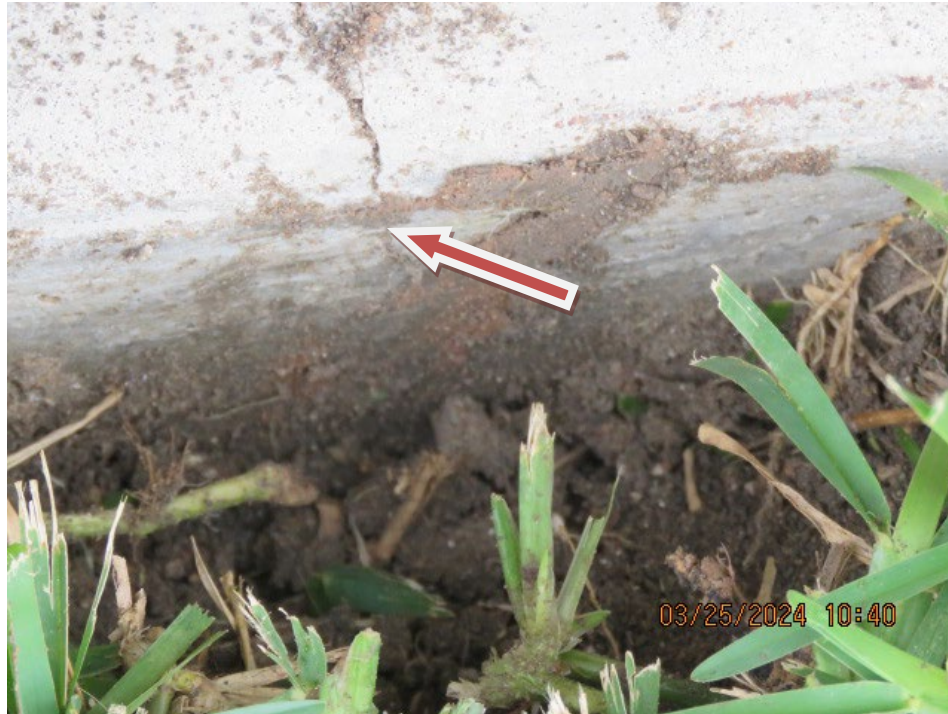
PHOTO #01

Exposed areas of the foundation appeared to be in good condition, excepting a 1/16" wide crack in the foundation on the exposed side of back porch. See photo #01. This crack ran forward in the porch slab and under the back grade beam of the family room. See photo #02.

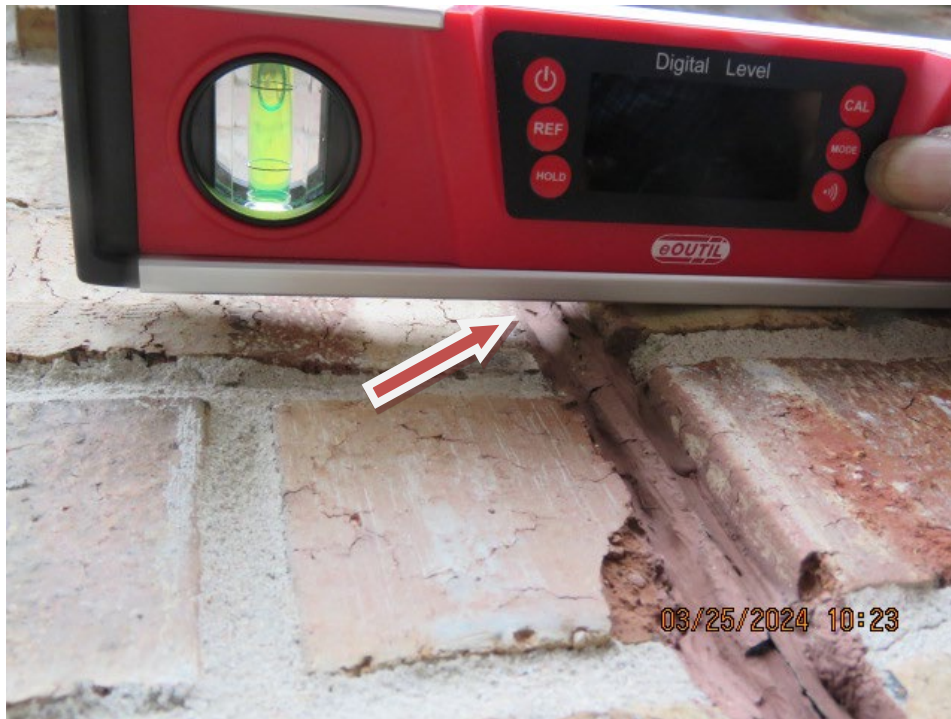
PHOTO #03

Bulging brick veneer was discovered at first brick expansion joint near top on right side. See. photo #03. Brick expansion joints were tight on both right and left sides.

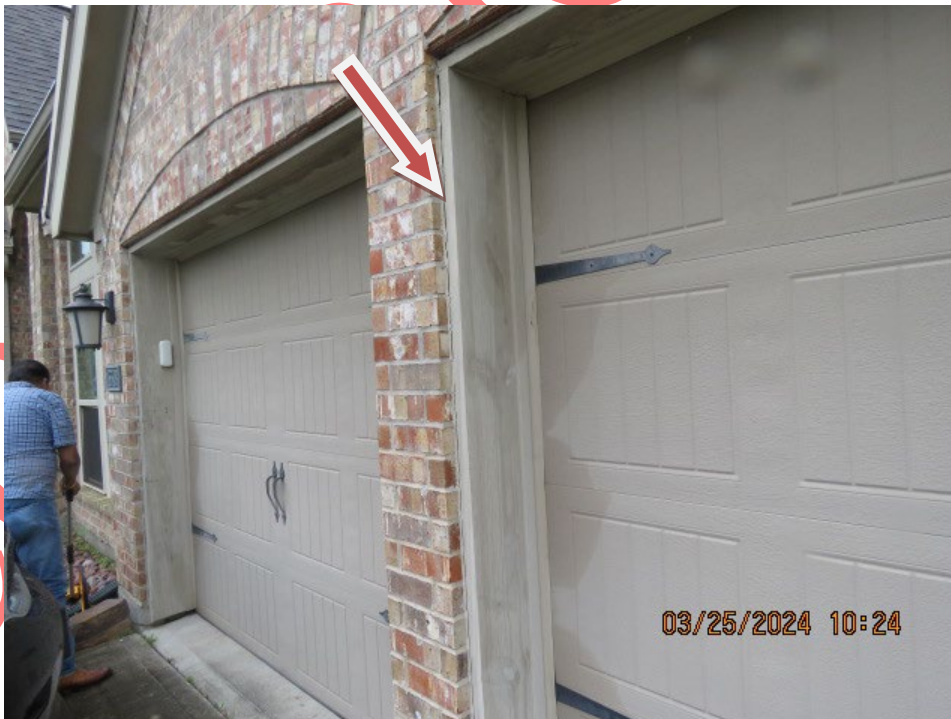
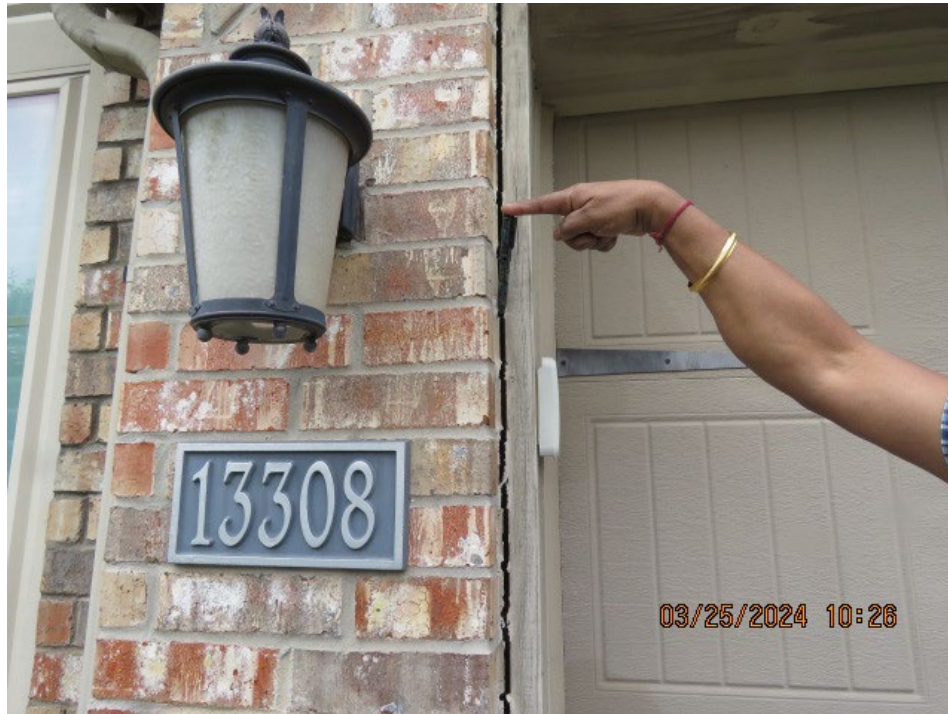
Large wall to frame separations were noticed at both garage doors. See photos #ed 04 and 05 with investigating engineer's pen in the space.

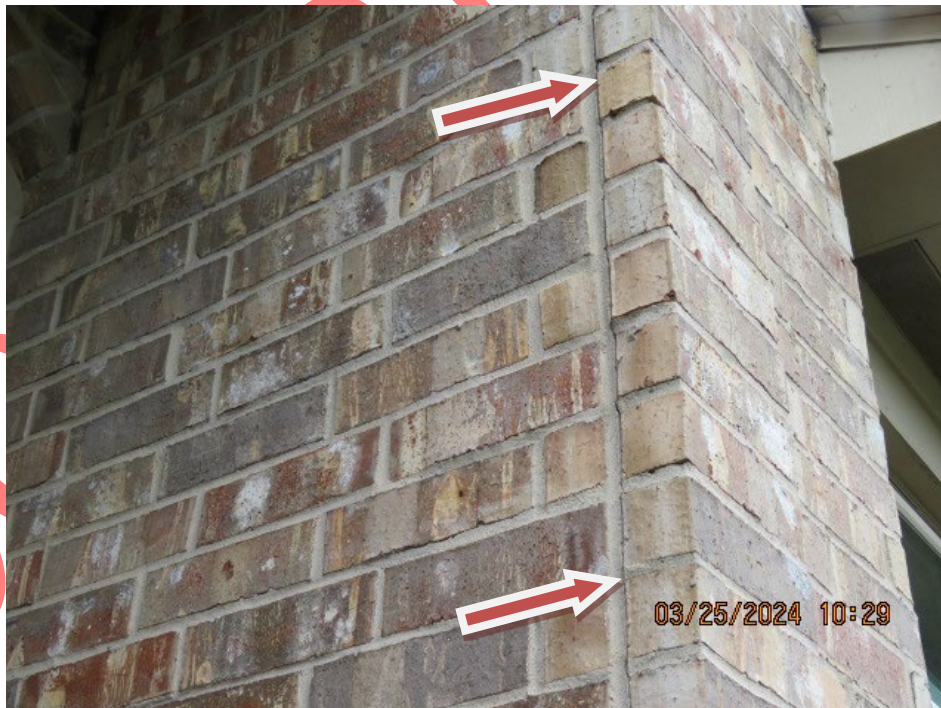
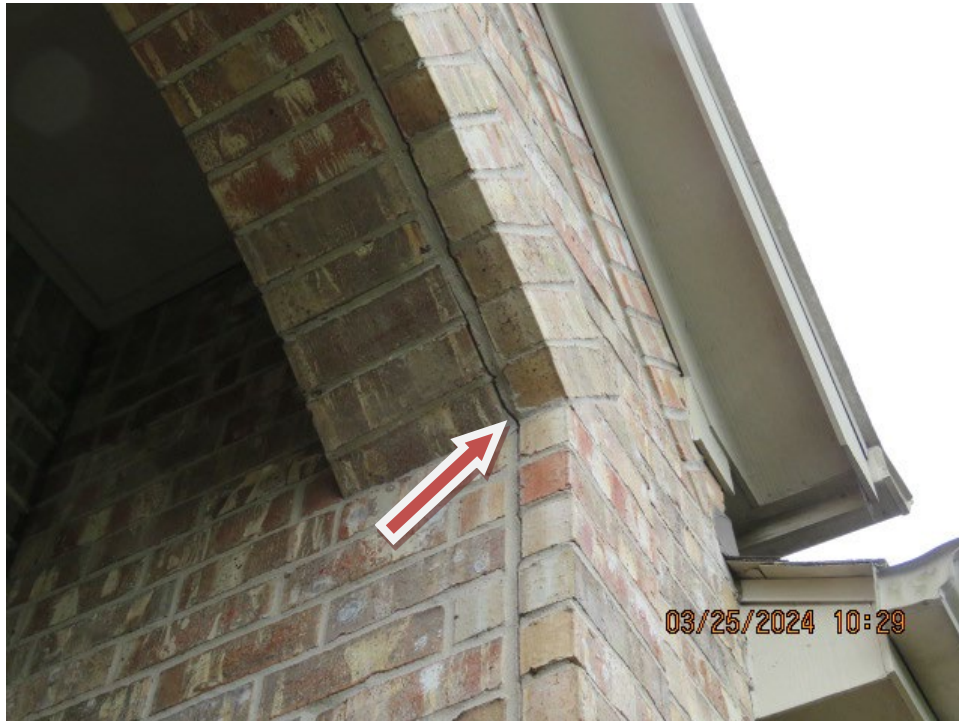
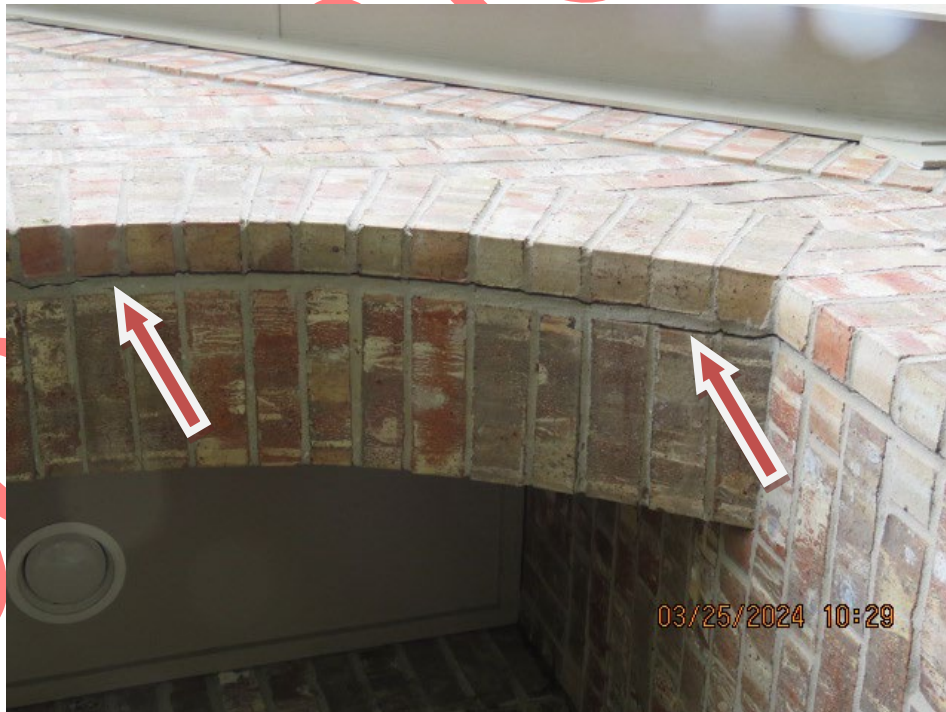
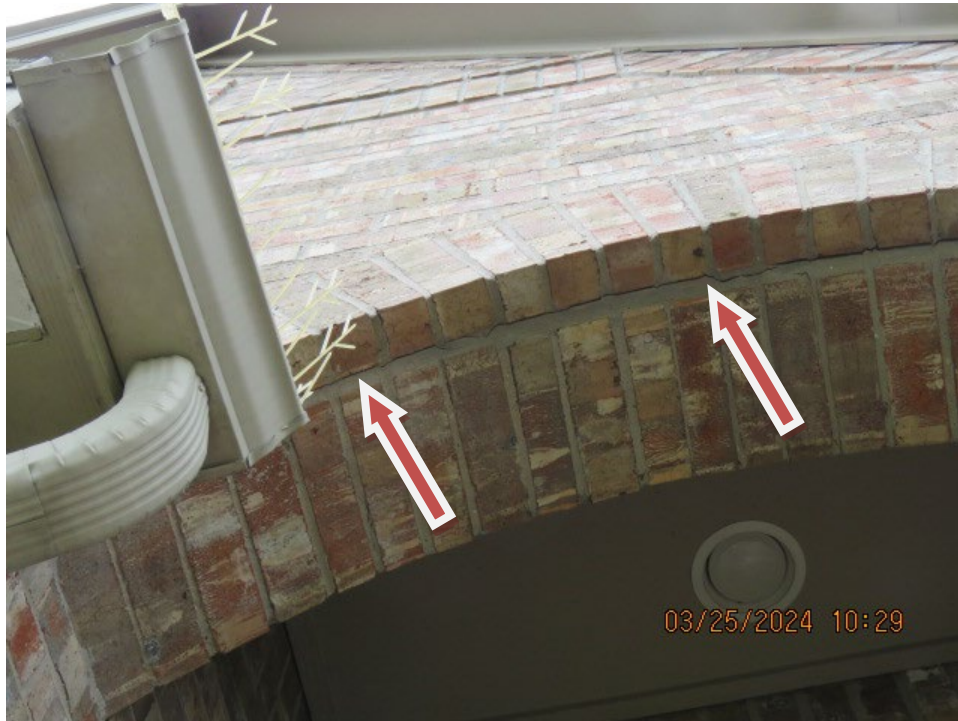
Brick veneer separation was discovered at right front corner of front porch which travelled upwards into the arch above. See photos #ed 06 through 09 with arrows pointing to the affected areas.

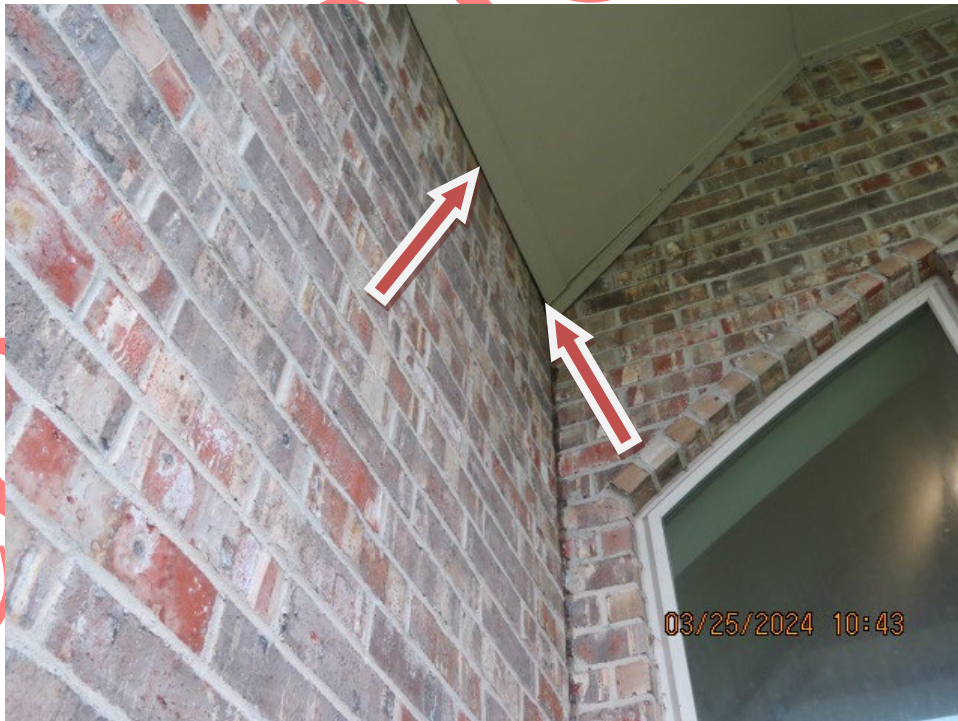
PHOTO #10

Ceiling and trim separations were seen at right front corner of back porch. See photo #ed 10.

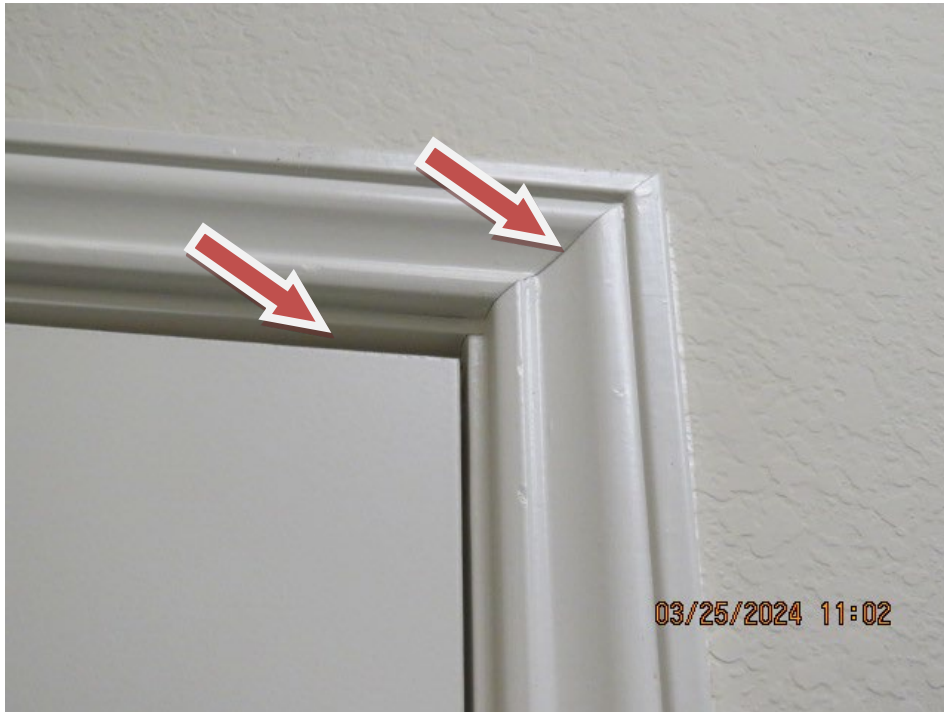
PHOTO #15

Most of doors had uneven reveals on them with some doors had casing joints open. See photo #ed 15.

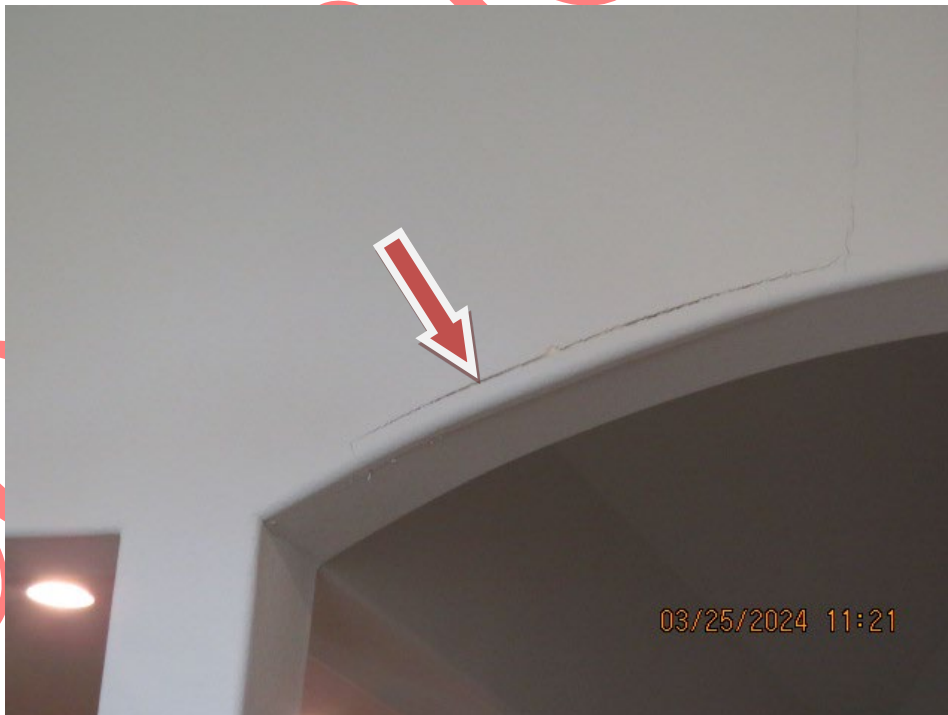
PHOTO #16

A drywall crack was noticed in the arched opening to family room. See photo #ed 16.

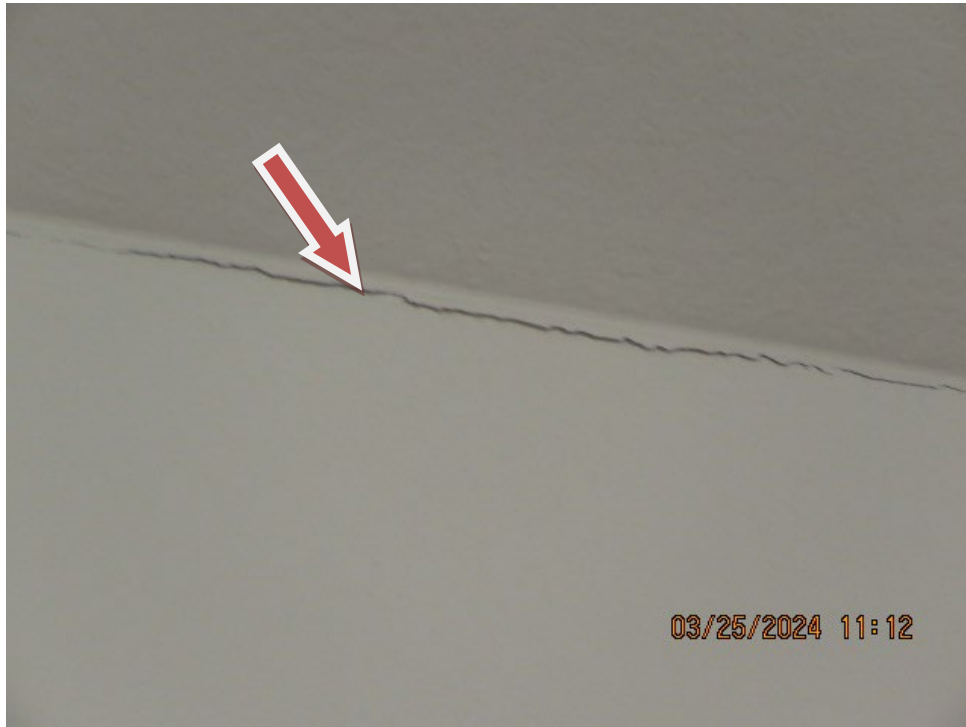
PHOTO #17

There was a drywall crack on back wall of dining room near ceiling. See photo #ed 17.

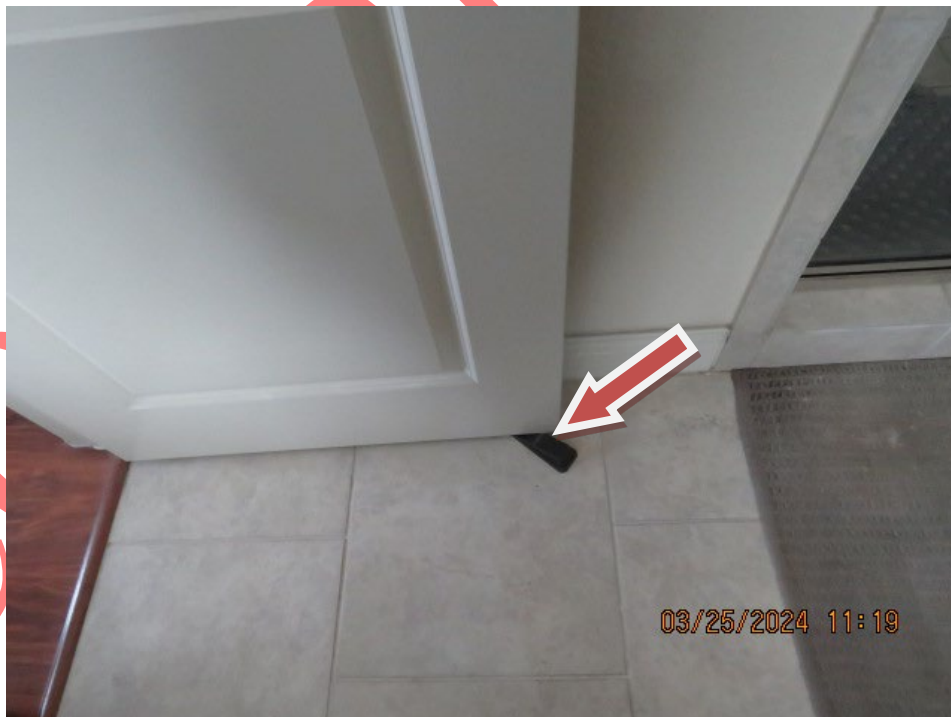
PHOTO #18

A door stopper was placed under the master bedroom door, but the did not appear to ghost at the time of inspection. See photo #ed 18.

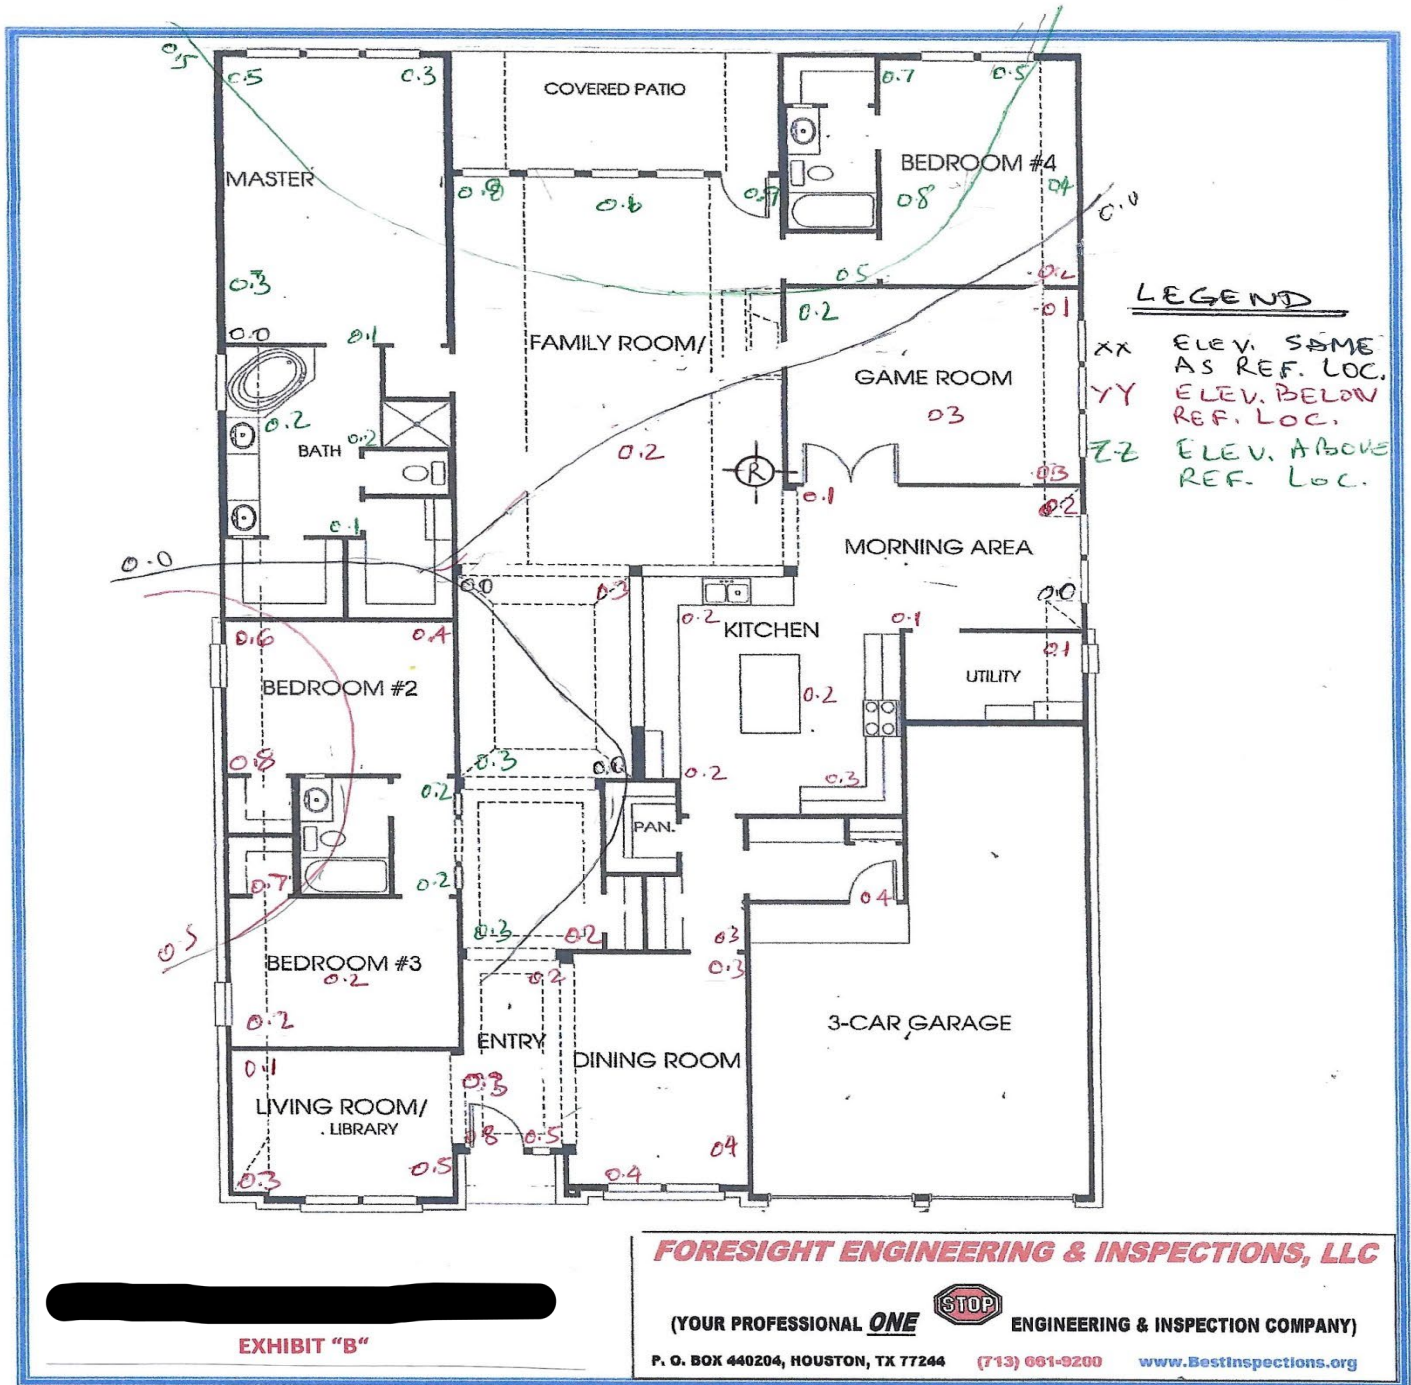
The relative adjusted micro-elevations vary from a high of +0.9" near back right corner of family room to a low of -0.8" near front door on left side and front right corner of bedroom #2. Other salient adjusted elevations fall this range and may be seen in Exhibit "B". Minus readings were shown in red ink, positive readings in green ink and elevations level with reference location in black ink for an easier visual look of floor condition. Contours are also drawn here.
