REPORT # 2XLGL-0707

## ENGINEERING VISUAL INVESTIGATIVE REPORT

**XXX BLVD., HOUSTON, TX 770XX**

Foresight Engineering & Inspections, LLC. was furnished with some pictures of the stair at the subject property where from Mr. ZZZ fell to the ground floor on/ around MMM DD, 20XX. We were asked to review such furnished pictures and offer our expert opinion on the condition as it existed prior to repairs.

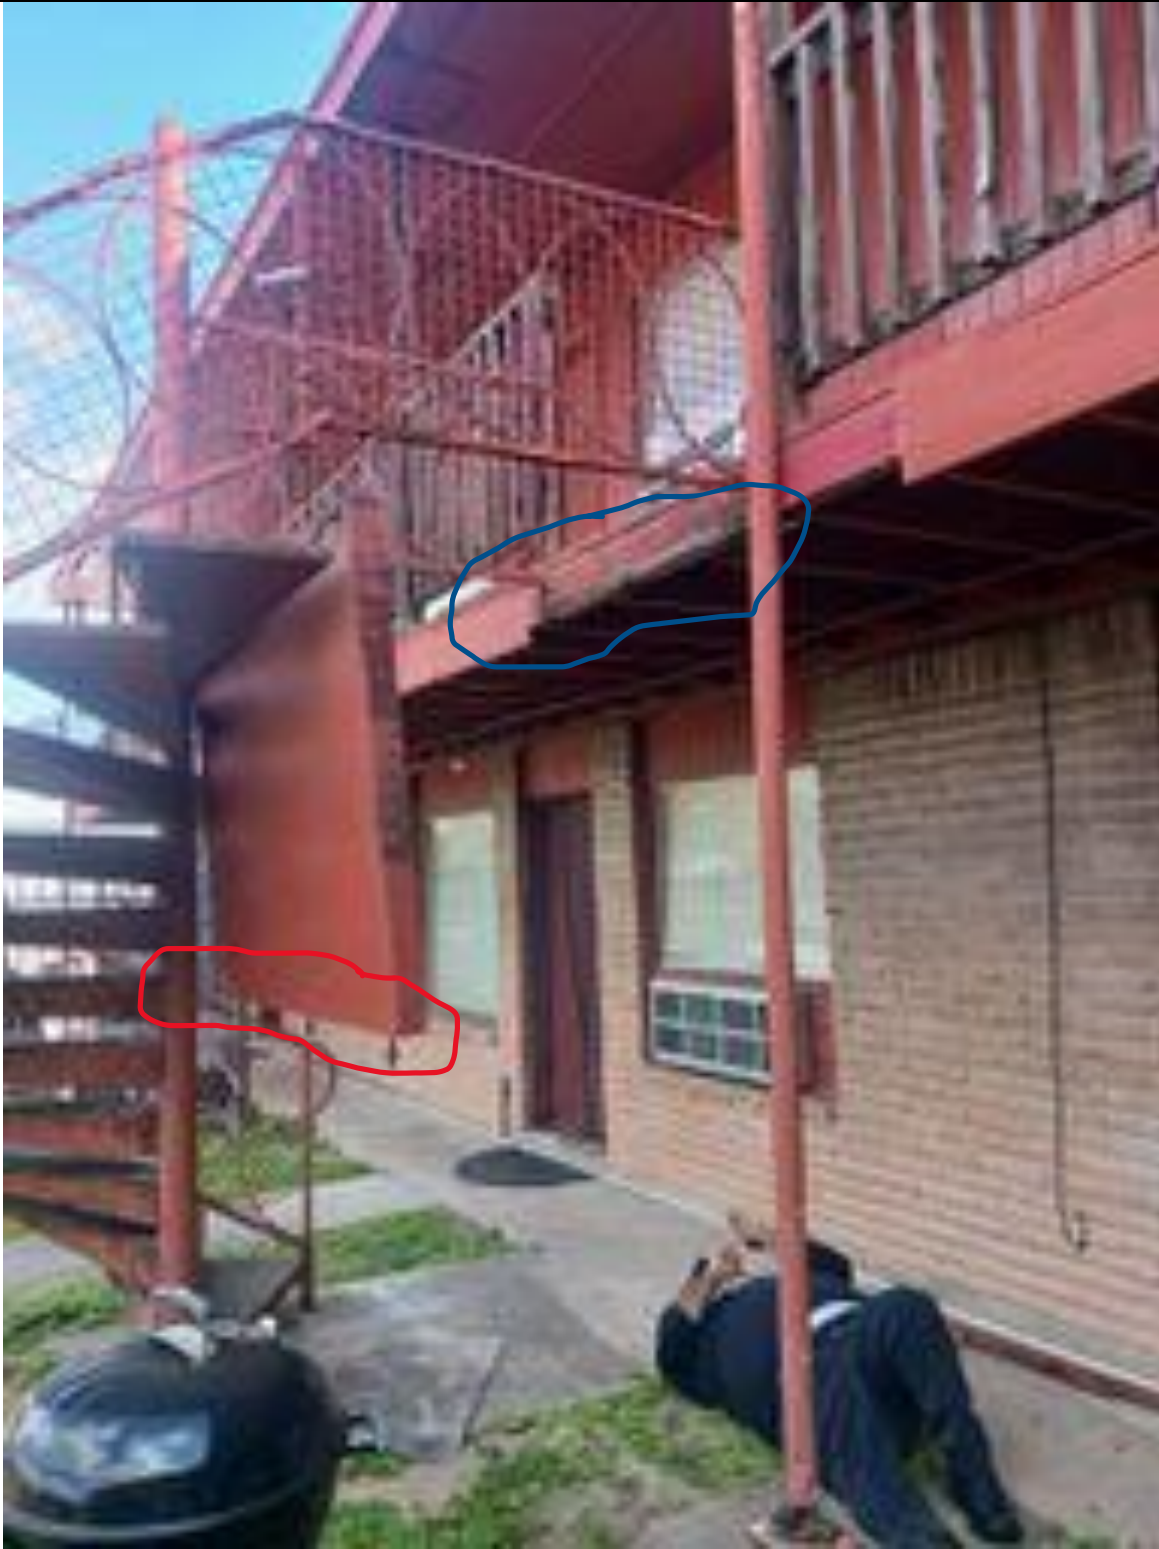
PHOTO 01

- Photo #ed 01 shows stair landing in the final position after it gave in and it was connected to the balcony board with three bolts (location circled in red).
- Photo #01 also depicts the rotted condition of supporting board near the bottom with the open (yielded) bolt holes. This location is circled in blue for easy identification.
- Another view of the stair landing with connecting bolts is shown in Photo #02.
- This view of the balcony in photo 03 displays rotted condition of the joist ends supporting the balcony. Location circled in green ink.

- ◇ Supporting wood, attached to balcony joists, was badly rotted at the bolt holes that it could not safely support the applied load and finally failed and let the landing fall.
- ◇ Connection of short mating joists attached to existing balcony joists were improper as creates a pinning effect.
- ◇ Gaps between walking wooden boards or board ends, wider than 1/4", are unsafe as any person walking with sharp shoe heels can have the heels catch between the gaps making the person loose balance and fall and possibly hurt.
- ◇ Badly rotted wood becomes very soft and can catch the shoe of the walking person and make the person to lose balance.
- ◇ While stair issues cited above could have met the building requirements when it was built, however, it fails the current safety standards and considered a safety issue.

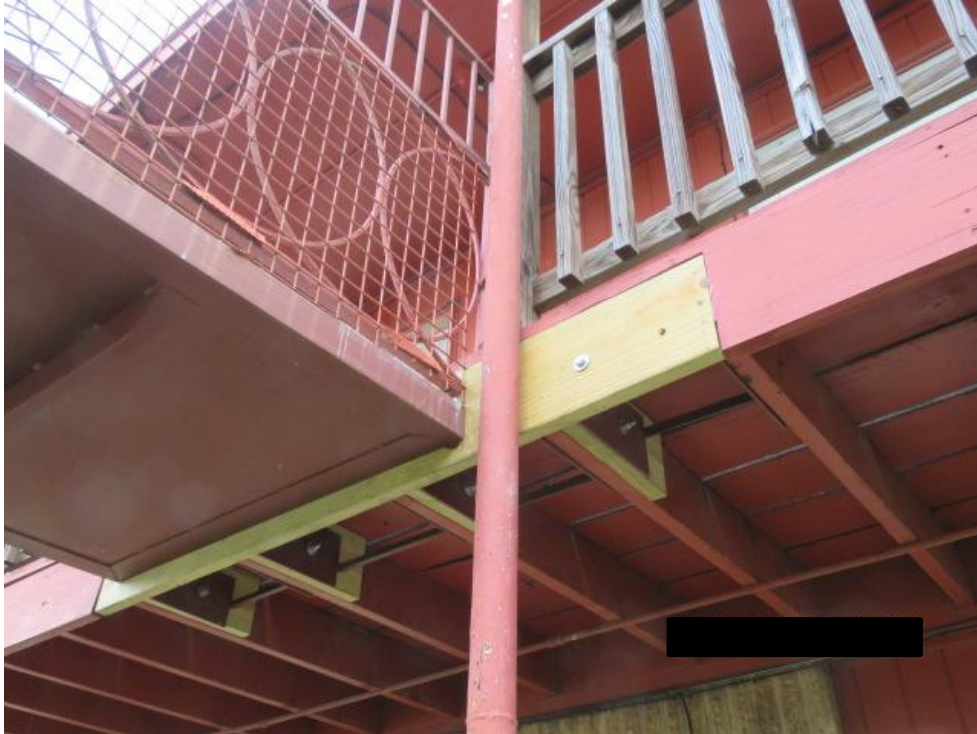
PHOTO 04

- Photos #ed 04 and 05 Show repaired condition of the balcony and the stair landing.
- It should be noted here that new butting joists used were short pieces of wood. See photo 05.
- The open spacing on stair rails had a ladder affect. Such ladder effects are unsafe for small children as the children can climb such open areas and fall down &/or hurt themselves. See photos #ed 06 and 07.
- Balcony floor Supports were 6"x2" used as platform's walking surface. Some them rotting at ends. See photo #ed 08.

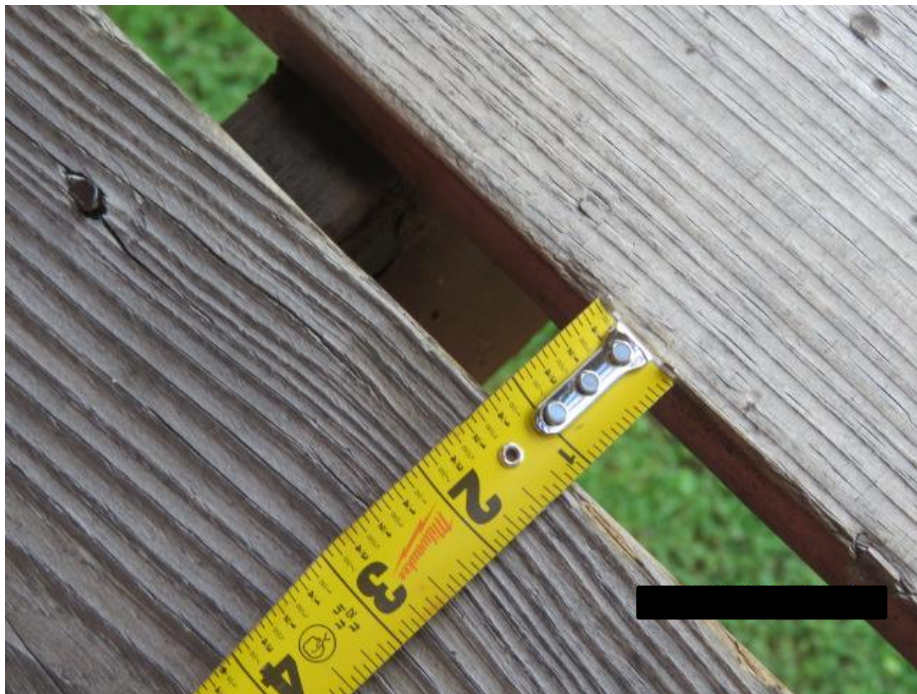
**PHOTO 09**

- There were large gaps (as much as 1 1/8"\*) between some of the adjoining balcony boards as can be seen in photo 09.
- The stair risers were noticed to be more than a maximum height of 7 3/4" (8" observed on all steps and does not comply with current industry standards which presents an unsafe condition). See photo #ed 10.

\* A space of 1/8" is recommended between boards to allow for expansion of boards. This prevents heels getting stuck in the gaps between boards.

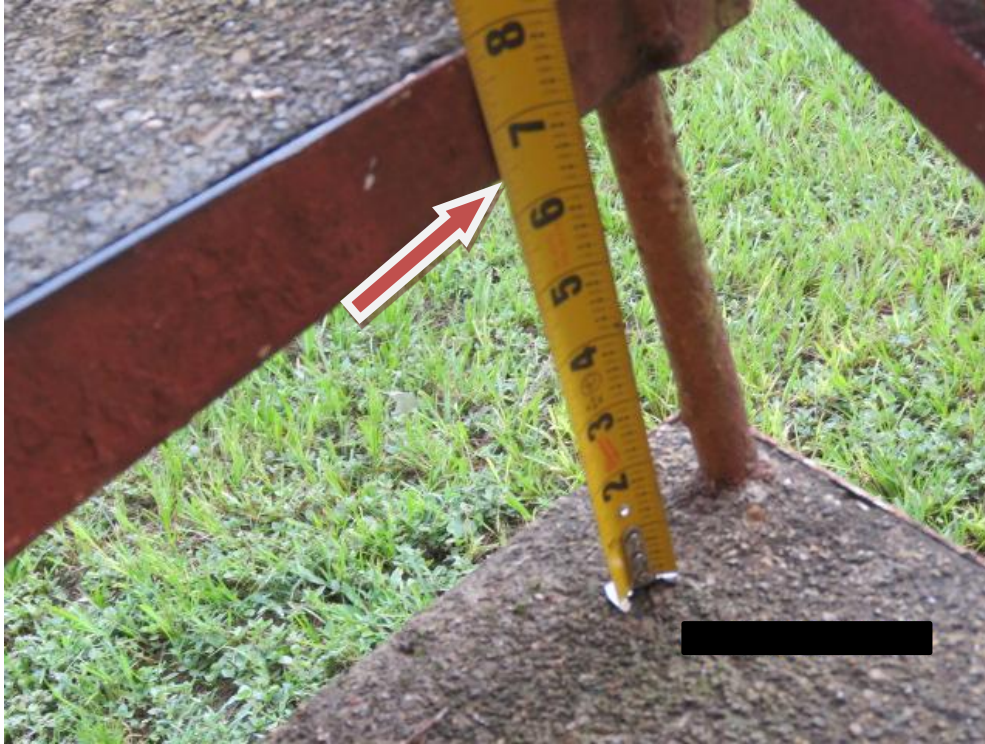
PHOTO 10

- The open riser spacing between treads exceeded 4" (6 1/2" noticed). Such openings are unsafe for small children as they have a potential of getting their head stuck &/or falling in such open areas and hurting themselves. Maximum allowed spacing should not allow passage of an object four inches in diameter. See photo #ed 10.

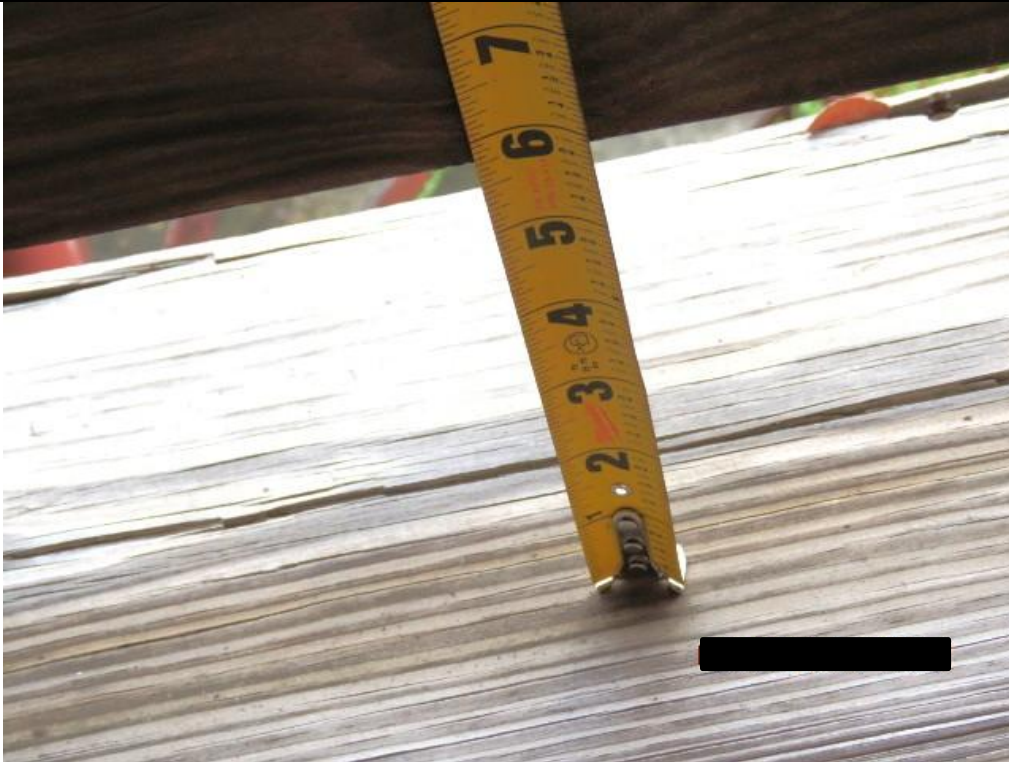
PHOTO 12

- Intermediate baluster on guard rails exceeded 4" (4 1/8" discovered). See photo # 12. Such openings are unsafe for small children as they a potential of getting their head stuck in such open areas &/or hurting themselves. Maximum allowed spacing between intermediate balusters should not allow passage of an object four inches in diameter.

- Open space between bottom rails on guards and balcony floor should not be more than 4" (5 13/16" noticed). See photo #ed 12. Such openings are unsafe for small children as they a potential of getting their head stuck in such open areas &/or hurting themselves. Maximum allowed spacing between intermediate balusters should not allow passage of an object four inches in diameter.

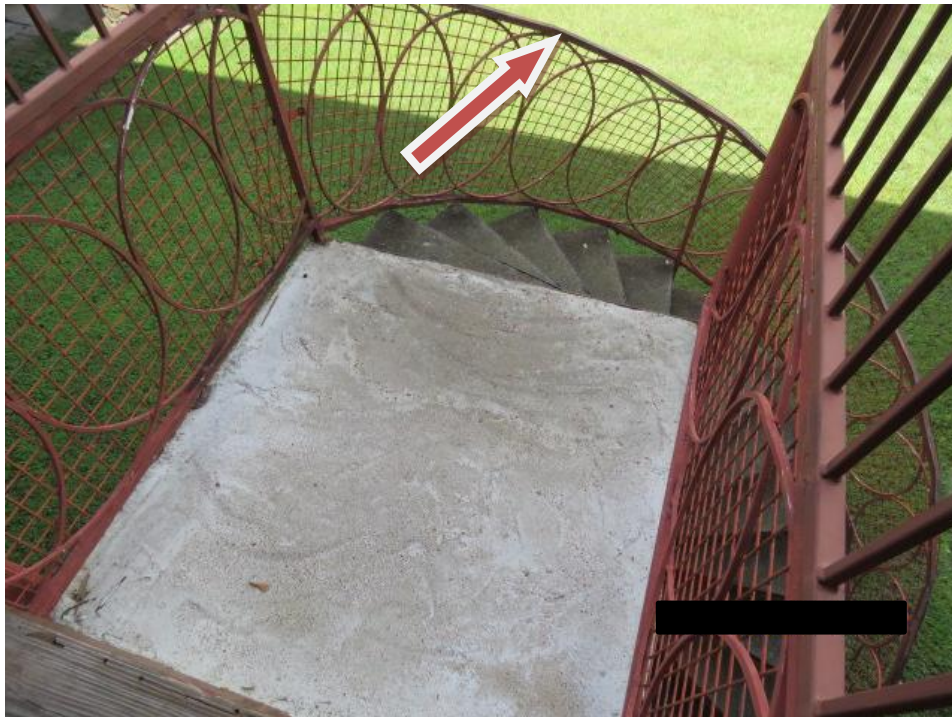
PHOTO 13

- Non-grippable handrails on stairs. This is potentially an unsafe condition. Handrails should be round and the diameter should be between 1 1/4" to 2 5/8". See photo #ed 13.

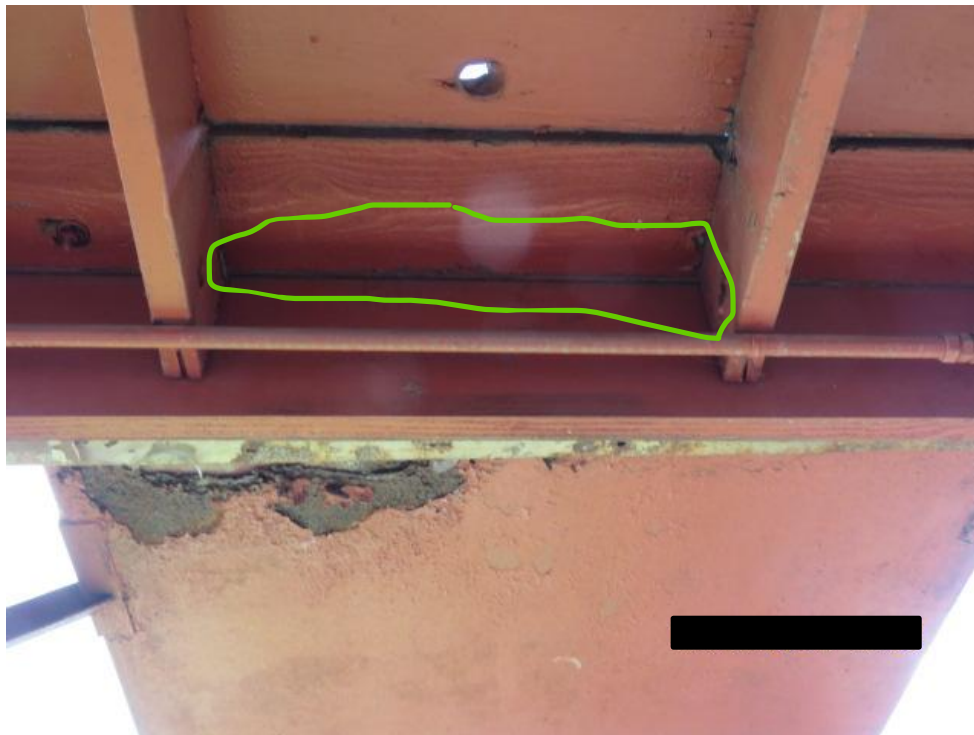
PHOTO 19

- Recently repaired landing connection to balcony on the other spiral stair. See photos #ed 19 & 20.
- Steel pan and angle on stair 2 were rusting on the landing as seen in these photos.
- Ceiling joist ends supporting landing on Stair 2 were rotting and split. See photos #ed 19 and 20. Location circled for of understanding.

- ◇ The repairs done on this stair are incomplete & appeared unsafe, and prone to failure in future.
