## STRUCTURAL & MECHANICAL SYSTEMS' CONDITION SURVEY REPORT

**1234 ABC ROAD**

**HOUSTON, TX 770XX**

**(XYZ APARTMENTS)**

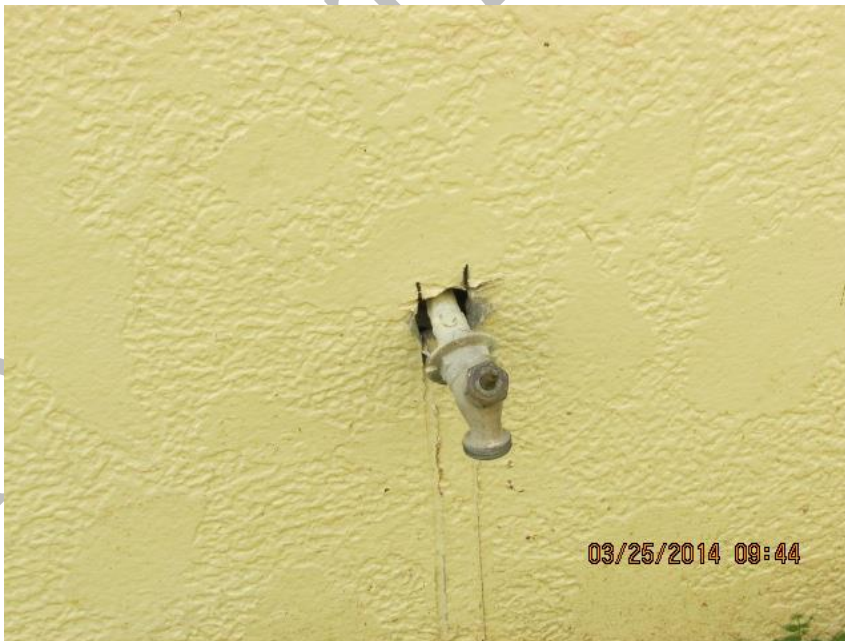
**PHOTO NO. 08**

Penetrations of light fixtures/piping/fasteners for guardrails, junction boxes, other similar/any kind of penetrations, etc. through the exterior cladding were not caulked/sealed. See photos #08 and 09. Water

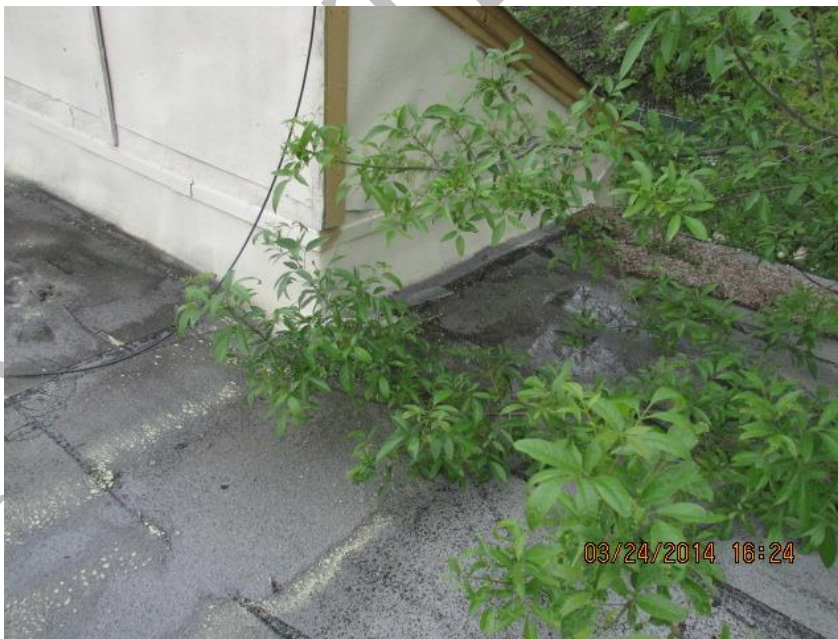
**PHOTO NO. 20**

Tree limbs were touching &/or overhanging roof line on many buildings. Tree limbs should be trimmed back at least 4 feet from roof. See photo # 20.

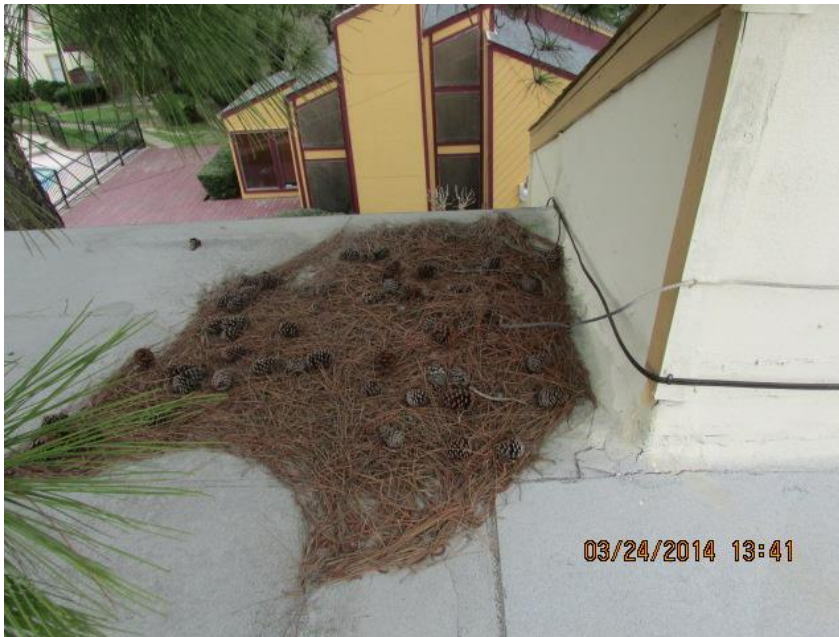
**PHOTO NO. 21**

Leaf pile up was observed on many buildings. Leaf pile up &/or debris is very detrimental to the life of the roof from the moisture of leaf pile up &/or debris. See photo #21.

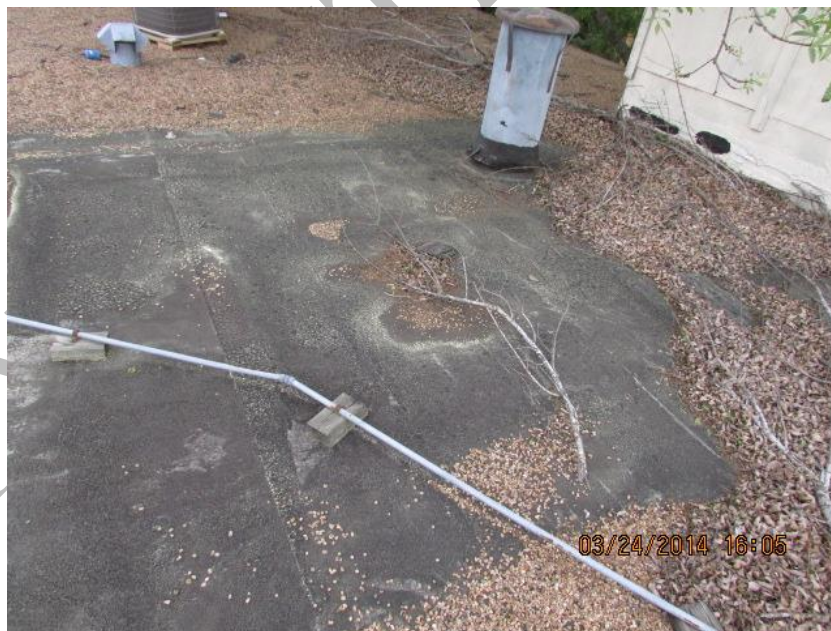
**PHOTO NO. 22**

Signs of ponding were observed on all buildings excepting building #s 4 & 12. See photo # 22.

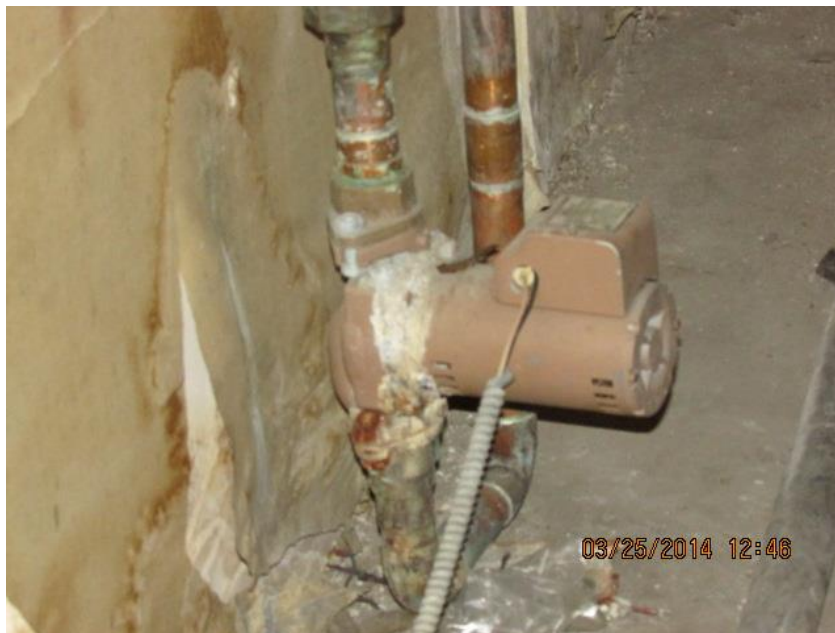
**PHOTO NO. 31**

Conduit on water circulating pump motor was not secured to the unit. See photo #31.

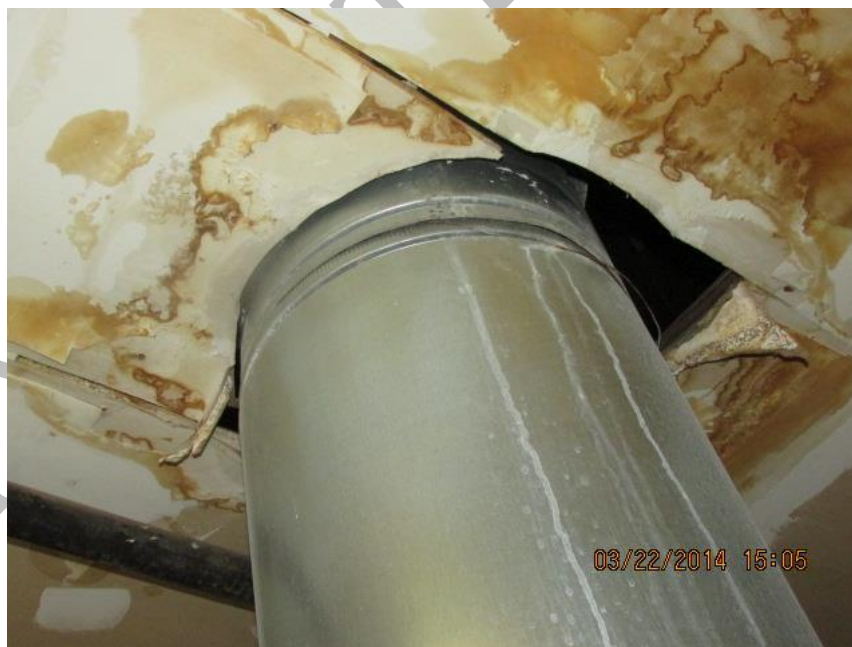
**PHOTO NO. 32**

Water heater vents did not have metal collar at ceiling and did not 1" clearance between unit and framing &/or other combustible materials as required by most water heater manufacturers-unsafe. See photo #32.

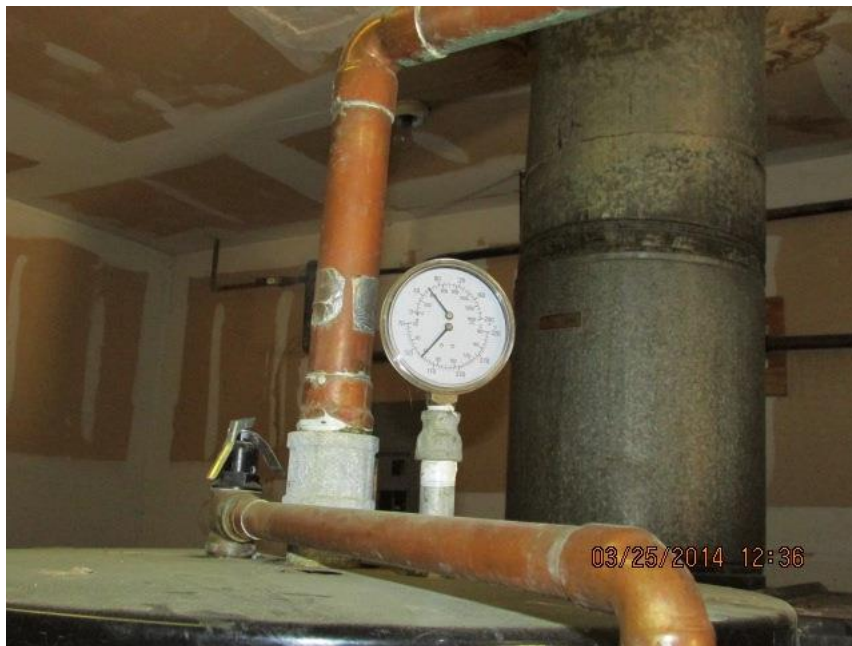
**PHOTO NO. 33**

Water temperature is too hot, scalding hazard, temperature measured above 120.0° F (observed 142° F at tank gauge). See photo #33. Water temp above 120 degrees F is a safety hazard. P2713.3. **The following temperatures will produce 2nd & 3rd degree burns on adult skin:**

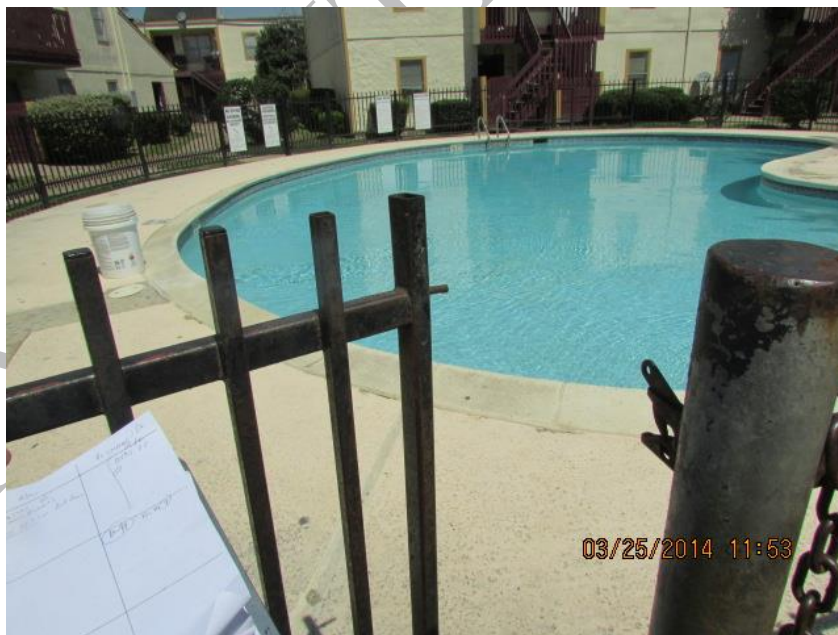
**PHOTO NO. 34**

1. Gate was not opening to the out. This presents a potentially unsafe condition and violates common industry practice. See photo #34.
2. Openings, within 18" of gate latch, were observed to be more than 1/2". See photo # 35.
3. Gate latch was discovered to be less than 54" high, however, the gate and barrier had openings larger than 1/2" within 18" of the release mechanism. See photo #34. This is required by common industry practice.
4. There were no handrails on steps to the pool. See photo #36.
5. Motor was not externally grounded. See photo #37.
6. One of the 2 drains was damaged-unsafe. See photo #38 (photo out of focus).
7. Pool light was on a sensor and could not be inspected, however, no GFCI was found to control the light from safety aspects.

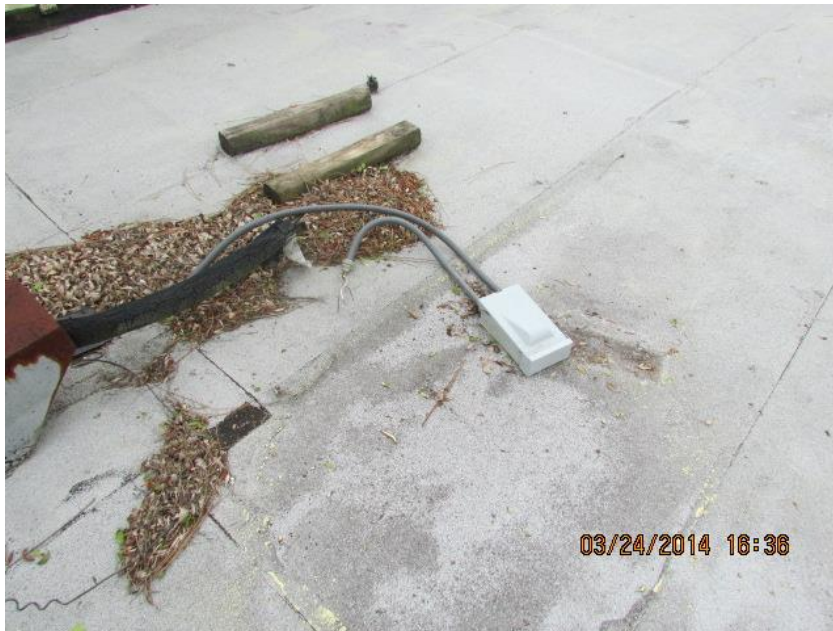
**PHOTO NO. 43**

Four condensing units were missing. See photo #43.

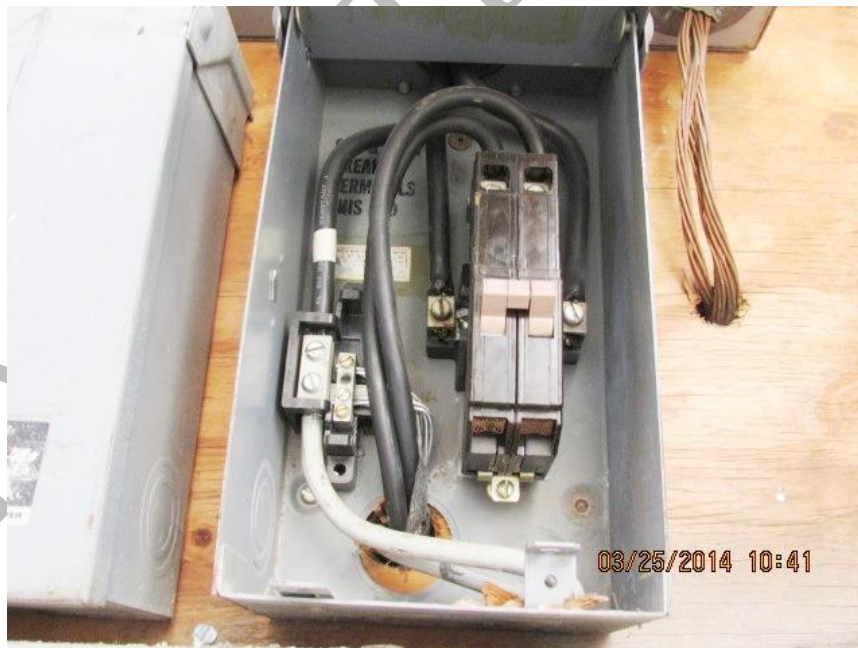
**PHOTO NO. 46**

All main and sub panels are identical for each apartment. The power is supplied by Cutler Hammer's 100 amp breaker main panel house in closets outside the building. All service and feeder wiring to the sub panel is aluminum. See photo # 46 for main panel and photo #47 for the sub panel. The sub panels are either located in clothes closet or laundry closet.

3. Bonding bushing was missing in the main electric panel at the entry of service conductors at the knockout. See photo #46.
4. There was no anti-oxidant compound on the exposed feeder aluminum wiring. Use of anti-oxidant prevents arcing and rusting of aluminum wires. See photo #ed 46 through 48.

5. Improperly identified neutral wire in left main/sub panel by taping. See photo # 46. It should be permanently identified.
6. Sub panels were not fully labeled or labeled at all.

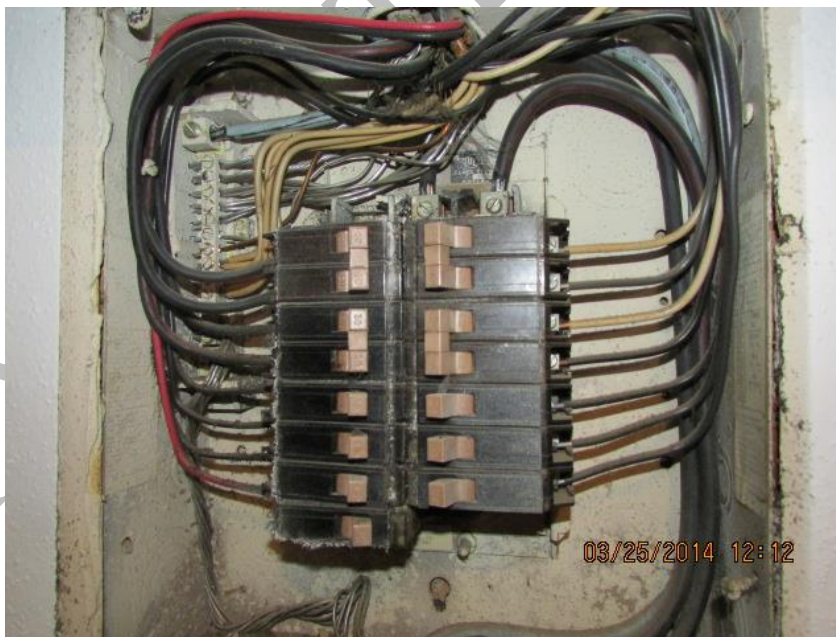
**PHOTO NO. 48**

8. The neutral wires (with white insulation) used as second hot were not re-identified or were not properly & permanently on 220 volt circuit(s). When using such wires as hot wires, they should be re-identified permanently for safety. All hot (ungrounded) conductors are required to be identified by the use of any color other than white, gray or green or bare copper. See photo # 48.

9. Neutral wires were double/triple lugged in neutral buss bar. Only one wire/screw is recommended. See photo # 48.

10. The sub panel(s) was(were) not properly wired. The neutral bus bar should be separate from ground bus bar. The neutral bus bar should be a floating bar with no contact with the panel or equipment grounds. The ground bus bar must be bonded to the panel. Each bus bar should be connected back to the main panel. Bonding these conductors is hazardous as it creates another path for current. See middle row left illustration. See photo # 48.

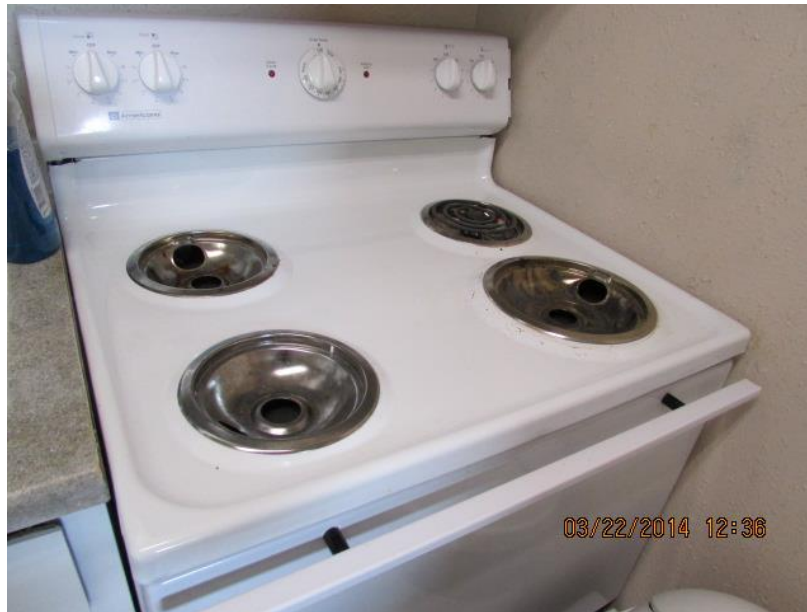
**PHOTO NO. 55**

1. The office stove made by Americana had 3 burners missing. See photo #55.
2. Anti-Tip brackets were not present on the office stove as well as all inspected apartment stoves. This presents a safety issue and should be promptly corrected.

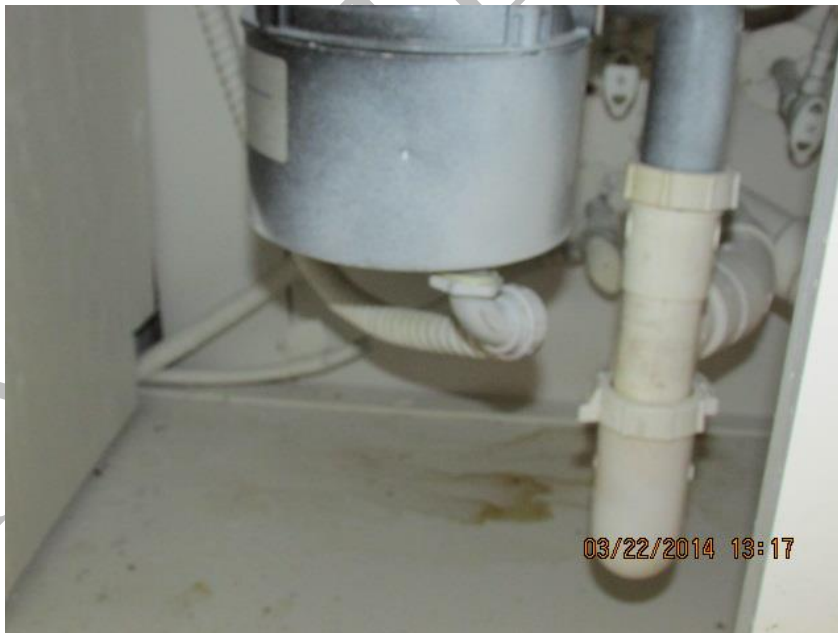
**PHOTO NO. 56**

3. The door for the oven did not seal adequately causing heat loss at oven door.
4. All the dishwashers lacked an air gap or backflow loop device. Air gaps are now standard equipment to assure a separation between supply and waste water and are recommended per common industry practices. It is advised that one be installed. See photo # 56.
