STRUCTURAL & MECHANICAL SYSTEMS SURVEYING REPORT

FOR PROPERTY LOCATED AT
**1234 FM ABCD EAST
HOUSTON, TX 77009**

Reg.: PROPERTY CONDITION SURVEY – 1234 FM ABCD East, Houston, TX 77009

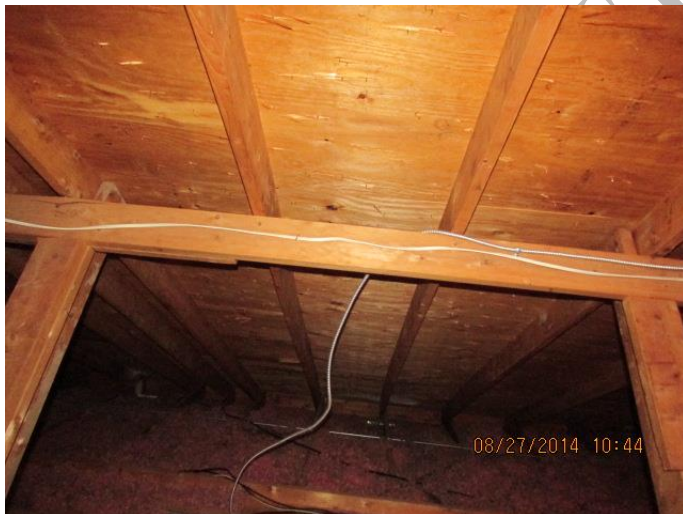
PHOTO NO. 15

3. Insufficient bracing or bracing exceeding standard 4' spacing. Installation does not comply with common industry standards and should be promptly attended to. See photo #15.

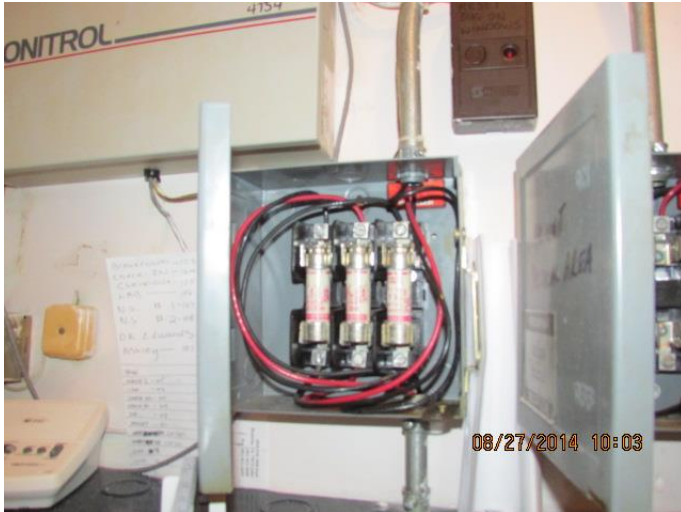
PHOTO NO. 29

1. Left fuse box had 3 phase wiring, however, the condensing units were single phase. See photo #29.

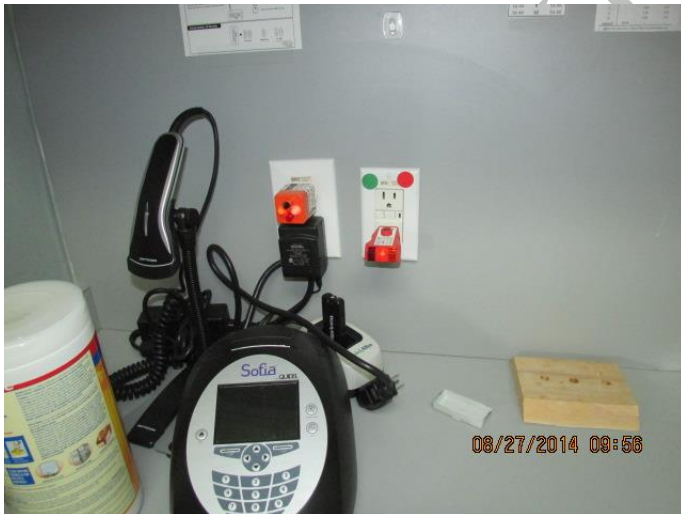
PHOTO NO. 31

1. The exterior outlets need a water proof bubble type plastic cover.
2. Ground fault circuit interrupters (GFCI) were not present &/or were inoperative on all the required receptacles {in the kitchen, wet bars, laundry room near sink, baths, exterior, hot tubs, pool, garage, unfinished basements, crawl space and other wet/potentially wet area(s)}. These were inoperative &/or missing on center service sink, laundry sink, and outside receptacles -a safety hazard. A ground fault circuit interrupter (GFCI) offers protection from shock or electrocution. The installation of a ground fault circuit interrupter (GFCI) is recommended. Such locations were marked with red dots for ease of identification of such receptacles. See photo #31.

3. Non-grounded or loose ground on 110 volt receptacles were observed, &/or grounded receptacles were installed on non-grounded (two conductor) wiring in several rooms/areas. This presents an unsafe condition because it gives the illusion of safety of grounded receptacles. Such locations were marked with green dots for ease of identification of such receptacles. See photo #31.

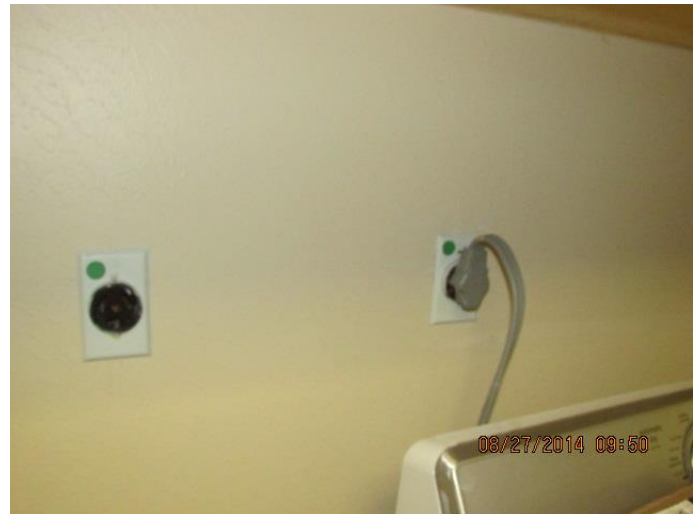
PHOTO NO. 32

4. Non-grounded 220 Volt dryer &/range plug was found. Does not comply with current National Electric Code (NEC) minimum standards and is unsafe as it has risk of electrical shock. Will not fit recently purchased dryer with 4 prong electrical plug. See photo #32.

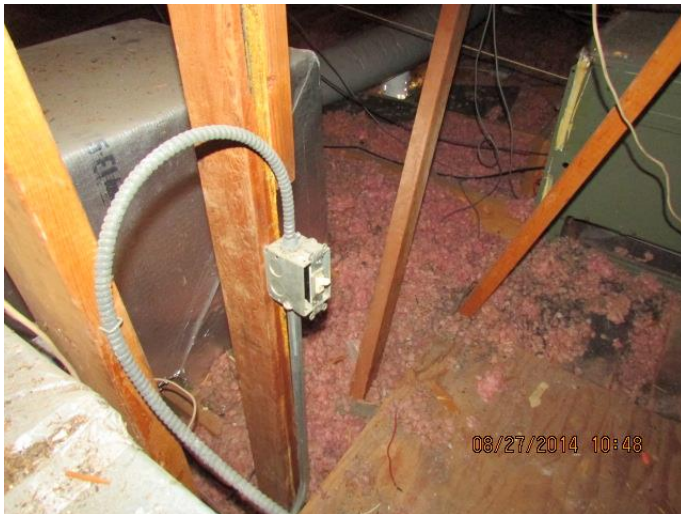
PHOTO NO. 33

5. Missing or damaged receptacle/switch plate(s) were observed. See photo #33.
6. Several lights were observed not working or missing bulbs.
7. Open wiring connections &/or termination without a junction box-unsafe and improper. It should be terminated in a junction box. See photo #34.

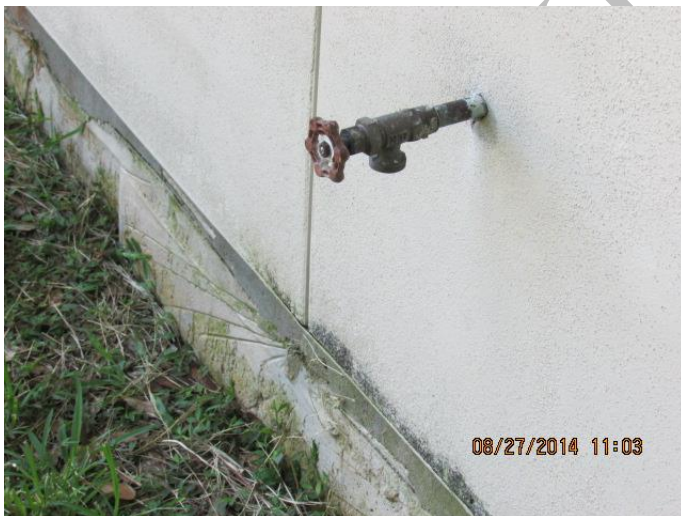
PHOTO NO. 35

1. Water pipes were not bonded as required per common industry practice {and NEC 250.104(B)}
2. Missing &/or damaged anti-siphon device(s) or back flow preventer(s) were discovered on one or more exterior hose spigot(s) and is recommended for safety by common industry practice (and IRC P2902.1). These should be installed to reduce the possibility of contamination of the potable water supply system. See photo #35.

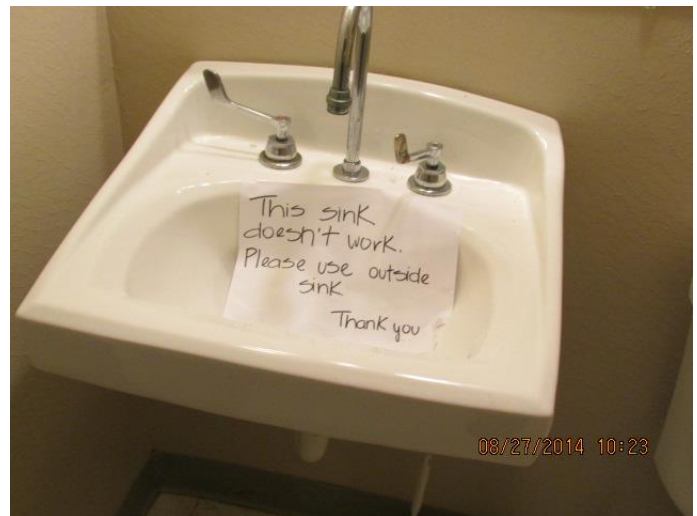
PHOTO NO. 36

3. Hand held sprayer was not fully operative on sink water in exam #2 as intended and thus wasting.
4. Left back 1/2 bath sink was inoperative. See photo #36.

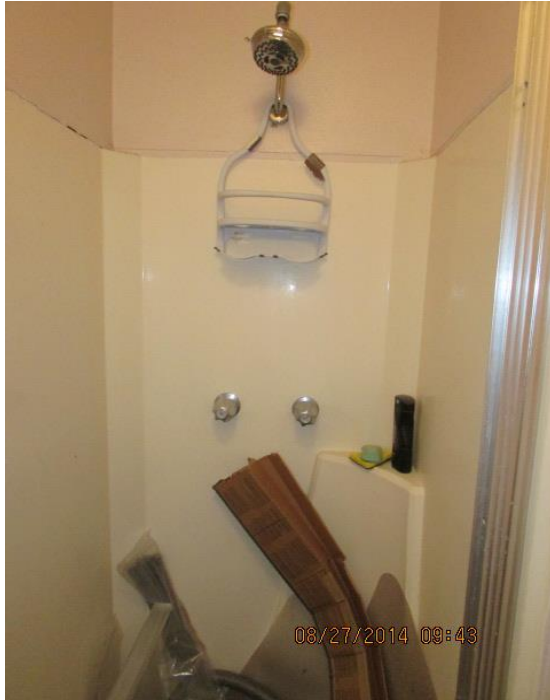
PHOTO NO. 37

5. Shower could not be inspected because of storage in it. See photo #37.
6. Hot & cold faucets of laundry room are not identified, color coded (red-hot, blue-cold). See photo #38.

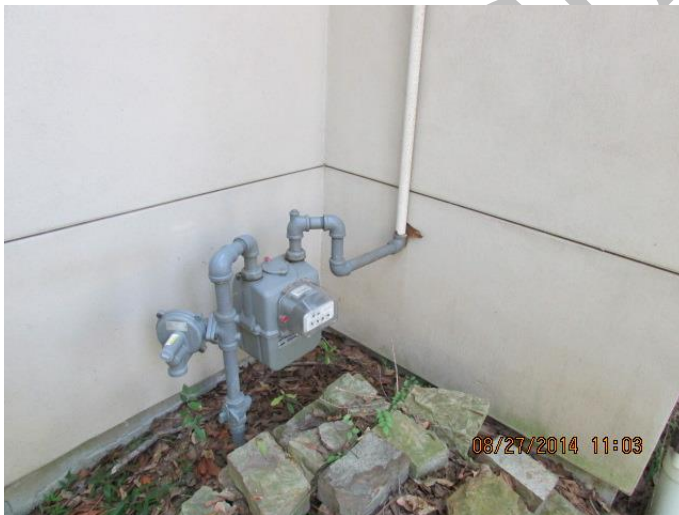
PHOTO NO. 39

9. Gas line was not bonded as required per common industry practice {and NEC 250.104(B)}. See photo #39.

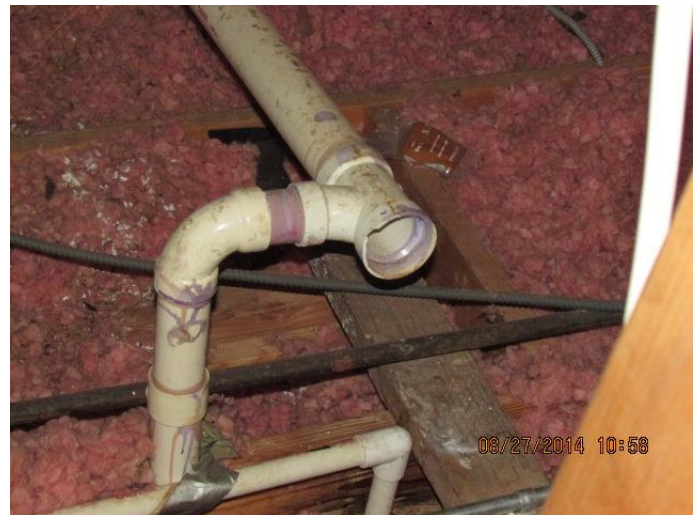
PHOTO NO. 40

1. Clean-out was discovered above ground and was a tripping hazard-unsafe.
2. Vent was open in the attic releasing sewer gases-unsafe. See photo #40.

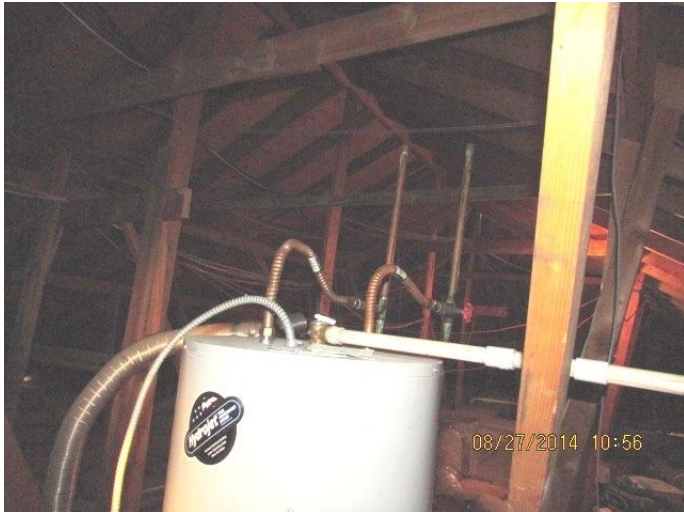
PHOTO NO. 41

3. No electrical service disconnect on or near unit-a potential safety hazard and does not meet current industry (and IRC T4101.5) requirements which recommend electric disconnect in sight or a lockable disconnect. See photo #41.

4. Water supply lines not insulated for first 6 feet at unit(s). See photo #41.
5. It appeared that TPR and pan drains were combined. They should be running independently and terminating outside to within 6" of ground and pointing down. P2803.6.1.6 and P2803.6.1.10. See photo #42.
