# PROPERTY INSPECTION REPORT ©2016

REPORT # SMC XX-03007BP

A SINGLE FAMILY RESIDENCE AT  
22861 XYZ DRIVE, PORTER, TX 77000

BY:  
JITENDRA M. VARMA, Professional Inspector # 3864

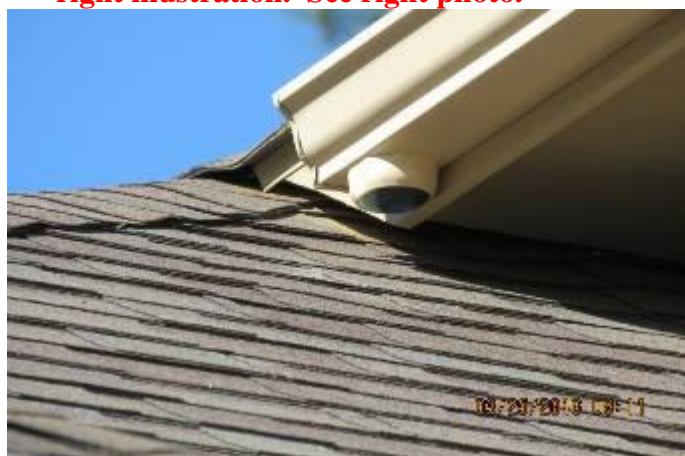
3. Downspout(s) &/or gutter drop(s) that were discharging onto the roof should be extended to discharge directly into the gutters below. This condition, if left unattended, can result in premature deterioration &/or failure and staining of the roofing, as the rain water washes the protective grit of the shingles which protects the roof from weather and ultra violet rays of the sun, on the downstream side of the downspout(s) &/or gutter drop(s). See left photo.
4. Missing kick out flashing at the junction of walls to divert rain water to gutters below or roof. See top right illustration. See right photo.

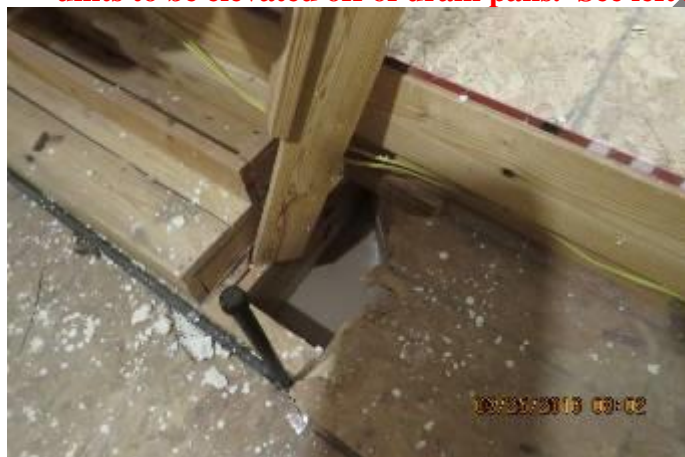
1. No proper size, unobstructed, safe and solid access and service platform was noted to furnace(s). A solid & unobstructed access 24" wide with a maximum length of 20' (50' if passageway 6' high), and a solid & unobstructed service platform minimum 30" deep and length equal to equipment width on the service side of the horizontal unit (& 30" deep all way around of a vertical unit) are recommended for safety purposes per IRC R1305.1.3. See top left illustration above. See left photo.
2. Step too high to service unit-unsafe.
3. No service disconnect within sight (IRC T4101.5) &/or service receptacle within 25' (IRC 3901.12) were discovered of the near unit(s)-potentially unsafe.
4. Furnace units sit directly on secondary drain pans. Manufacturer's installation instructions call for units to be elevated off of drain pans. See left illustration above. See right photo.
