REPORT # 23LGL-CONST-1107P DATE OF INSPECTION: 11/07/23 (10:00 AM) & 11/13/23 (09:30 AM)

123 ABC COURT, CONROE, TX 77385

CONSTRUCTION QUALITY REPORT

Subject Property: 123 ABC Court, Conroe, TX 77385

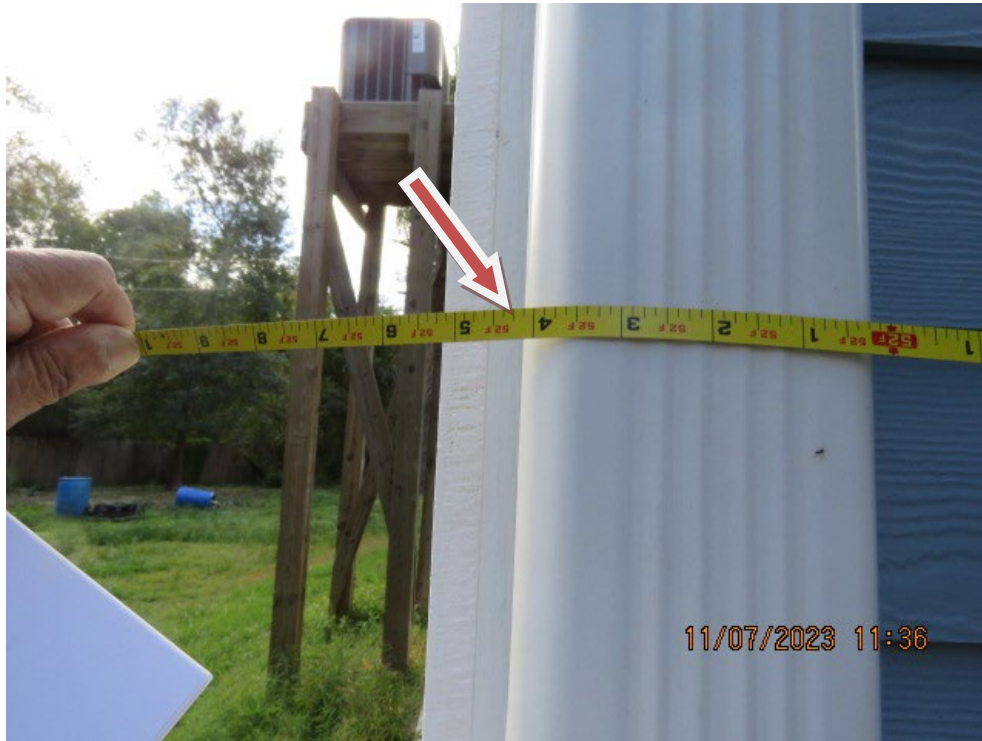
PHOTO #03

1. The structure was a straight up two-story box building. See cover photo.
2. Concrete pad around the building was measured at 30'-0" on front and back, and 54'-0" along sides. See photos #ed 01 and 02.
3. The building was measured, at the ground level, to be 28'-4" by 52'-4". See photos 03 and 04.
4. The concrete pad extension was observed to be 10" all the way around $\{(30'0"-28'4")/2$ and $(54'0"-52'4")/2\}$. See photo #05.

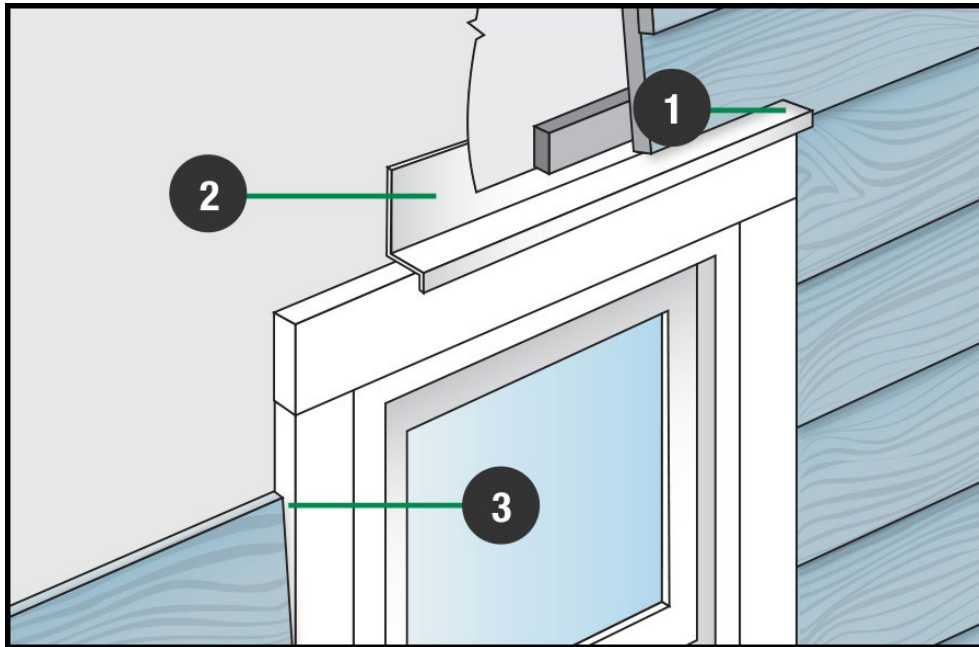
PHOTO #20

Note: Circled 2 indicates flashing in the Photo #20.

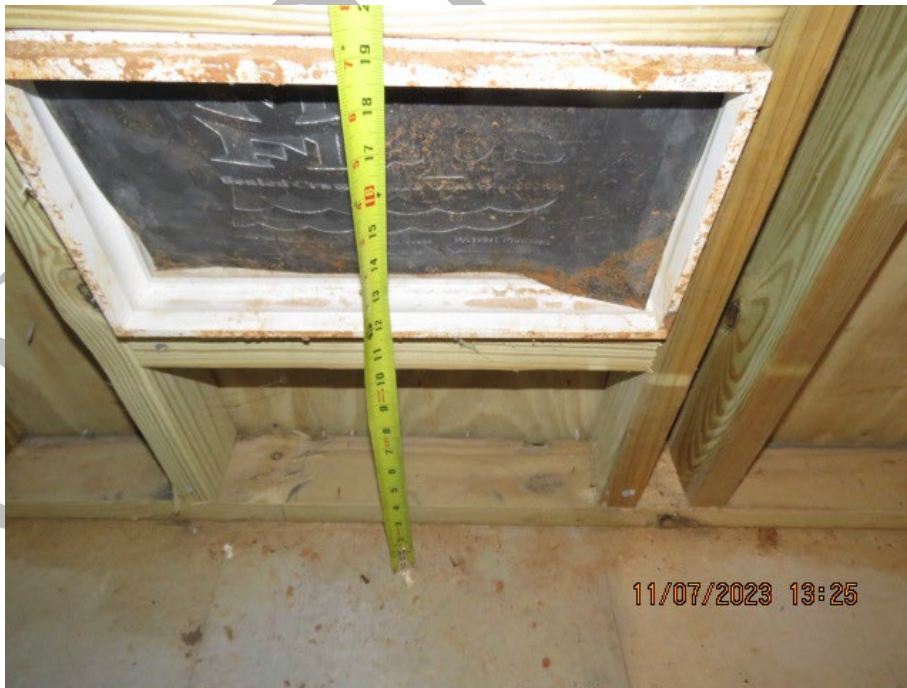
PHOTO #29

1. Most of the vents were closed defeating the basic purpose of having vents. See photo #29.

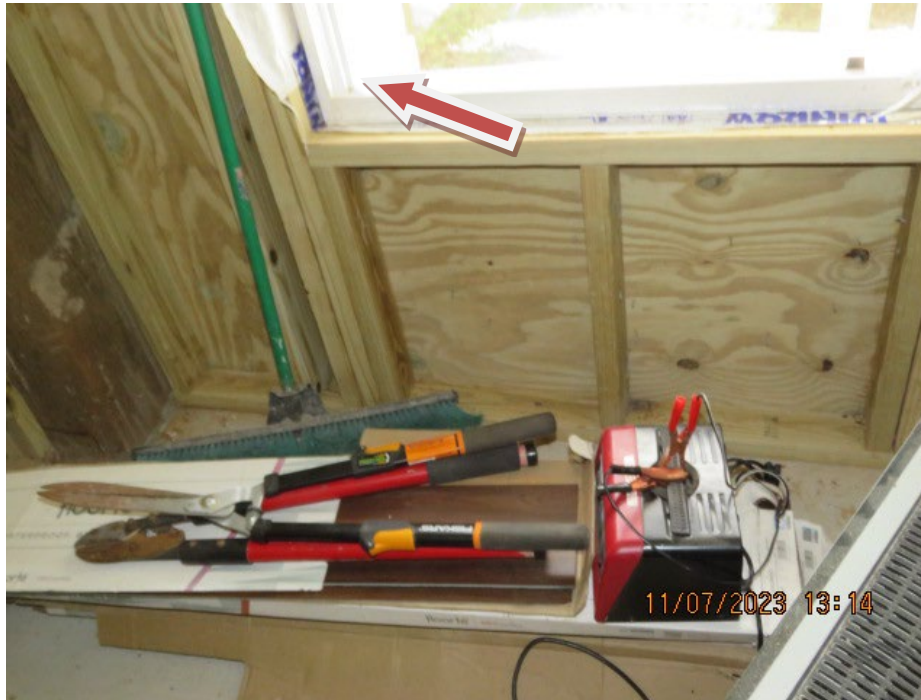
PHOTO #32

4. The said window did not have ANSI or CPSC tempered glass label. See photos #ed 32 and 33. Arrow on photo 33 shows typical location of safety etching on glass near a corner.

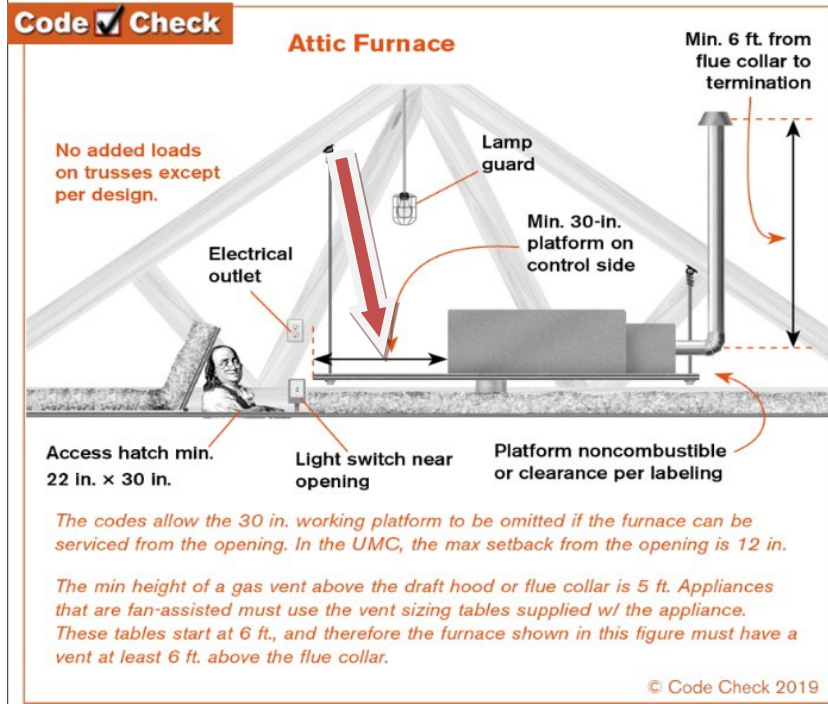
PHOTO #51

A solid & unobstructed access 24" wide with a maximum length of 20' (50' if passageway 6' high), and a solid & unobstructed service platform minimum 30" deep and length equal to equipment width on the service side of the horizontal unit (& 30" deep all way around of a vertical unit) are recommended for safety purposes per IRC R1305.1.2. See code illustration as photo #51.

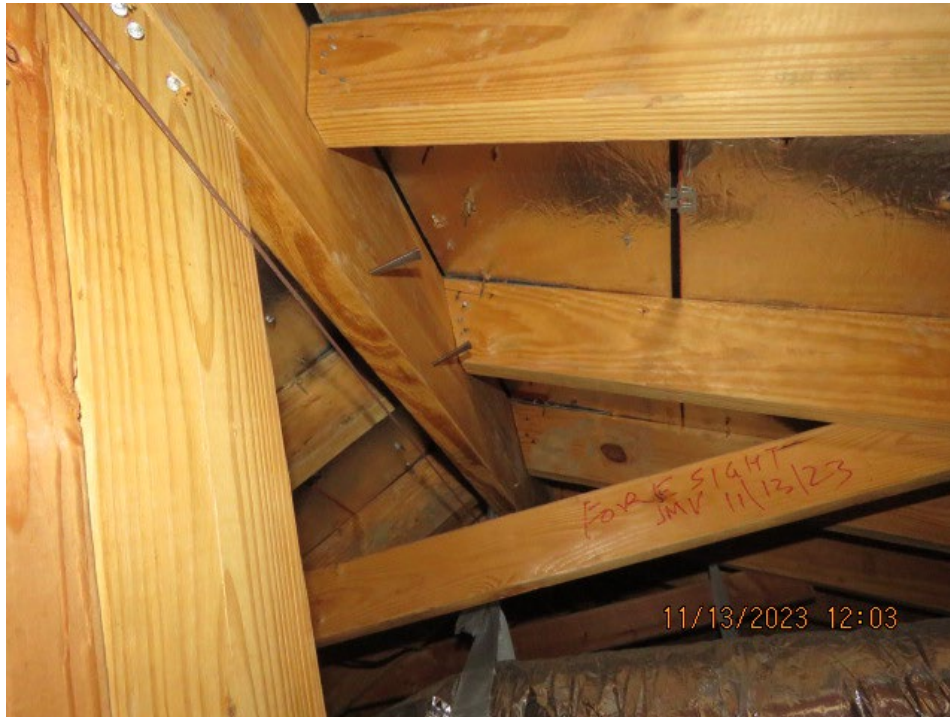
PHOTO #55

5. There was no safe access to examine purlin struts over the dining room on the left near front and the access was blocked with duct work (photos # 53 and 54). It was observed from a location past the furnace. This location was marked on the collar tie. See photo # 55. It appeared from this location that purlin struts were directly resting on the ceiling joists. See photo # 56 with arrow pointing to struts.

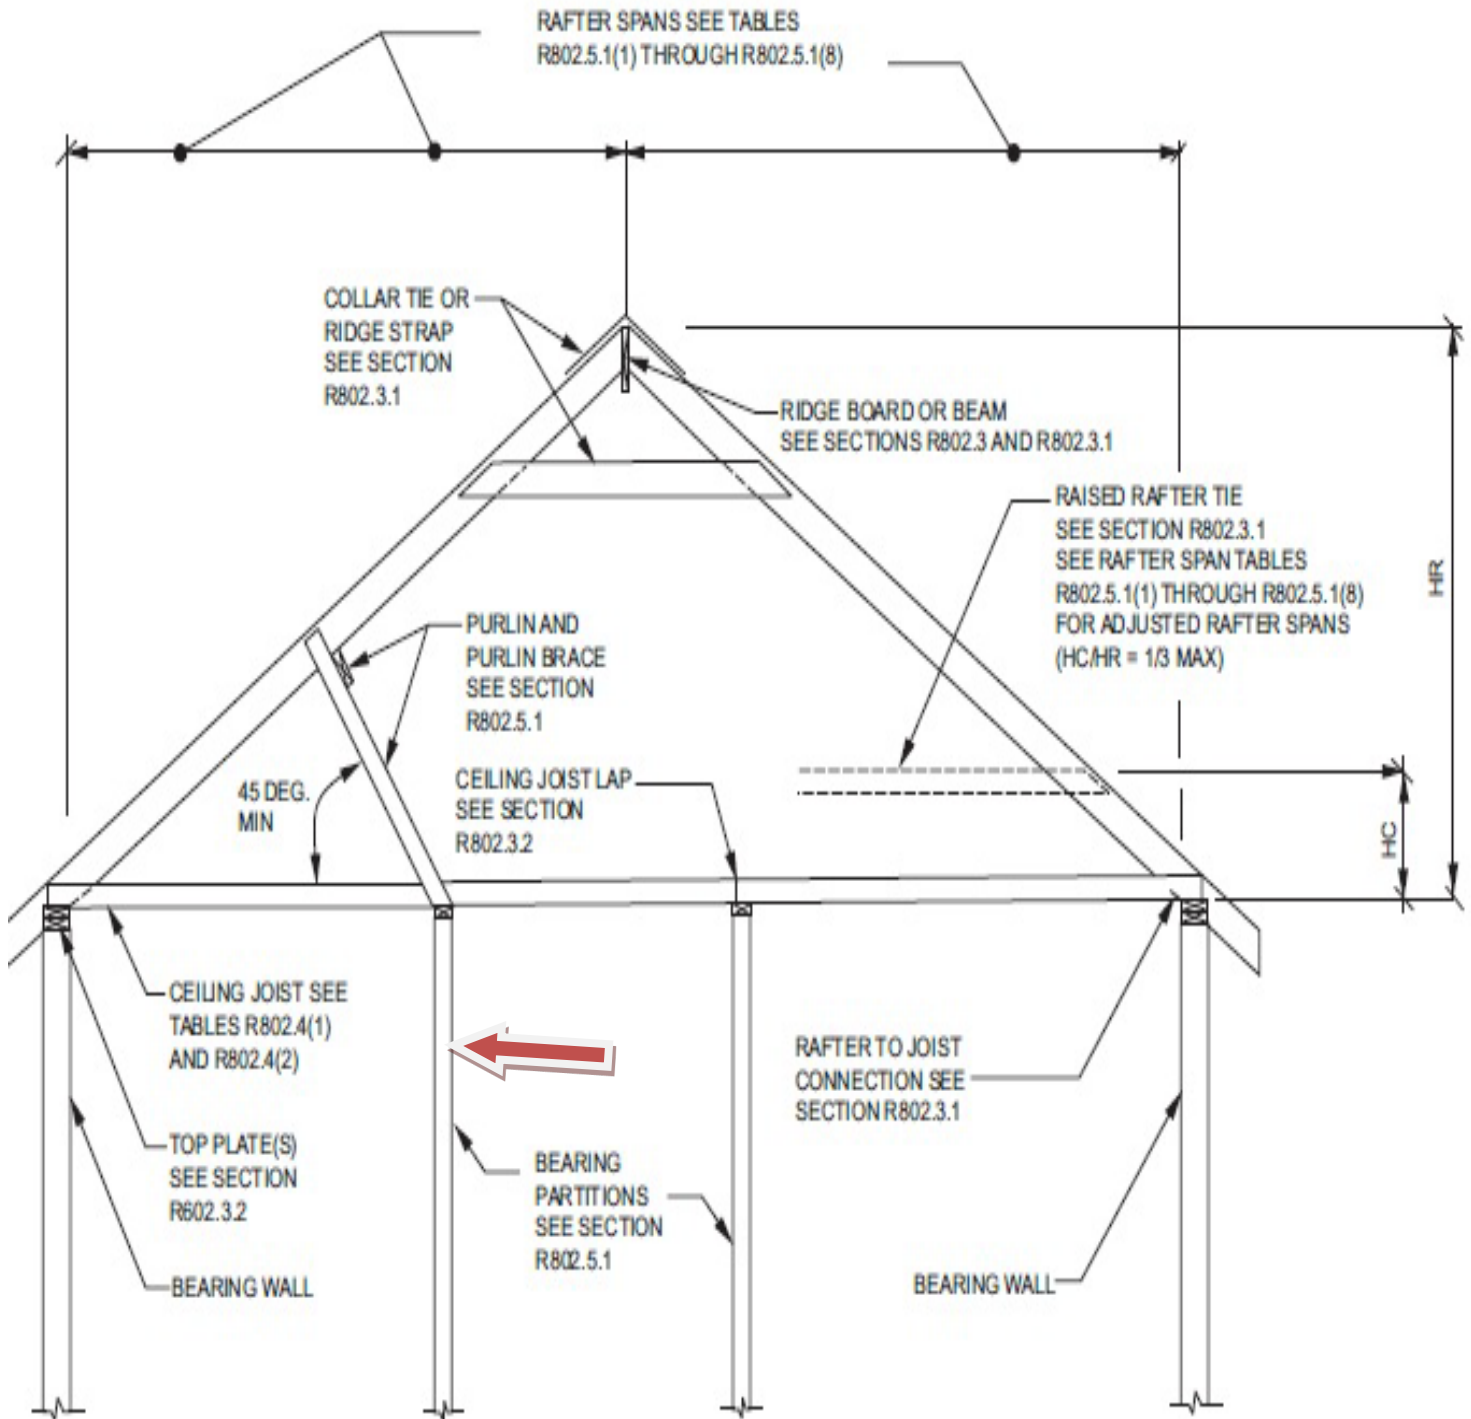
PHOTO #57

Purlin struts are required to be supported on to interior bearing partitions per IRC Code 805.4.5 (see Illustration as Photo #57).

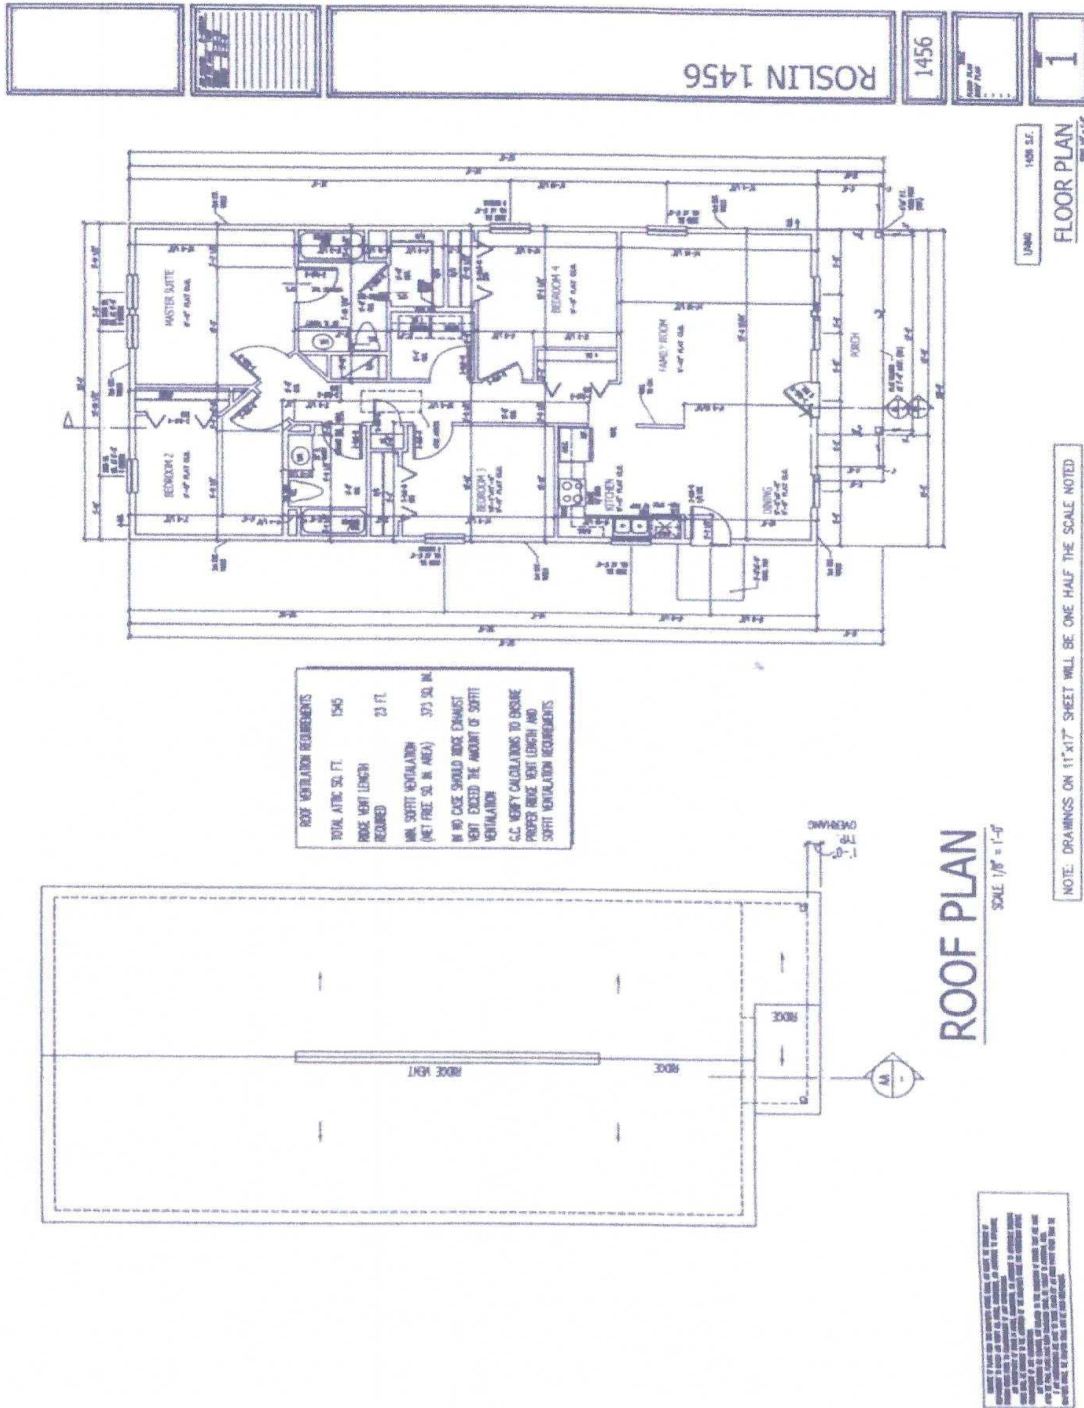
PHOTO #58

Reviewing the floor plan, there was no wall between family room and dining room near front. See Floor Plan (photo # 58). Studying the Ceiling Joist Plan, it appeared that 2x8 joists were placed at 16" on centers on 2x6 joists 16" centers on left side (dining room). See Ceiling Plan (Photo #59). That signaled that purlin ends were resting directly on ceiling joists near front over dining area. Ceiling joists are not designed to carry heavier roof loads.
