**123 ABC COURT, CITY, TX 12345**

REPORT NO.: **23LGL-CONST-1107P**

## CONSTRUCTION QUALITY REPORT

Subject Property: **123 ABC Court, City, TX 12345**

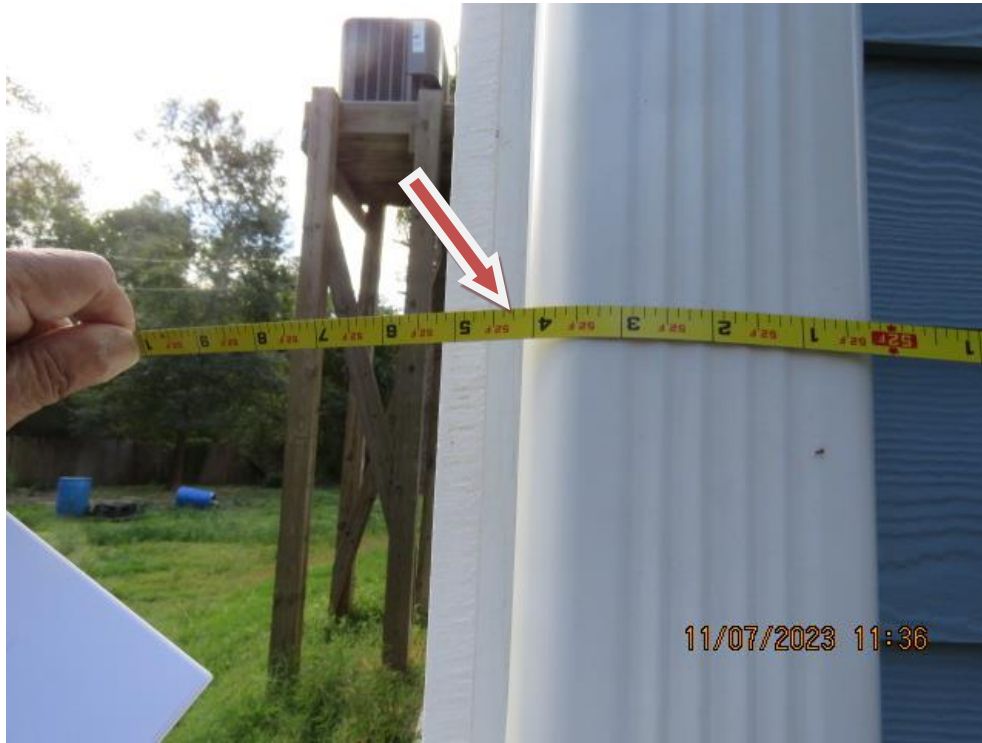
PHOTO #03

1. The structure was a straight up two-story box building. See cover photo.
2. Concrete pad around the building was measured at 30'-0" on front and back, and 54'-0" along sides. See photos #ed 01 and 02.
3. The building was measured, at the ground level, to be 28'-4" by 52'-4". See photos 03 and 04.
4. The concrete pad extension was observed to be 10" all the way around  $\{(30'0"-28'4")/2 \text{ and } (54'0"-52'4")/2\}$ . See photo #05.

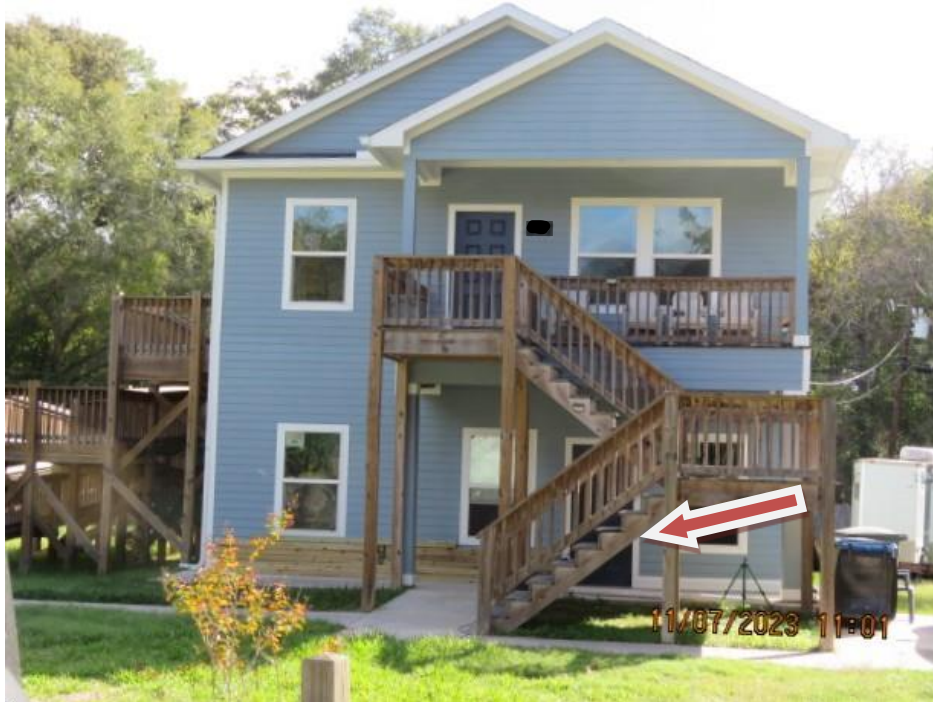
**PHOTO #08**

7. Door to the first-floor storage area had one window on right side and two windows on left of the door, (photo # 08).
8. The Floor Plan Drawing 1 showed one window on left of the door and 2 window on right of the door. (high-lighted). See photo # 09.

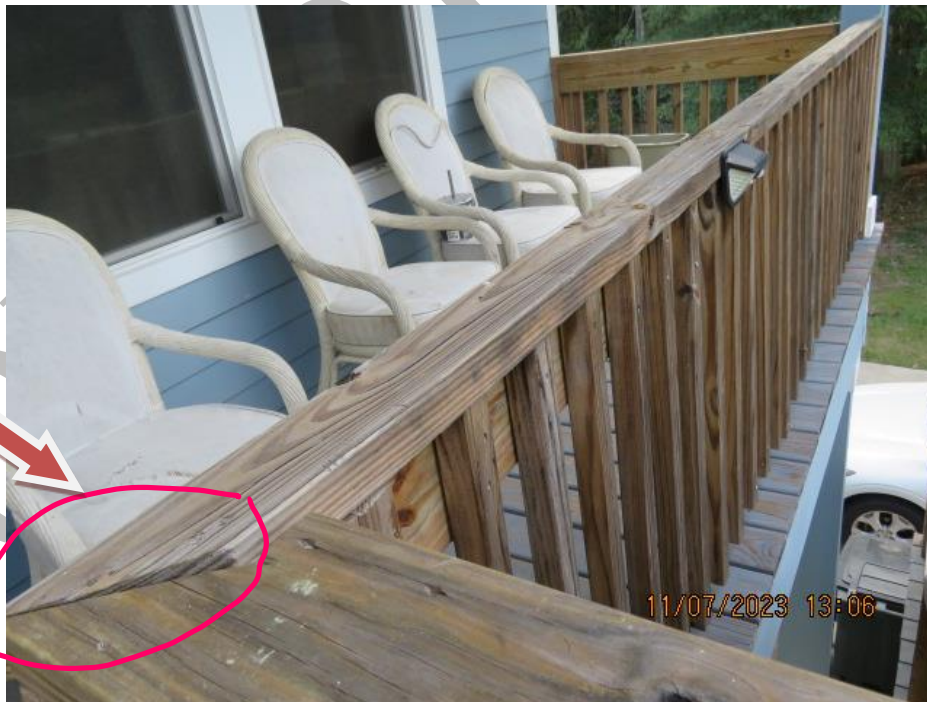
**PHOTO #15**

11. Hand rail was warped, twisted and lifted off the supports. See Photos #ed 15 and 16. Photo #16 depicted a closer view of the far end.

**This condition was happening as the builder did not use shanked nails or wood screws which bite into the meat of the wood and prevent them popping out.**

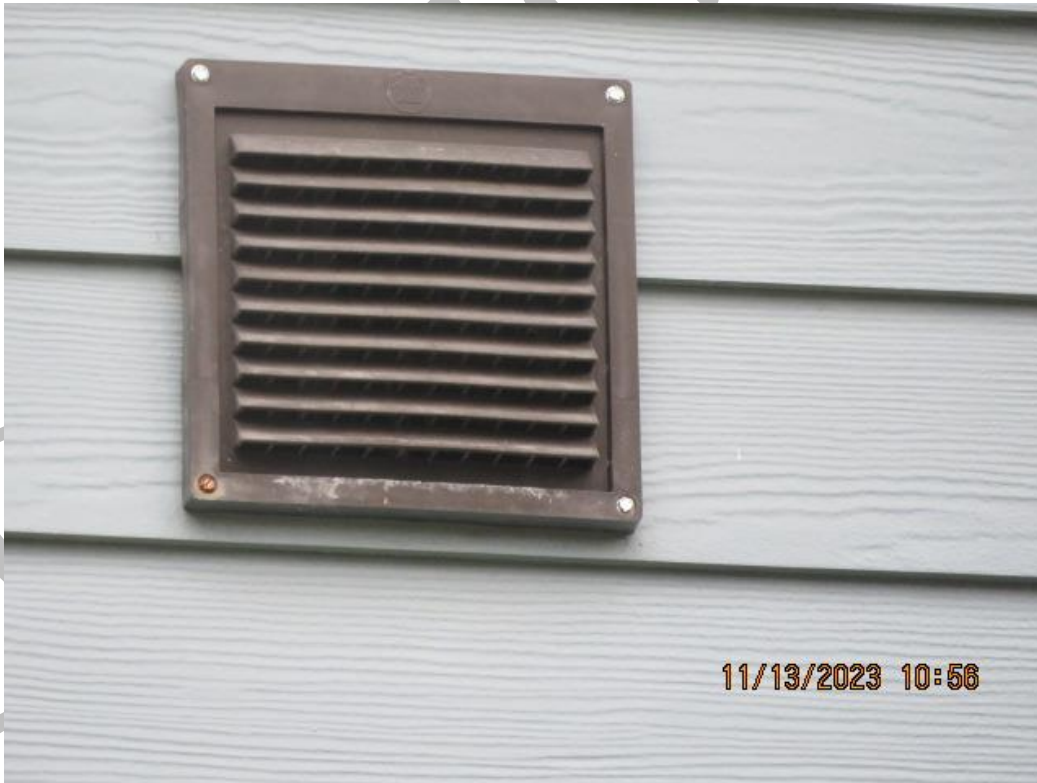
PHOTO #21

13. Fixed louvers were discovered on clothes dryer vent. See photo #21.

**Backdraft damper should be used on the exhaust vent as required by 2021 IRC 1502. Fixed louver allows rats and vermin entry into the dryers through the exhaust ducts. See illustration as photo #22.**

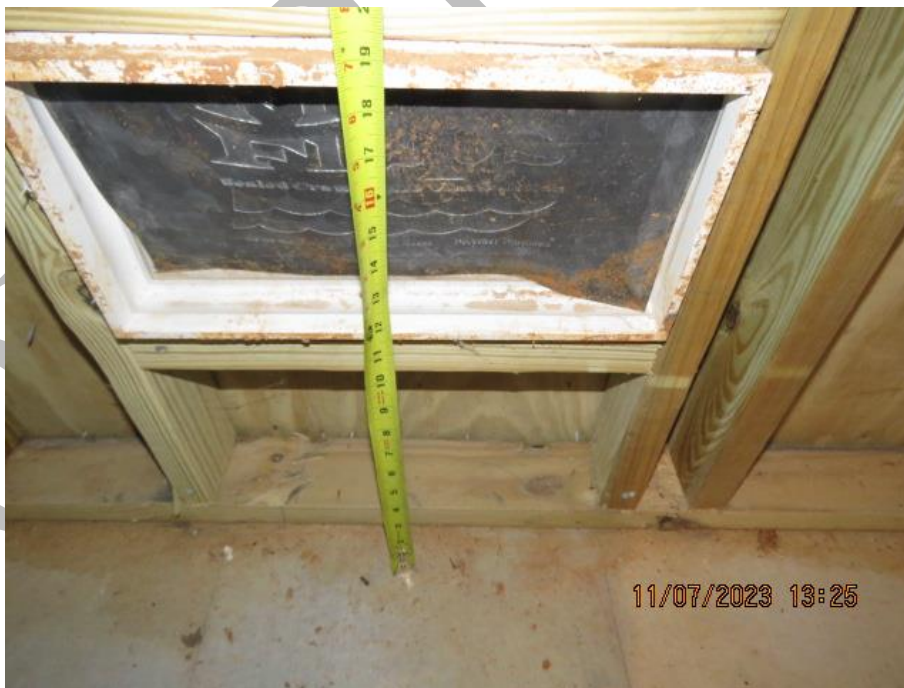
PHOTO #29

1. Most of the vents were closed defeating the basic purpose of having vents. See photo #29.

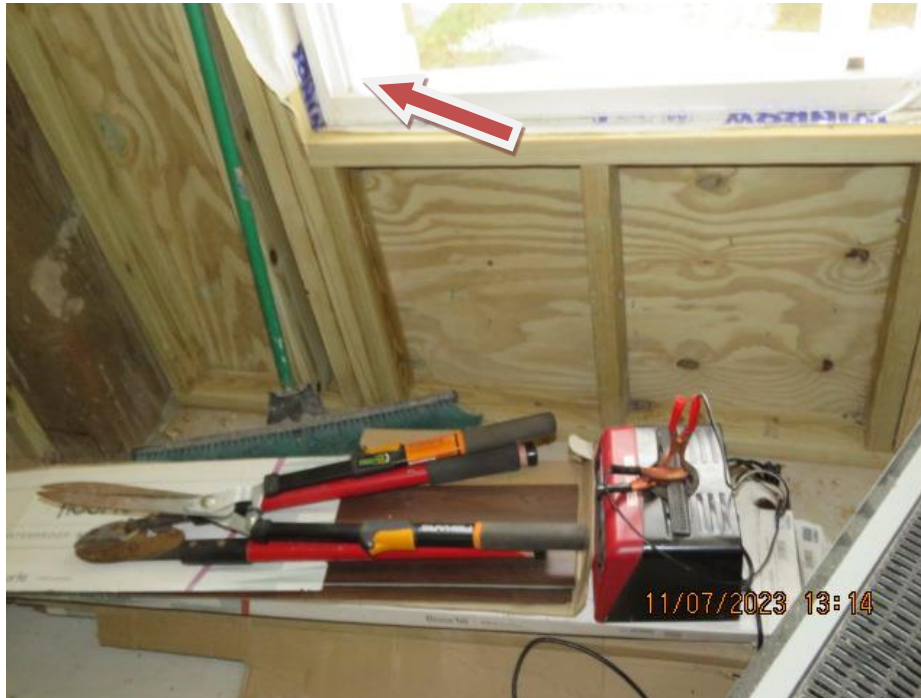
PHOTO #32

4. The said window did not have ANSI or CPSC tempered glass label. See photos #ed 32 and 33. Arrow on photo 33 shows typical location of safety etching on glass near a corner.

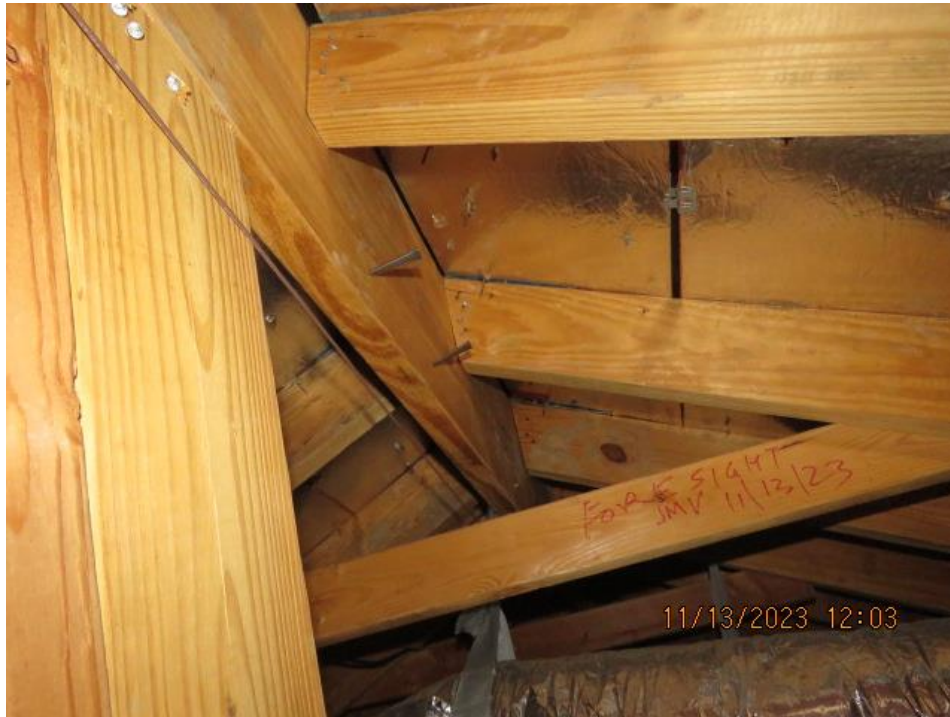
**PHOTO #55**

5. There was no safe access to examine purlin struts over the dining room on the left near front and the access was blocked with duct work (photos # 53 and 54). It was observed from a location past the furnace. This location was marked on the collar tie. See photo # 55. It appeared from this location that purlin struts were directly resting on the ceiling joists. See photo # 56 with arrow pointing to struts.

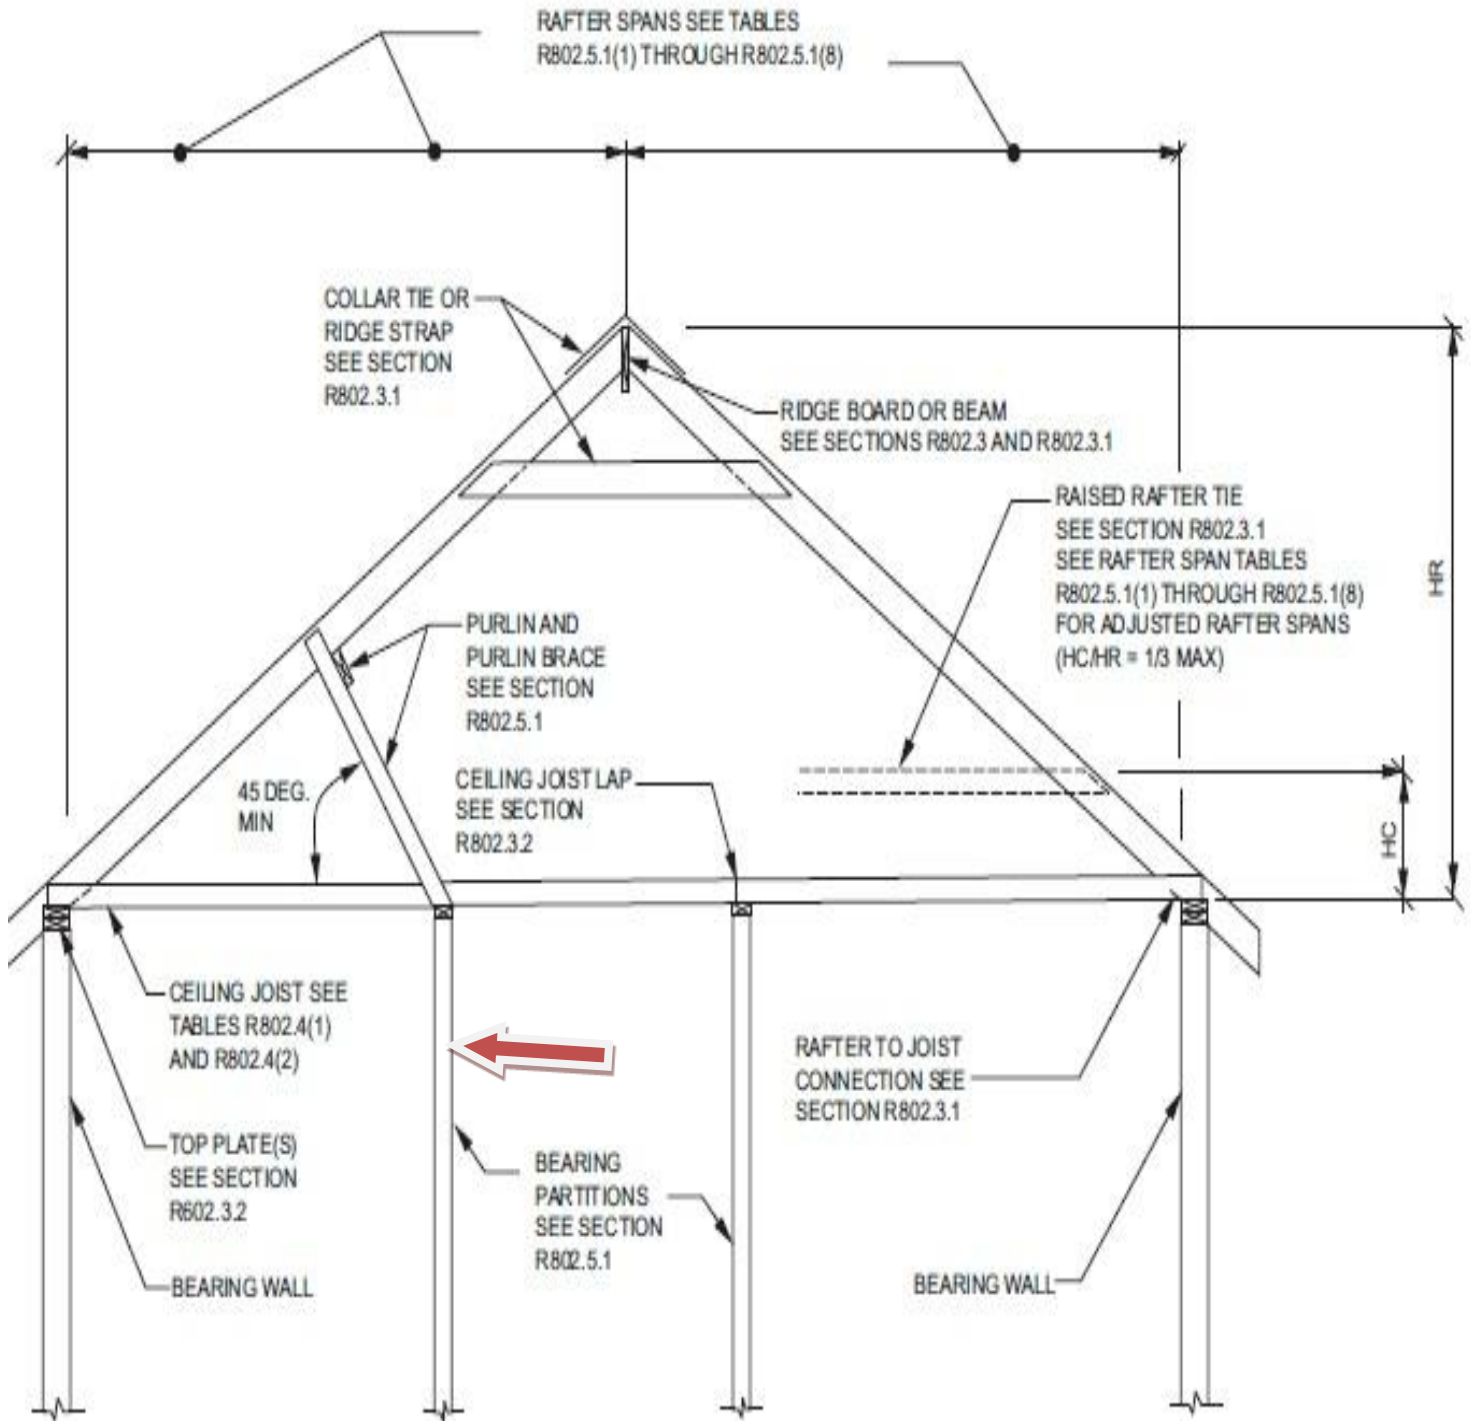
**PHOTO #57**

**Purlin struts are required to be supported on to interior bearing partitions per IRC Code 805.4.5 (see Illustration as Photo #57).**

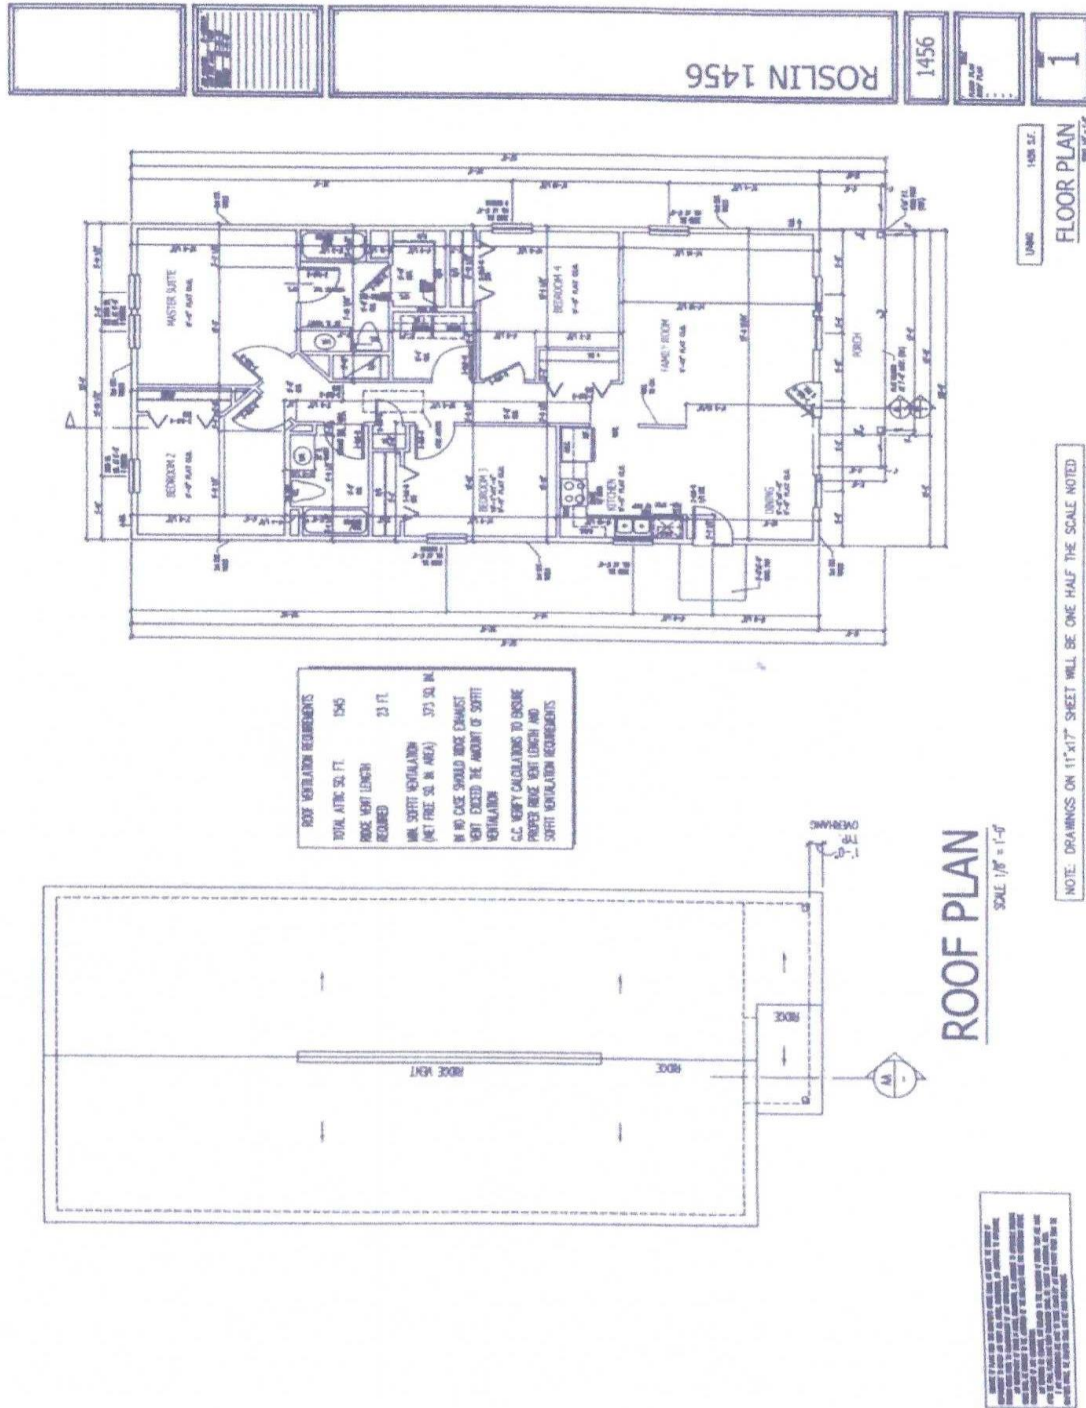
PHOTO #58

**Reviewing the floor plan, there was no wall between family room and dining room near front. See Floor Plan (photo # 58). Studying the Ceiling Joist Plan, it appeared that 2x8 joists were placed at 16" on centers on 2x6 joists 16" centers on left side (dining room). See Ceiling Plan (Photo #59). That signaled that purlin ends were resting directly on ceiling joists near front over dining area. Ceiling joists are not designed to carry heavier roof loads.**
