REPORT NO.: **XXLGL-CONST-XXXXP**

FOUNDATION INVESTIGATIVE REPORT

Subject Property: **123 XYZ Street, Friendly City TX 77XXX**

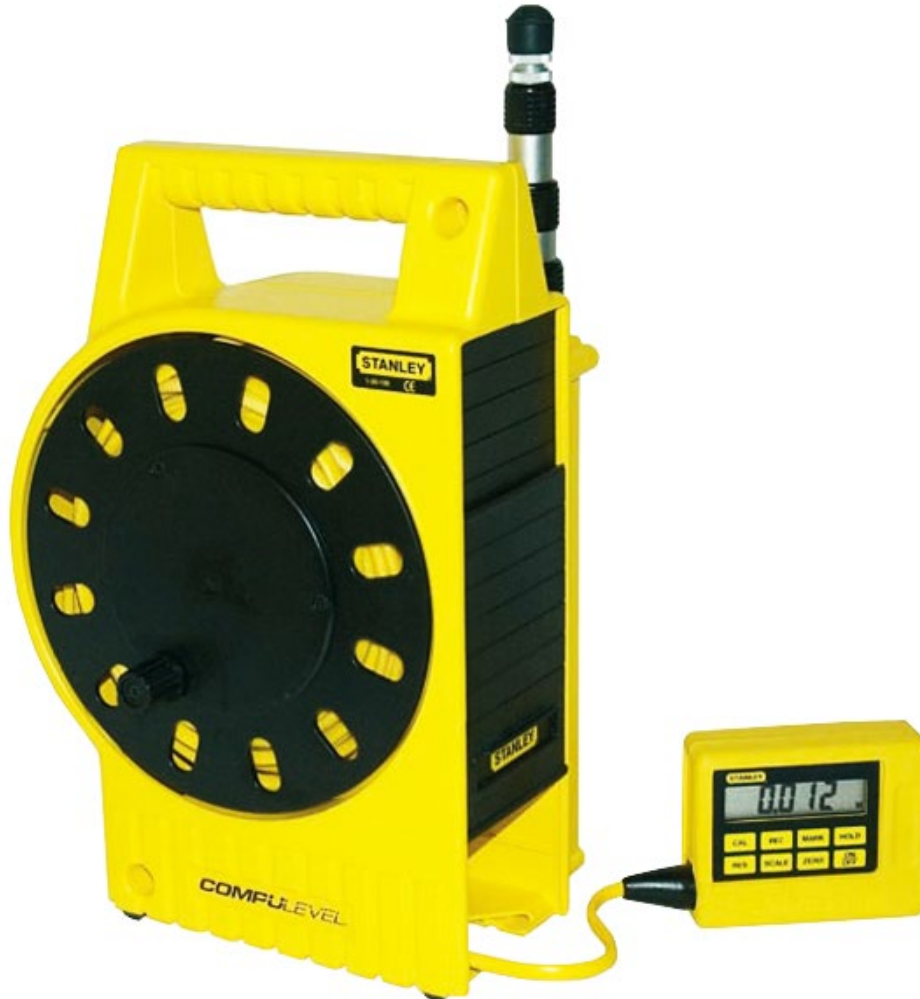
PHOTO #19

*It's a self-contained altimeter instrument that needs only one person to set/observe/verify floor elevations. The instrument has a base unit and connected to a display unit through a 100 feet cord. As such, it has the capability of covering an area of 200' diameter. See photo # 19.
